# **Conductive Filament Formation Failure in a Printed Circuit Board**

Keith Rogers, Craig Hillman, and Michael Pecht  
CALCE Electronic Products and Systems Consortium  
University of Maryland  
College Park, MD 20742

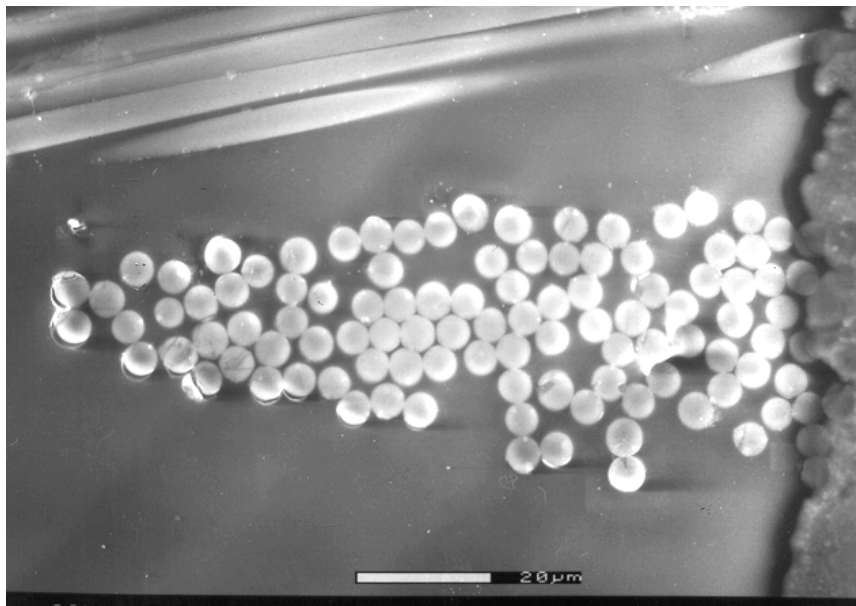
**Figure 2b (820x):** After thermal cycling, several instances of interfacial degradation (debonding) can be seen to have occurred at the fiber/epoxy resin interface.

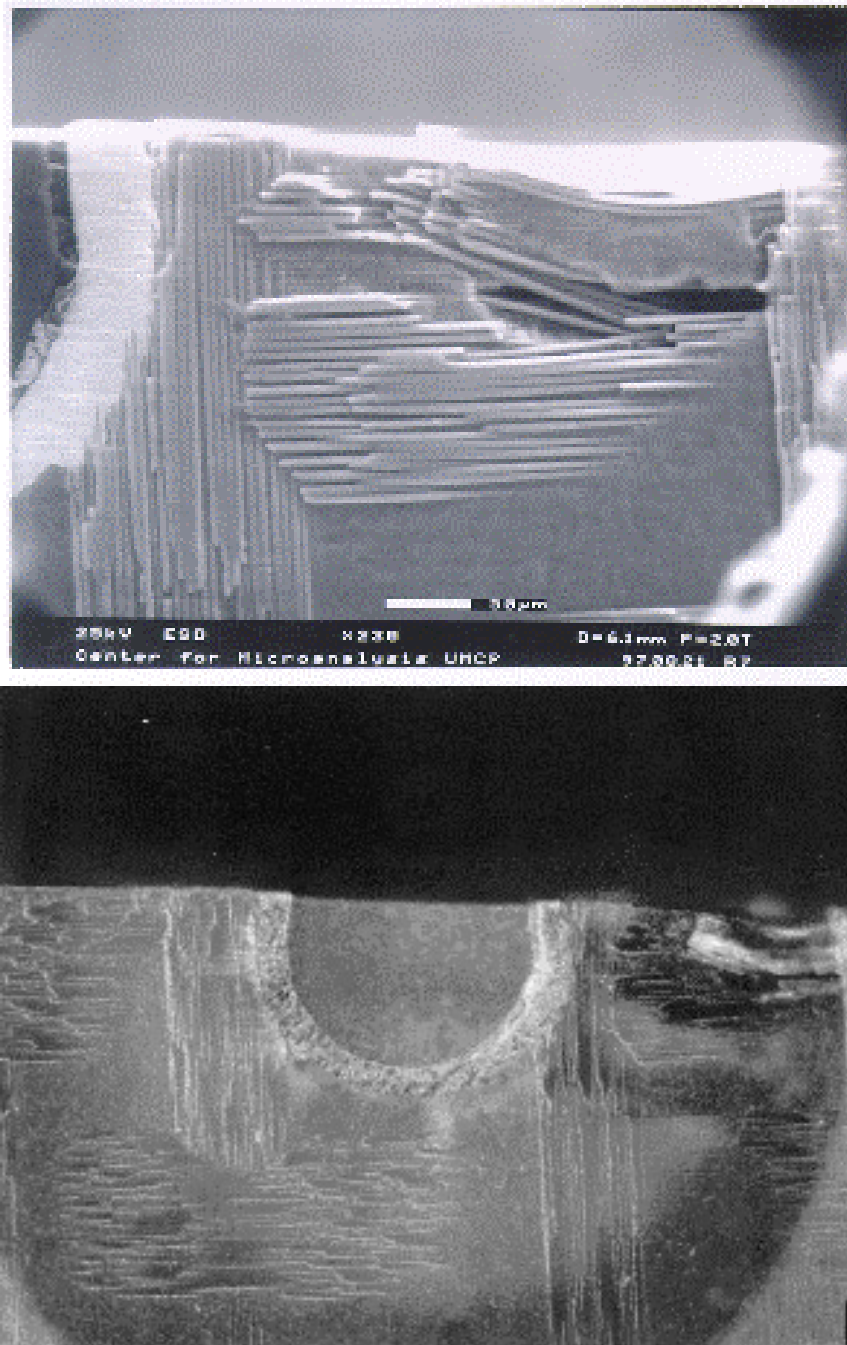
**Figure 3:** (a) An optical micrograph (100x) shows a view of the interior of the PCB, parallel to the fiber weave. The plated-through-hole (PTH) and the area identified as the location of electrical failure are marked. (b) This electron micrograph (230x) is a higher magnification of the area of electrical failure marked in Figure 3a. The epoxy resin matrix is deformed and cracked and many of the reinforcing glass fibers are broken.

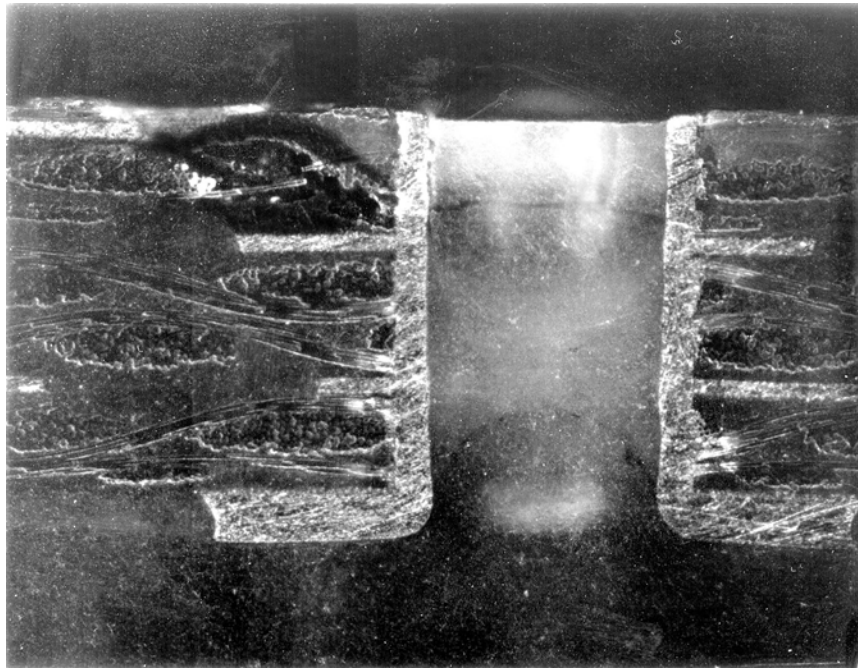
**Figure 4a (100x):** This optical micrograph shows a cross-section of a PCB that has failed by conductive filament formation (CFF). In the top left corner of the plated-through-hole (PTH), a dark, hollow region is observed. This charred region was identified as the area of electrical failure. It can be seen to extend from the outer wall of the PTH to the copper trace observable at the far left hand side of the picture.

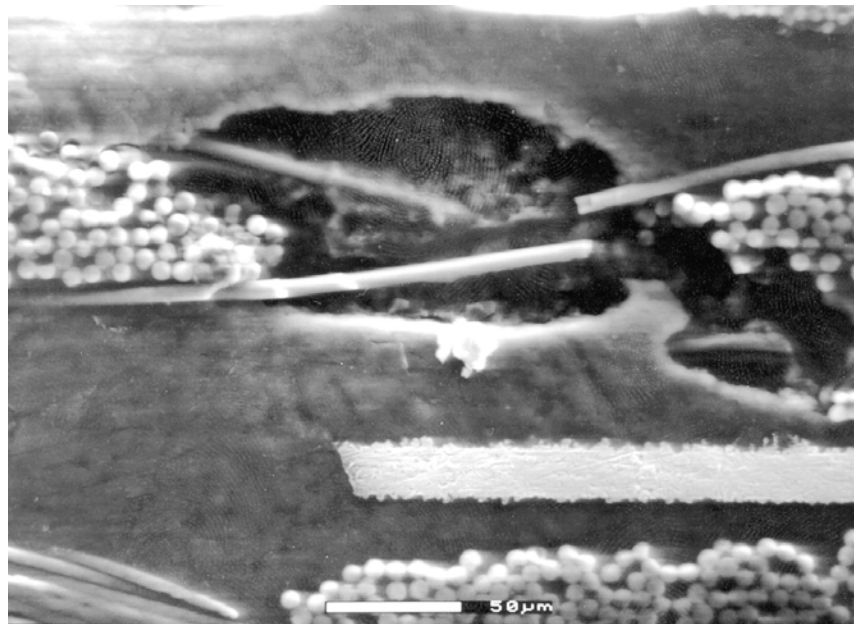
**Figure 4b (360x):** This electron micrograph is a higher magnification of the area of electrical failure marked in Figure 4a. Note the dark hollow region, suggesting some of the epoxy resin has vaporized. Several broken glass fibers can also be identified.
