Identification of Missing or Insufficient Electrolyte Constituents in Failed Aluminum Electrolytic Capacitors

Craig Hillman and Norman Helmold

CALCE, University of Maryland

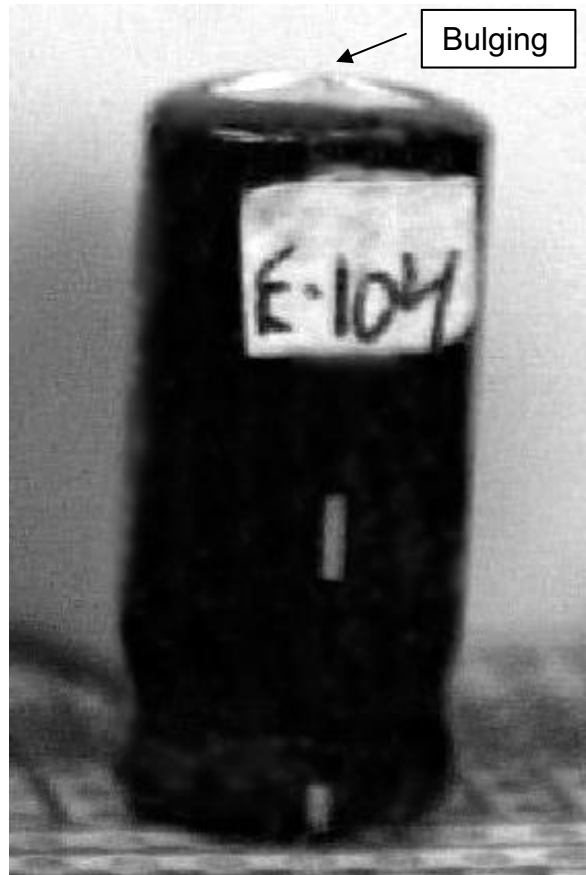
Beginning in late 2001, a number of online newsgroups and industry publications started reporting the early failures of low effective series resistance (ESR) aluminum electrolytic capacitors manufactured in Taiwan. The most obvious characteristic of these failures was the bulging of the capacitor enclosure prior to loss of electrical function (see Figure 1). These capacitors had been produced in the millions under contract to multiple capacitor suppliers, and they had widespread use in the mass-produced electronic products of several companies, potentially causing the early failure of hundreds of thousands of end units.

Figure 1: A bulged 1000 microfarad, 10 volt, aluminum electrolytic capacitor manufactured in Taiwan in 2002. The photograph has been retouched to obliterate manufacturer identity information.
