A Novel Approach to Identifying and Validating Electrical Leakage in Printed Circuit Boards through Magnetic Current Imaging

Craig Hillman

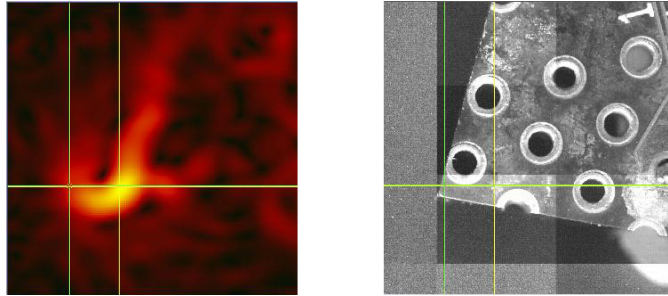
The results from performing SQUID microscopy on a shorted board are displayed in Figure 1. The bright yellow area on the current map corresponds to the area of highest current density. This is representative of necking down of the conductor path, which is often a strong indication of an electrical short. Cross-sectioning of the board was performed at this location based upon the SQUID image.

Figure 1: Current map (left) and corresponding photograph (right) of an electrically shorted printed circuit board.

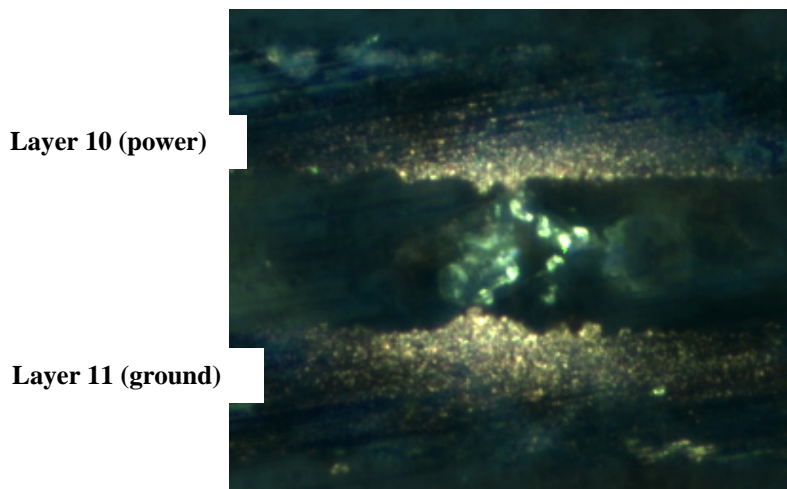
The results of the cross-sectioning are displayed in Figure 2. A large, angular particle is observed bridging the dielectric between the power and ground planes. Tangential evidence, including mounding of copper at the power and ground planes and blackening of the surrounding dielectric material, strongly suggested that the particle was the cause of the drop in internal resistance. Definitive findings were provided through SQUID imaging of the cross-section

Figure 2 (500x): Particle identified between internal power and ground planes in the approximate area of electrical leakage.

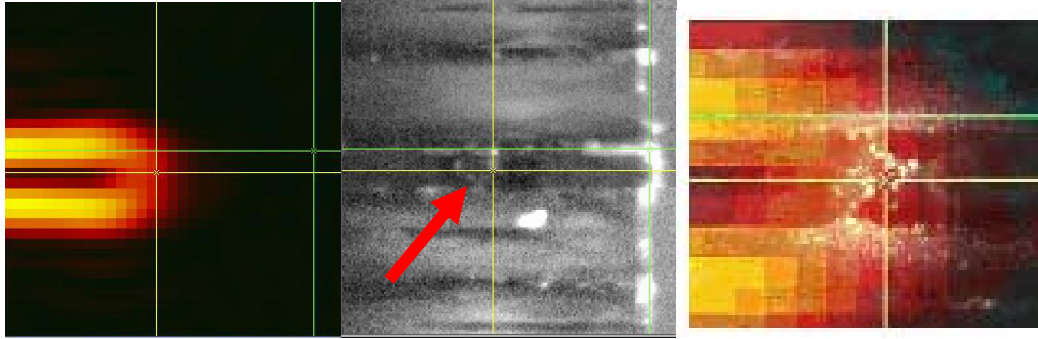
The SQUID images are shown in Figure 3. The results clearly demonstrate that current is flowing through the particle, therefore verifying that the identified particle is the location of the short. However, bridging alone can not explain the electrical failure. This is because the angular nature of the particle suggests that it is electrically insulative. An additional mechanism, known as electrochemical migration (ECM), was most likely required.

Figure 3: Current map (left) and corresponding optical image (center) of the board cross-section shown in Figure 2. The red arrow identifies the particle sandwiched between layers 10 and 11. A higher resolution overlay is shown on the right.

In conclusion, based on a review of potential failure mechanisms, measurement of relevant parameters, and the results of SQUID microscopy, the process of electrochemical migration around or through the particles was determined to be the most likely root-cause of electrical shorting between power and ground. Actual physical evidence of a conductive path was not observed. This is not surprising. A calculation of the conductor thickness, assuming that the conductor is a copper slab and that the particle is about 2 mils on a side, shows that the conductor is probably 2 to 5 nanometers thick. This calculation explains why the conductor was not seen optically. Even if the resistance prediction, similar to copper, was overly generous, an increase in resistance by three orders of magnitude would still only result in a conductor with a thickness of 2 to 5 microns. In this situation, magnetic current imaging with the SQUID was critical to validate the identified particle as the site of the electrical failure.
