Technical Case Study: **Projection Lamp Failure Analysis**

DfR Solutions recently investigated the reduced reliability of projection lamps used onboard many wide-body jet aircraft for showing movies and safety videos.

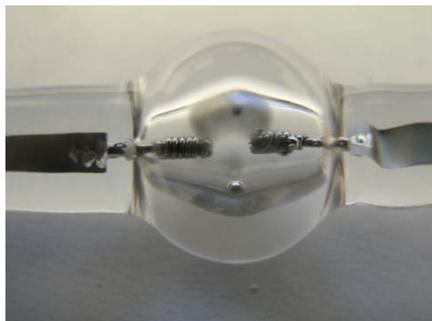
Pristine Bulb

Upon comparing a pristine bulb to a bulb that had undergone 150 power cycles, the team found noticeable differences between the two bulbs. The cathode electrode in the power-cycled bulb was shorter and the end of the electrode was flat. In addition, the starting coil on the electrode had been consumed, as shown in the picture below.

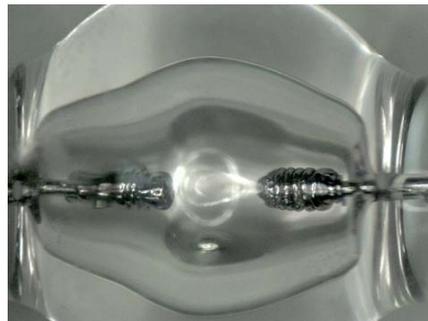
Power-Cycled Bulb

Further observation by the DfR team indicated that the electrode tip was vaporized during repeated ignition. As the tip is vaporized, hot air rises vertically from the electrode and cools, depositing the electrode material on the inside of the bulb. The DfR team noted a blackening of the glass where the electrode material was deposited.

More and more material was deposited as the power cycling continued, causing a metallic growth to form at the blackened area. In addition, the temperature of the glass around the deposit increased relative to the surrounding glass, creating a “hot spot.” As the temperature reaches the melting point of glass, the bulb will eventually rupture and fail.
