## Identification of Missing or Insufficient Electrolyte Constituents in Failed Aluminum Electrolytic Capacitors

Craig Hillman and Norman Helmold

CALCE, University of Maryland

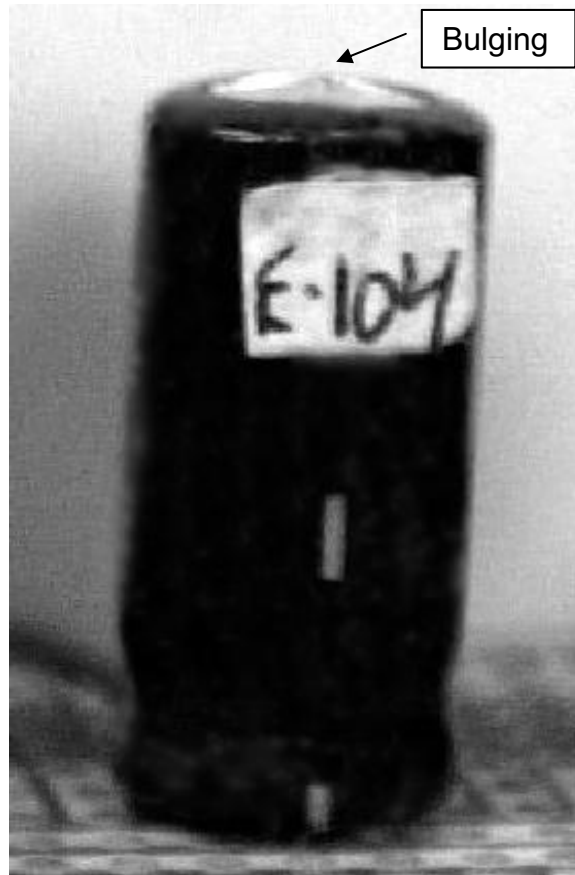
Beginning in late 2001, a number of online newsgroups and industry publications started reporting the early failures of low effective series resistance (ESR) aluminum electrolytic capacitors manufactured in Taiwan. The most obvious characteristic of these failures was the bulging of the capacitor enclosure prior to loss of electrical function (see Figure 1). These capacitors had been produced in the millions under contract to multiple capacitor suppliers, and they had widespread use in the mass-produced electronic products of several companies, potentially causing the early failure of hundreds of thousands of end units.

Figure 1: A bulged 1000 microfarad, 10 volt, aluminum electrolytic capacitor manufactured in Taiwan in 2002. The photograph has been retouched to obliterate manufacturer identity information.

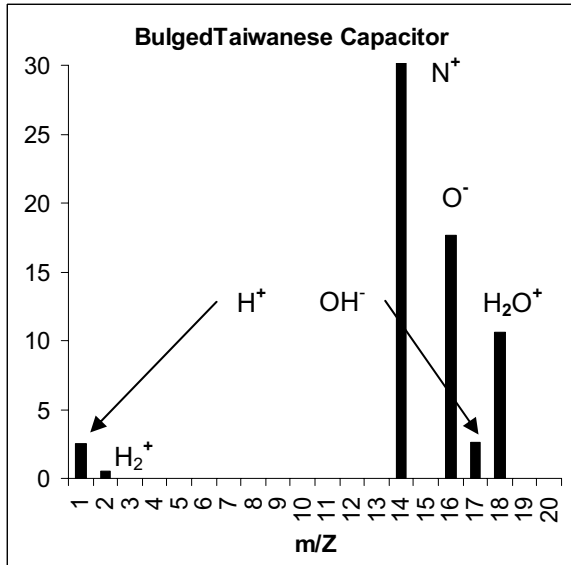
The initial effort was to establish cause of the case bulging. Based on an understanding of electrolyte chemistry and knowledge of similar failures from older generations of electrolytic capacitors, it was speculated that hydrogen evolution was initiating the increase in internal pressure. Mass spectroscopy of gas emanating from several punctured bulged capacitors confirmed this hypothesis (see Figure 2).

Figure 2: Mass spectrograph of the gas from a Taiwanese 1000 microfarad, 10 volt, aluminum electrolytic capacitor that had just started to bulge.

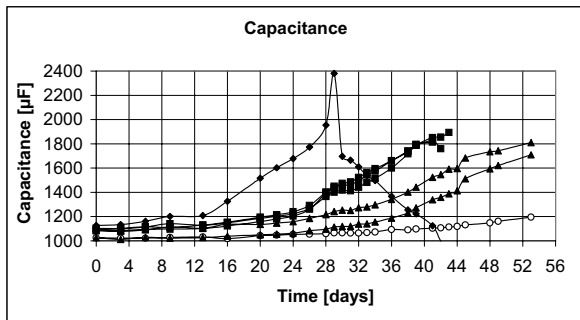
temperature. The capacitance was found to increase slowly up to 1100 microfarads, at which point the rate of capacitance rise increased significantly and leakage current exceeded manufacturer's specifications. This trend continued until seal breakage and electrolyte loss, at which point capacitance and leakage current plummeted and ESR increased (see Figures 4, 5, and 6).

Figure 3: Capacitances of capacitors from the bulging Taiwanese lot tested at 55°C at a bias of 3.3 volts. Diamonds indicate the earliest failure, which has complete data. Squares indicate the second group of failures; data collection for these was terminated after they blew their cans off. Triangles indicate the third group of failures, which had just started to bulge. Circles indicate a capacitor just starting to produce a significant quantity of gaseous hydrogen.

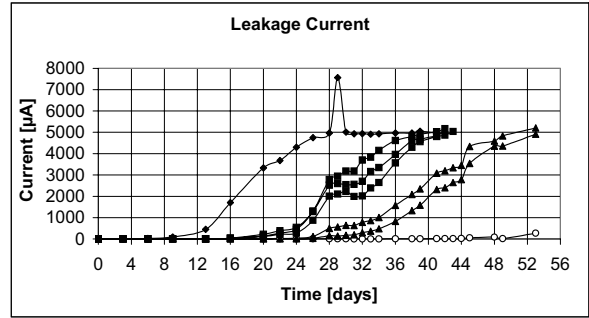
Figure 4: Leakage current of capacitors from the bulging Taiwanese lot tested at 55°C at a bias of 3.3 volts. Diamonds indicate the earliest failure, which has complete data. Squares indicate the second group of failures; data collection for these was terminated after they blew their cans off. Triangles indicate the third group of failures, which had just started to bulge. Circles indicate a capacitor just starting to produce a significant quantity of gaseous hydrogen.

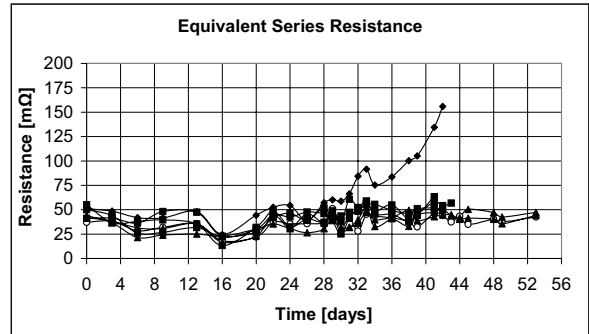
Figure 5: Equivalent series resistance of capacitors from the bulging Taiwanese lot tested at 55°C at a bias of 3.3 volts. Diamonds indicate the earliest failure, which has complete data. Squares indicate the second group of failures; data collection for these was terminated after they blew their cans off. Triangles indicate the third group of failures, which had just started to bulge. Circles indicate a capacitor just starting to produce a significant quantity of gaseous hydrogen.

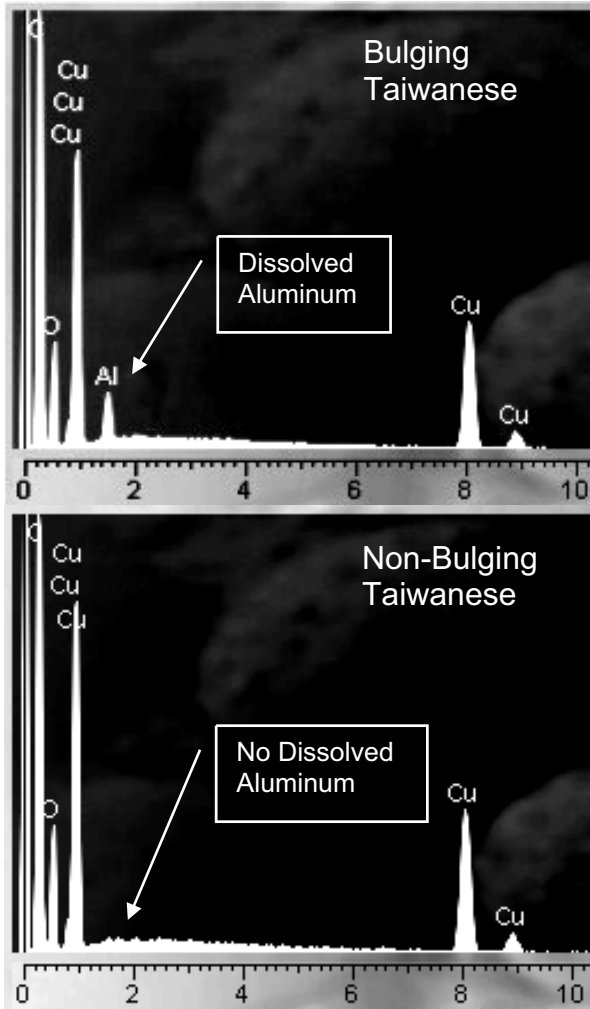
Suspecting that unprotected aluminum oxide dielectrics were dissolving into the alkaline electrolytes, energy dispersive spectroscopy (EDS) was performed on evaporated electrolyte from the capacitor samples described previously. The electrolyte from the lot of Taiwanese capacitors exhibiting bulging contained aluminum; aluminum was not detected in the electrolyte from the other capacitor samples (see Figure 6).

Figure 6: Energy dispersive X-ray spectrographic analyses of electrolyte samples from the Taiwanese capacitors exhibiting bulging and the Taiwanese capacitors not exhibiting bulging.
