# Let it flow

While much of the fame and glory, and money, may go to semiconductor manufacturing, the fabrication of printed circuit boards (PCBs) can often be a more difficult and challenging endeavor. Complex composites with anisotropic properties that change with time and temperature can be difficult to predict and control. An excellent example of this was a root-cause analysis performed on a board-mounted power supply that experienced a thermal event.

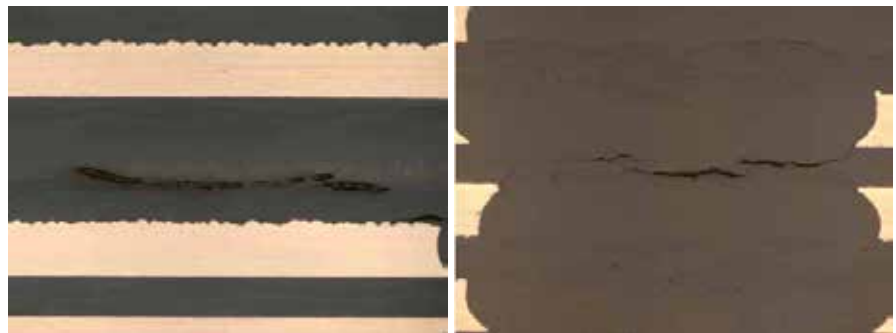
Observations of cross-sections from the first step (similar area, different PCB) showed indications that resin was unable to flow during lamination. Inability to flow resulted in some areas starved of resin. Other areas may have experienced severe stresses, resulting in crack propagation. The differentiation is based upon the edges of the anomaly. In the resin starvation image, the edge of the anomaly is rounded. In the cracking image, the edge of the anomaly is pointed (Figure 1)

Figure 1. Resin starvation (left) and cracking (right).

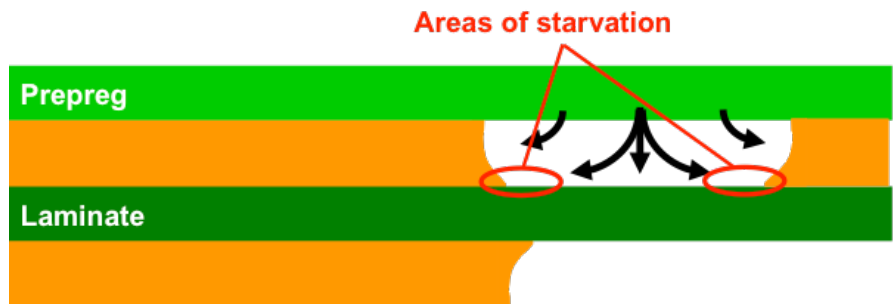
The resin starvation seemed to be affiliated with the edges of the copper foil, where it would be the most difficult for the resin to flow (Figure 2).

Figure 2. Illustration of resin starvation.

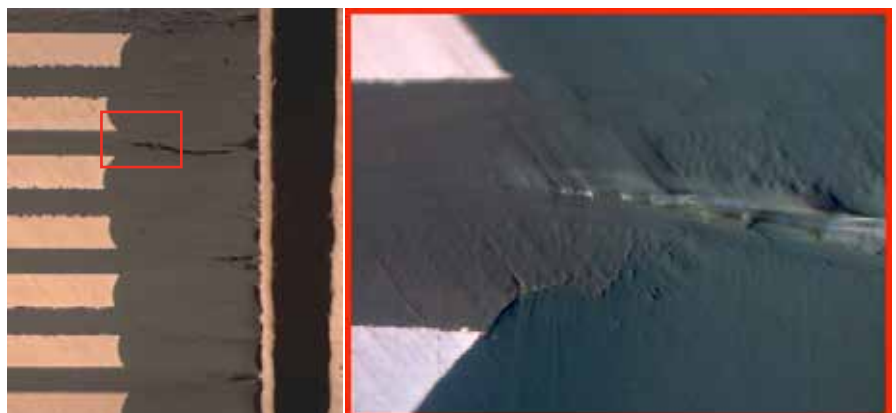
Figure 3. Void/delamination from resin starvation is linked to cracks emanating from the copper foil.

The first potential driver for failure was the intersection of the two types of anomalies. As seen in *Figure 3*, the void/delamination from resin starvation linked to cracks emanating from the copper foil. This junction provided a clear and complete path for metal migration from the internal plane to the plated through via. When the step of path formation is eliminated, CAF or metal migration can occur relatively rapidly (minutes to hours), even under relatively benign conditions, due to capillary condensation. The condensation event can immediately create an electrolytic cell and can extract contaminants from the epoxy resin.
