## **Technical Case Study:** **Projection Lamp Failure Analysis**

DfR Solutions recently investigated the reduced reliability of projection lamps used onboard many wide-body jet aircraft for showing movies and safety videos.

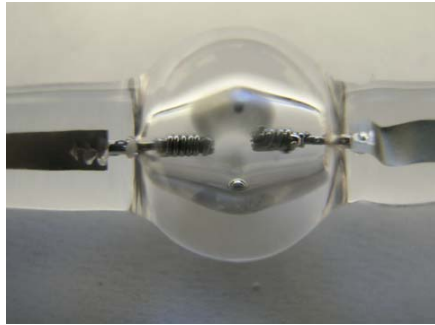
Pristine Bulb

Prior to testing, DfR investigators visually inspected the glass bulbs. A blackening on the inside of the glass wall of failed bulbs was noted, as well as a deformation or rupture of the bulbs. The investigators also noted that the electrodes inside a pristine (never used) glass bulb were not aligned properly. This slight misalignment could lead to premature failure.

- **Screen bulbs with regards to electrode alignment**  
Misalignment of the electrodes would lead to excessive vaporization of the electrodes during startup, greatly reducing the life of the bulb. Bulbs should be screened before assembly and those bulbs where misalignment is identified should be rejected.

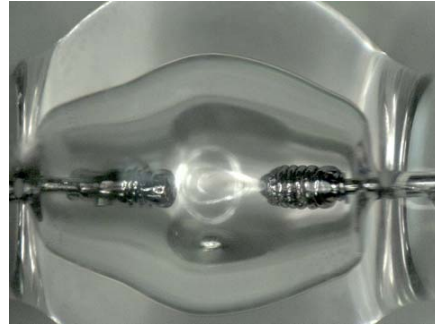
Power-Cycled Bulb

Upon comparing a pristine bulb to a bulb that had undergone 150 power cycles, the team found noticeable differences between the two bulbs. The cathode electrode in the power-cycled bulb was shorter and the end of the electrode was flat. In addition, the starting coil on the electrode had been consumed, as shown in the picture below.

Further observation by the DfR team indicated that the electrode tip was vaporized during repeated ignition. As the tip is vaporized, hot air rises vertically from the electrode and cools, depositing the electrode material on the inside of the bulb. The DfR team noted a blackening of the glass where the electrode material was deposited.

More and more material was deposited as the power cycling continued, causing a metallic growth to form at the blackened area. In addition, the temperature of the glass around the deposit increased relative to the surrounding glass, creating a “hot spot.” As the temperature reaches the melting point of glass, the bulb will eventually rupture and fail.
