Failure Analysis of Electrostatic Discharge and Electrical Overstress Failures of GaAs MMIC

Yu-chul Hwang, Mikyoung Lee, and Michael Pecht
CALCE Electronic Products and Systems Center
University of Maryland
College Park MD 20742

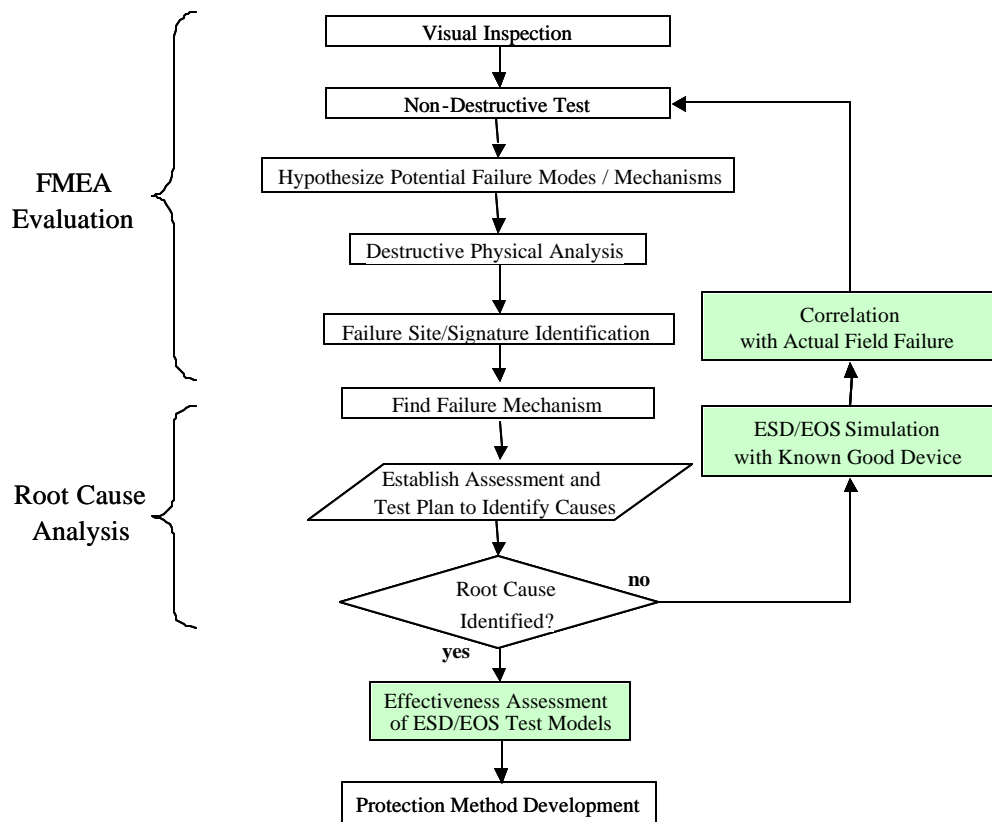
Figure 1. Flowchart for the failure analysis process

Once ESD and EOS testing were completed, failure characteristics following failure analysis process in Figure 1 were analyzed with the help of various identification methods for failure location and damage shape. It starts with visual inspection for anomaly, electrical test of the performance, and X-ray, optical microscopy and SEM for locating the defect. Liquid crystal or Infrared thermal tracer observation is also considered to implement in order to indicate failure sites which are not found by optical microscopy or scanning electron microscopy (SEM) [6].
