## Design Guidelines for Preventing Flex Cracking Failures in Ceramic Capacitors

N. Blattau, D. Barker, and C. Hillman  
CALCE Electronic Products and Systems Center  
Building 89, Room 1103  
University of Maryland  
College Park, MD 20742  
Tel.: (301) 405-5323  
Fax: (301) 314-9269

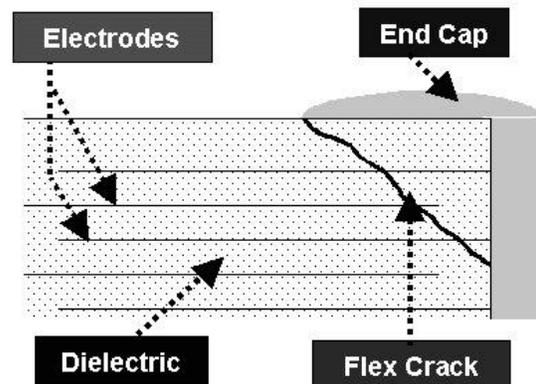
**Figure 1:** Schematic of a flex crack in a multilayer ceramic capacitor

Improper usage of MLCCs can cause them to fail prematurely this includes handling damage, thermal shock, excessive flexing, or applied voltage exceeding manufacturer's specifications. Cracks due to thermal shock or excessive flex are the most common failure mechanisms, with the primary difference between these two root-causes being the morphology of the resulting crack. Both thermal shock cracks and flex cracks tend to propagate at 45-degree angles from the termination of the end cap. Both types of cracks can also range in size, but flex cracks tend to be larger, propagating through the ceramic until the crack reaches the end cap. A schematic of a typical flex crack is displayed in Figure 1.

Failures that occur during connector insertion, depaneling, or bolting are often due to excessive printed wiring board (PWB) flexure. Excessive PWB flexure will cause flex cracks, which often emanate from the termination of the end cap and propagating at a 45-degree angle. In order to avoid designing, manufacturing or using circuit card assemblies in manner that will induce flex cracking in MLCCs, it is important to determine the failure criterion that will cause flex cracks to initiate and what drivers will increase the susceptibility of capacitors to flex cracking.

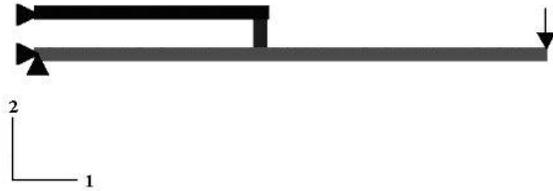
**Figure 2:** Simple FEA beam model of capacitor mounted on printed wiring board

Using a simple FEA model (Figure 2) of the 0805 MLCC and the materials listed in Table 1 and Table 2, the stress in the capacitor as a function of displacement can be approximated. The failure data for the 1206 capacitor will be used later to verify a model to predict capacitor failure during printed wiring board bending.

To examine the effect of capacitor length on flex cracking, CALCE ran FEA models similar to the one shown in Figure 2 and used the previously derived stress failure criteria. The FEA results for the 0805, 1206, 1812 and 2220 capacitors undergoing a 3-point bend test are shown in Figure 11. The results show that length greatly influences the capacitors reliability with regards to flex cracking.

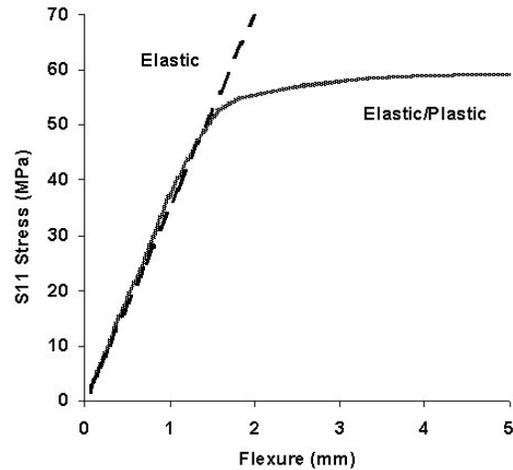
**Figure 3:** Flexure Stress relationship for 0805 Capacitor mounted on a 1.6 mm PWB including solder plasticity

Since plasticity of the solder is included, the maximum tensile stress that can be generated is limited. The critical stress in the capacitor is shown to be between 55 and 60 MPa and agrees with values found in literature [8]. This verifies that beam type equations can adequately represent the behavior of the capacitor as flexing occurs and that there isn't a large variation in the stresses required to fail the capacitors because of the solder plasticity. Neglecting plasticity and rerunning the model results in the tensile stress verse displacement plot shown in Figure 3. These results coupled with various types of finite element models will be used to extend the available experimental data to larger size capacitors.

The maximum tensile stress in the capacitor is plotted versus the displacement during the three-point bend test in Figure 3.

By using the results shown in Figure 3 a stress failure relationship for the 0805 capacitor can be developed and used as a failure prediction model for other capacitors regardless of size and board parameters.

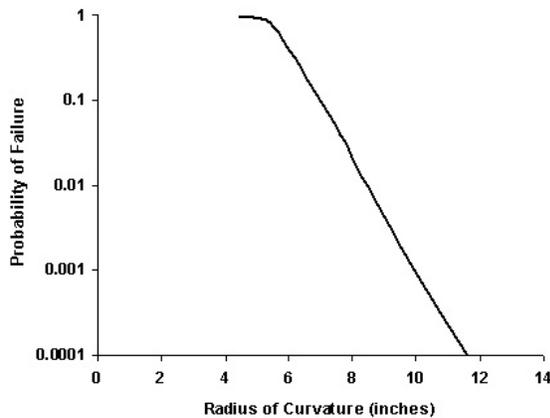
**Figure 4:** Probability of flex cracking in a 0805 capacitor as a function of the radius of curvature of the board. Plot is based upon results in ref. 3.

The results of the 0805 capacitor Kemet tests and the equivalent radius of curvatures and strains are displayed in Table 3 and Figure 4.

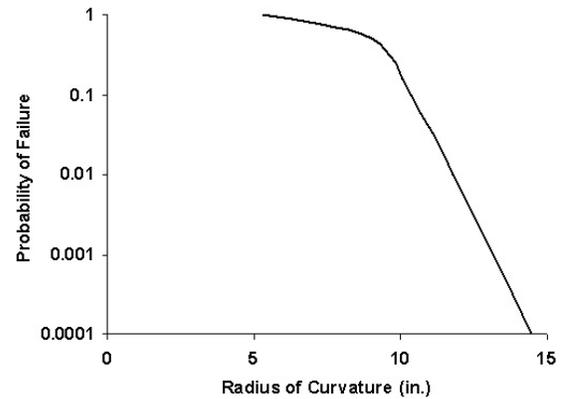
**Figure 5:** Probability of flex cracking in a 1206 capacitor as a function of the radius of curvature of the board. Plot is based upon results in ref. 3.

The results of the 1206 capacitor Kemet tests and the equivalent radius of curvatures and strains are displayed in Table 4, and Figure 5.

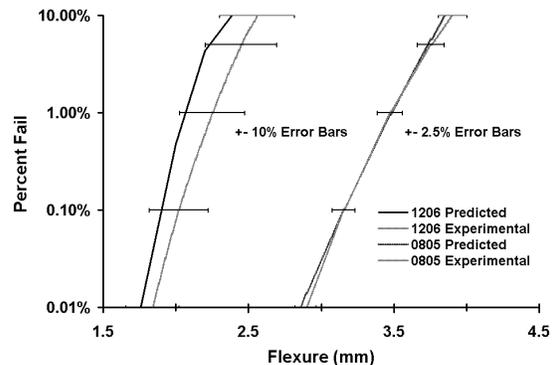
**Figure 6:** Model predictions of failure for 0805 and 1206 capacitors. Test span was 90 mm and test board thickness was 1.6mm.

This is verified using the 1206-capacitor failure data from the Kemet tests. The plot in Figure 6 shows the results in ref.3 plotted against the predictions from FEA and the failure model. The results indicate that failures can be predicted within 10% for the 1206 capacitor.

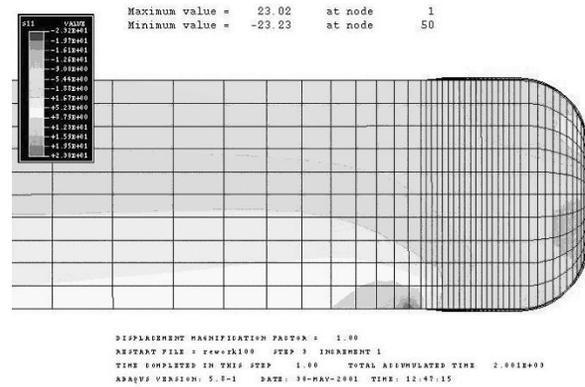
heated in the simulation, they were brought back down to room temperature and the model was run an additional 3600 seconds to see if any significant stress relaxation occurred. The result of the FEM analysis is shown in Figure 7. This resulted in a residual stress in the capacitor of approximately 20 MPa. This level of stress could have a significant effect on capacitor susceptibility to flex cracking.

**Figure 7:** Stresses in the 11 direction (s11) in an 1825 capacitor heated to 50°C during solder rework

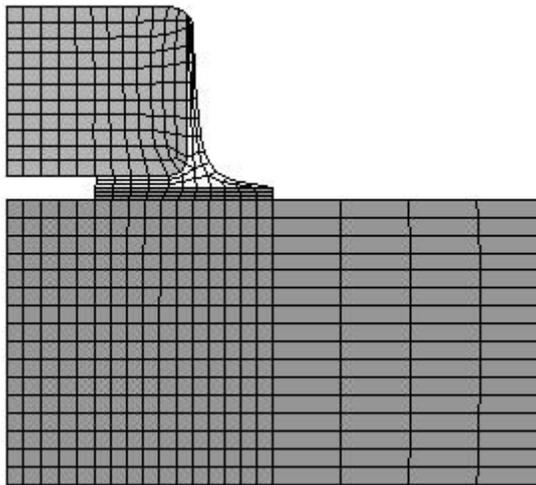
**Figure 8:** 2D FEA model used for verifying the effects of chip thickness on internal stresses, based upon an 0805 capacitor during a 3 pt bend test of a 1.6 mm pwb with a 90 mm span.

An initial review of the literature indicates some confusion on whether thickness has an effect on susceptibility to flex cracking. Anecdotal evidence provided by Pickering [11] implied that thicker capacitors are more resistant to cracking than thin capacitors. Viswanadham [5] states that the thicker the capacitor, the greater propensity for cracks, but does not differentiate between thermal shock cracks and flex cracks. Bergenthal [4] believes that for the available range of MLCC thicknesses, chip thickness has minimal effect on the incidence of flex cracking. The FEA model shown in Figure 8 is used to verify the effect that capacitor thickness has on the internal stresses developed.

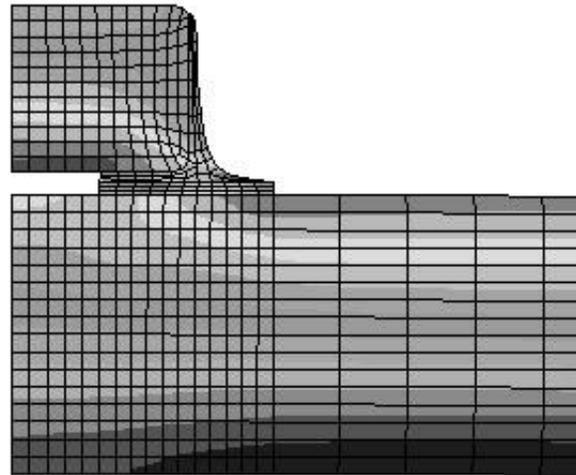
**Figure 9:** Tensile stress distribution during 3 pt bend test.

As seen in Figure 9 the bottom of the capacitor is in tension indicating that the bending moment transmitted into the capacitor is significantly smaller than the tensile forces. The effect of changing the capacitor thickness is shown in Figure 10. These results indicate that capacitor thickness has very little effect on the internal stresses and that one can expect a

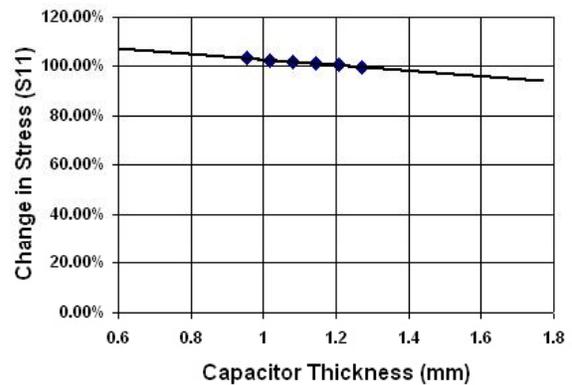
**Figure 10:** Variation in tensile stresses in the 0805 capacitor as a function of capacitor thickness.

3.47% increase in the internal stresses for a 25% reduction in the capacitor thickness.

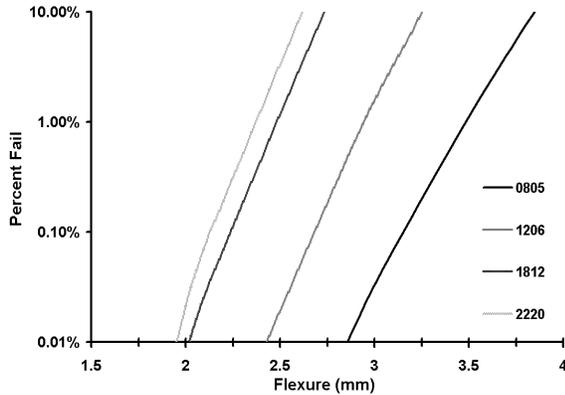
**Figure 11:** FEA and stress failure criteria based probability of flex cracking during a 3 point bend test of a 1.6 mm pwb with a 90 mm span.

There are three design modifications that can be made that will improve the strength of the capacitor. The first is changing the MLCC dimensions. As previously discussed the width and thickness of the capacitor have little effect on flex cracking opportunity. However, as shown in Figure 11 capacitor length can have a very significant effect on the occurrence of flex cracking. The major drawback to this design change is the reduction in capacitance for a given voltage rating. 1825 MLCC's are able to deliver 0.39 microfarads at 200 volts, while 1210 deliver only 0.10 microfarads and 0805 only deliver 0.01 microfarads<sup>2</sup>. Circuit design issues must be addressed before these changes can take place.

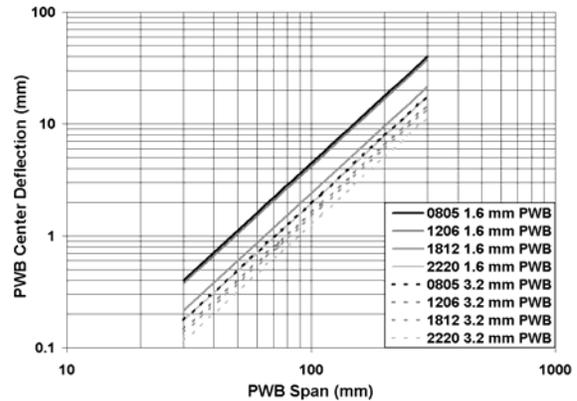
**Figure 12:** Span/displacement relationships for simply supported PWB given 0.01% allowable failure

Figure 12 and Figure 13 are displacement graphs for various chip capacitors given a 0.01% allowable failure probability for simply and fixed boundary conditions.

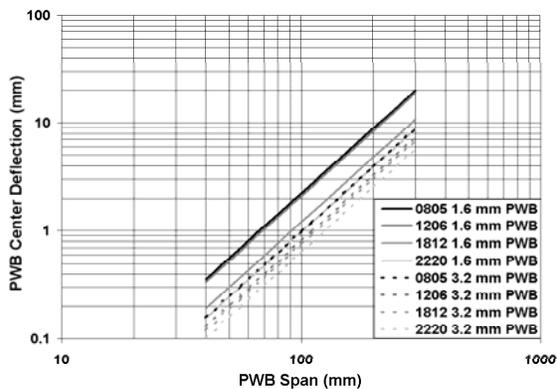
**Figure 13:** Span/displacement relationships for fixed supported PWB given 0.01% allowable failure

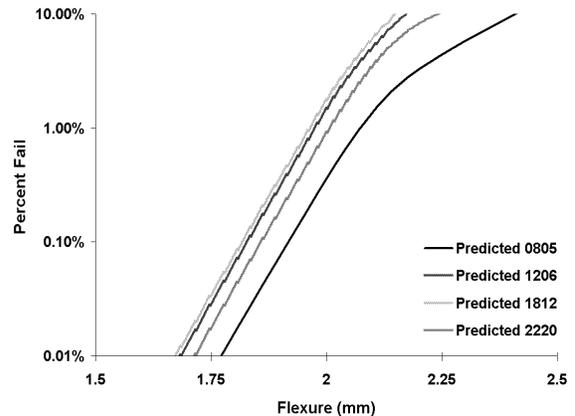
**Figure 14:** FEA and stress failure criteria based probability of flex cracking during a 3 point bend test of a 3.2 mm pwb with a 90 mm span.

A thicker board will lead to an increase in the resistance to flex. This design change would be useful in preventing unexpected flex events through the manufacturing process, such as during handling or testing. However, a thicker board applies more load to the capacitor for a given displacement as shown when comparing the results in Figure 14 to Figure 11. This is due to the increase in board-level strain in the area of the capacitor since board level strain is a function of the bend radius and the board thickness. As shown in

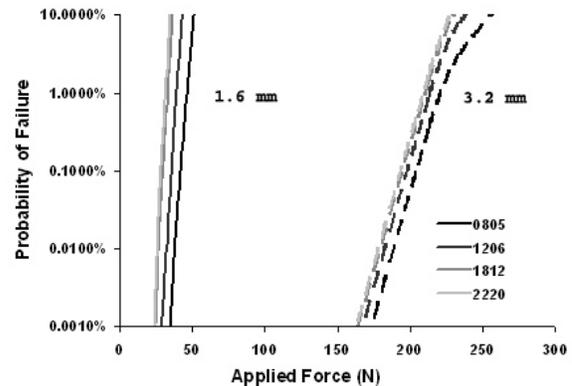
**Figure 15:** Comparison between 1.6 mm and 3.2 mm pwb applied forces during a 3 point bend test with a 90 mm span

Figure 15 the use of a 3.2 mm thick board significantly increases the forces required to fail the capacitors during a 3 point bend test.
