Solder Failure Mechanisms in Single-Sided Insertion-Mount Printed Wiring Boards

C. Hillman, K. Rogers, A. Dasgupta, and M. Pecht

CALCE Electronic Products and Systems Consortium, University of Maryland, College Park, MD

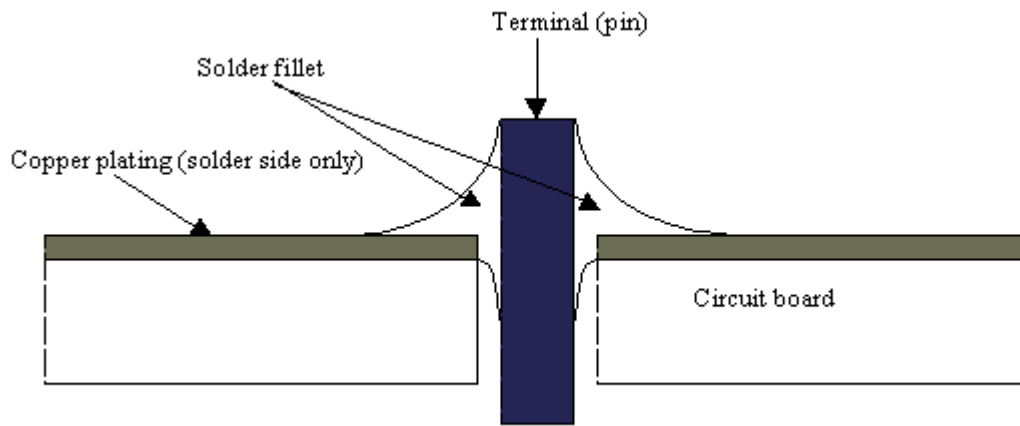
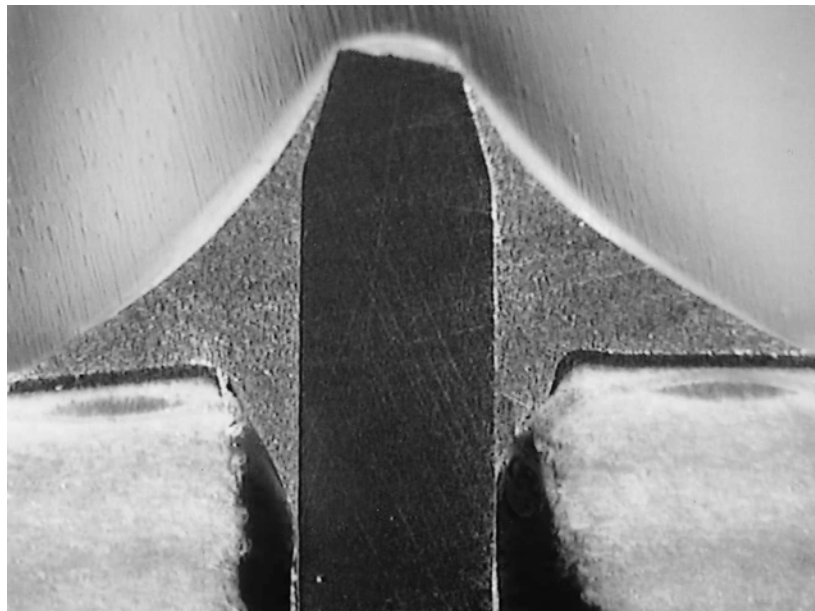
Figure 1: Schematic of a single-sided insertion-mount solder joint. (b) An optical micrograph (28x) of the cross section of a terminal with the characteristics of a good solder joint. These include good fillet formation, centering of the pin (dark), and good wetting at the solder/pin and solder/copper pad interfaces.

An example of a good solder joint in a single-side insertion-mount CEM-1 PWB is illustrated in Figure 1b. The joint is well formed, showing symmetry on all sides, with the solder sloping from the terminal tip outwards to the board at approximately 45 degrees. Both the component-side and solder-side fillets between the terminal and the hole walls are well formed. The terminal is centered and is at an appropriate height in the hole. The solder microstructure is uniform and no voids are present. Inspection of the solder/terminal and solder/copper interfaces, using electron microscopy, shows a continuous bond with good intermetallic formation (shown in Figures 2a and 2b).

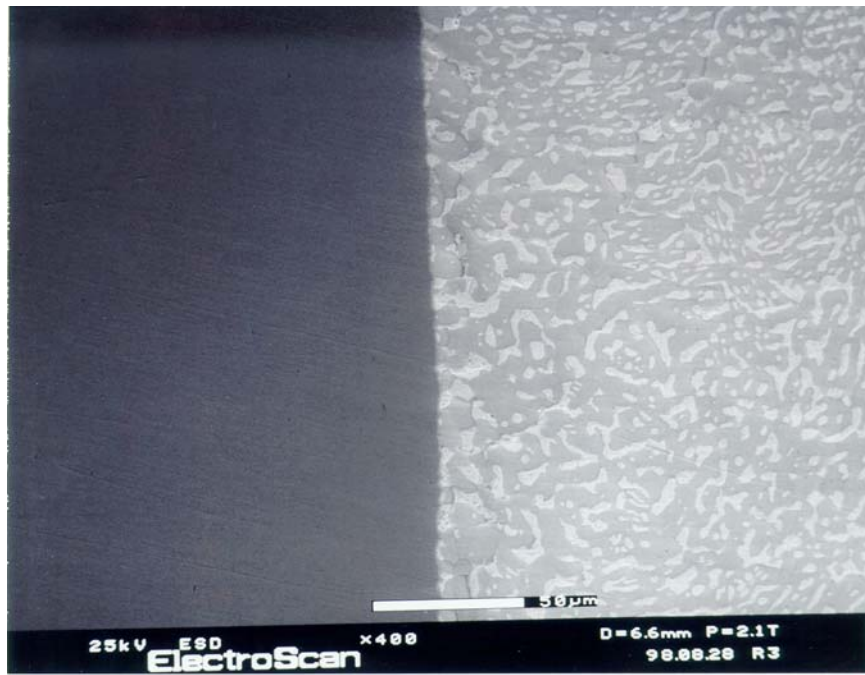
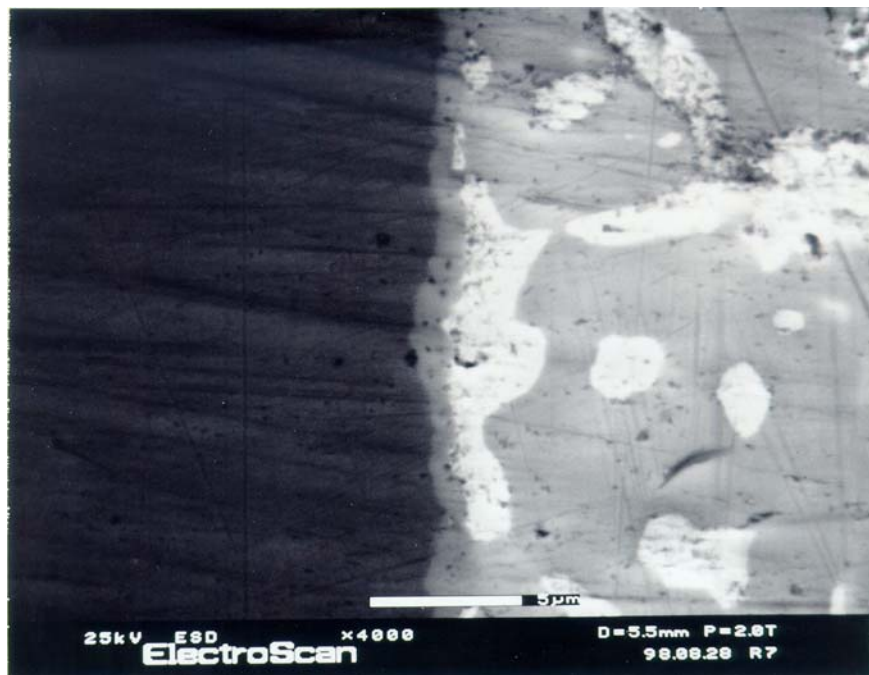
Figure 2: (a) Electron micrograph of a strongly bonded interface between a brass pin (dark) and the solder. Note the Pb-rich (white) and Sn-rich (gray) zones in the solder. (b) At higher magnification the intermetallic region is observable as a dark gray interface, approximately $1\mu\text{m}$ thick, between the brass pin (dark) and the solder. The interface is deficient of the Pb-rich (white) phase, which suggests a Cu-Sn intermetallic.

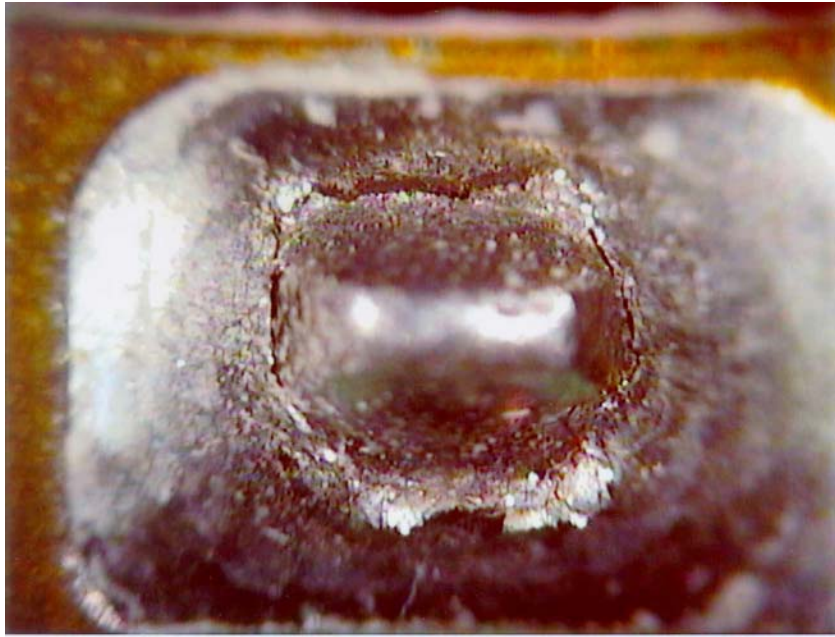
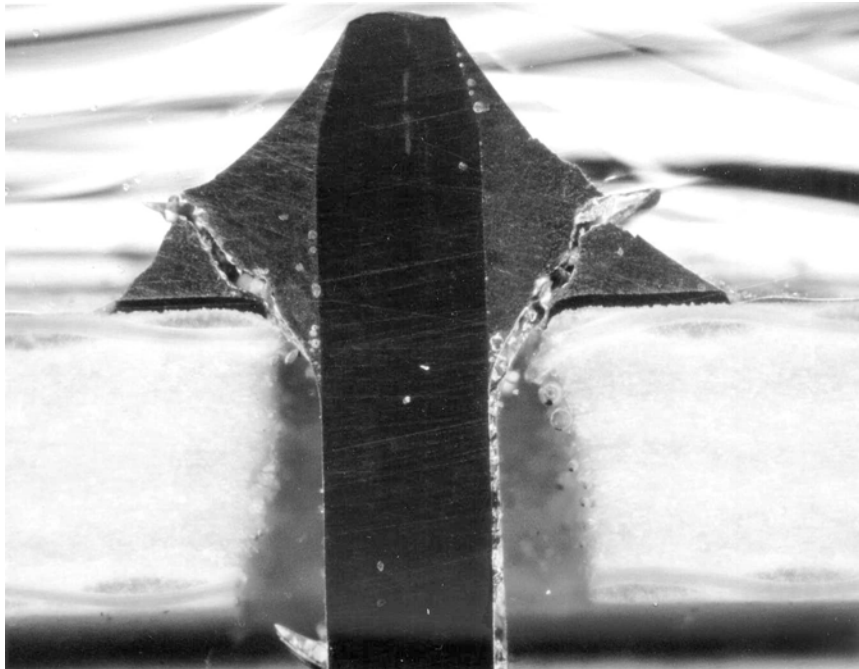
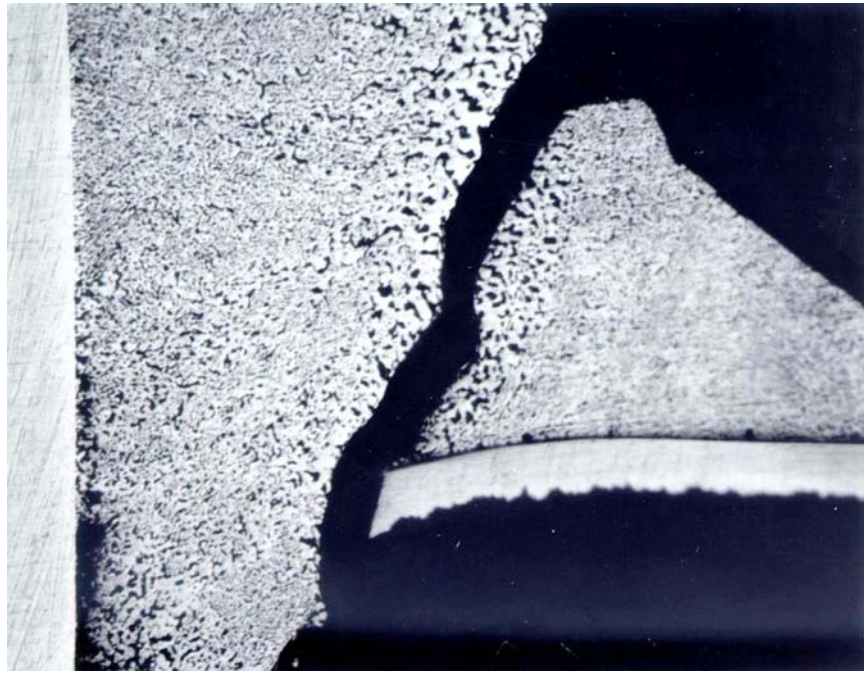
Figure 3: Optical micrographs of a strong single-sided through-hole solder joint which has failed during operation due to bulk solder fatigue. (a) From the top view (20x), a circular crack can be seen to have propagated through the solder and not at pin/solder interface. (b) After cross-sectioning, a 45° crack propagation path can be observed on each side of the terminal through the bulk solder. (c) At higher magnification (100x), grain coarsening (larger grain size compared to the surrounding areas) at the crack edges is indicative of a fatigue failure rather than an overstress fracture.

If the primary loads are cyclic in nature and below the ultimate strength of the solder joint, the failure mechanism of a strong solder joint will tend to be low-cycle bulk solder fatigue. Figures 3a through 3c show an example of single-sided solder joints that failed due to fatigue cracking. In Figure 3a, the top of the terminal displays wrinkling of the solder surface and micro-cracking, surface evidence of internal fatiguing. The crack has propagated 360 degrees around the terminal, running through the bulk solder and not at the solder/terminal or solder/pad interfaces. Figure 3b illustrates the cross section of this terminal. The fatigue crack propagation path in the solder is the trajectory of maximum shear deformation due to the combination of in-plane and out-of-plane thermal expansion. In this terminal design, with a rectangular terminal, the crack initiates at the root of the solder fillet, near the PWB bond pad. The crack then propagates at a 45-degree angle to the terminal through the bulk solder. Confirmation of failure due to bulk solder fatigue can be observed at higher magnification (Figure 3c). Solder microstructural fatigue damage accumulation and failure due to hygro-thermo-mechanical loading is characterized by a sequential set of events. The initial stage is marked by extensive grain growth along the paths of maximum shear deformation. Since this is also the eventual trajectory of the contiguous fatigue crack through the solder material, large solder microstructural domains adjacent to the crack faces will accompany cyclic fatigue, as shown in Figure 3c.

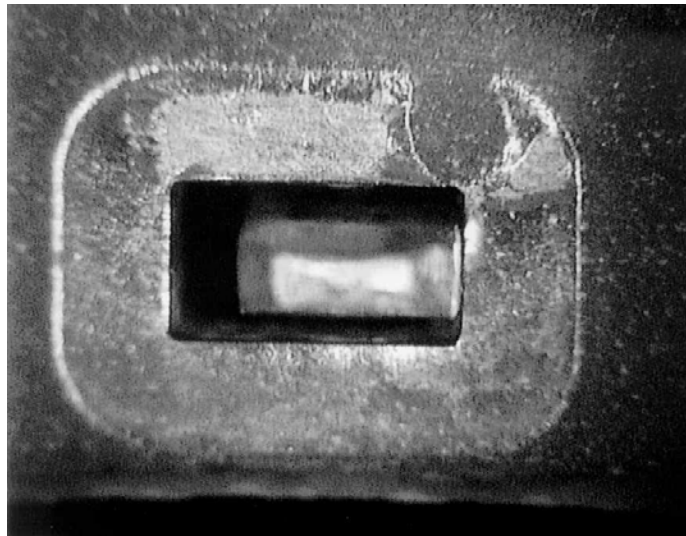
Figure 4: Schematic and optical image (16x) of top view of non-soldered terminal and PWB bond pad. Note the absence of metallization at the upper right of the bond pad.

Optimization of the formulation, application, and development of the solder mask is critical. Defects due to poor formulation, presence of contaminants, inadequate curing, or inability to produce fine features will increase the likelihood of rework, scrap during assembly, a costly reduction in product lifetime. Figure 4 shows an absence of solder on a pad around a through-hole due to an error in the solder mask pattern. This defect will be present in all units produced with this setup.

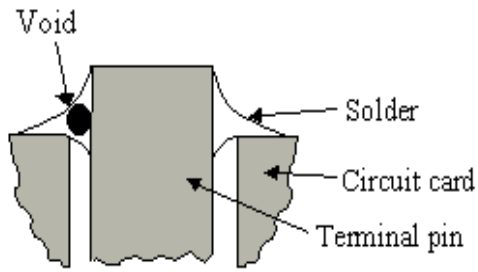
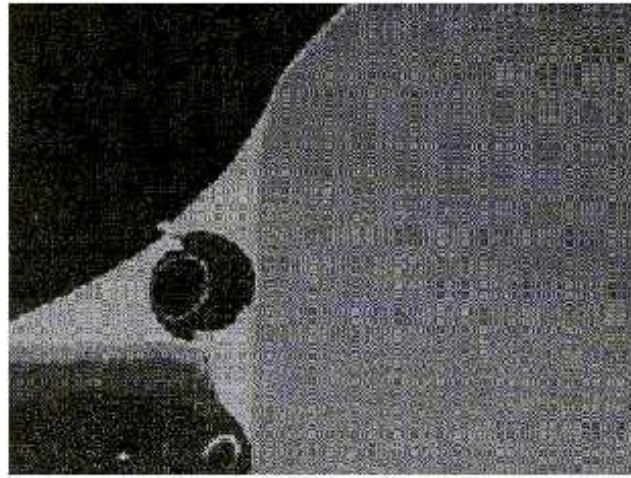
Figure 5: Schematic and electron micrograph (60x) of a large void present in a single-sided through-hole solder joint which was subjected to accelerated testing. This joint failed after a short number of thermal cycles.

One of the most common defects observed in solder joints are voids. Small voids tend to be primarily cosmetic defects, especially when they are not located in the regions of maximum shear strain. This is because the stress concentration from a spherical defect is low and will be significantly reduced due to plastic and creep deformation in the surrounding solder. Larger voids can accelerate premature failure by significantly decreasing the net cross-sectional area, hence increasing the stress. In addition, the presence of large voids can cause local perturbations in the crack initiation site and change propagation paths due to stress re-distribution. An example of a single-sided solder joint that failed prematurely due to the presence of a large void can be seen in Figure 5.

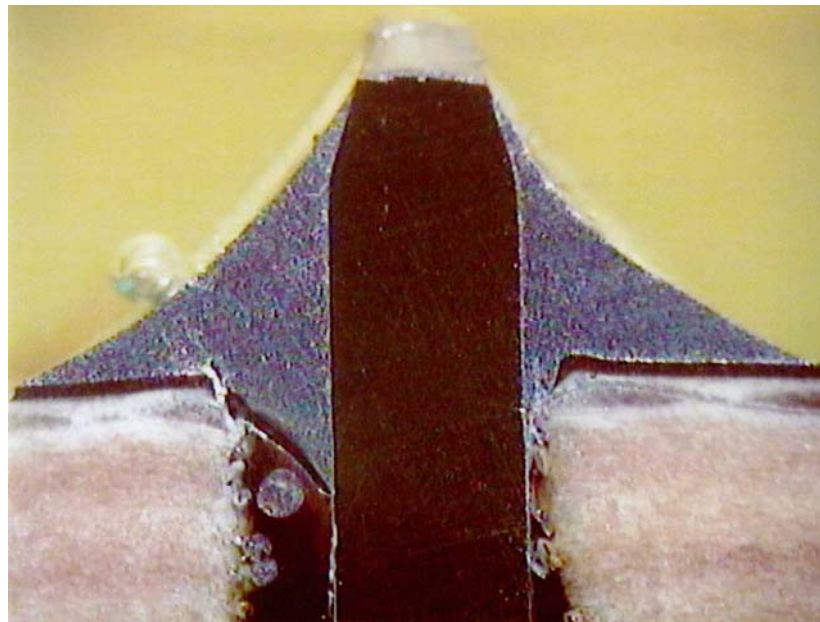
Figure 6 (25x): Optical micrograph of the cross-section of a single-sided through-hole solder joint that is misregistered. The terminal is shifted to the right, beyond the IPC allowable guidelines, which has resulted in a "starved" bottom fillet.

Poor terminal seating can cause defects if alignment and height are not as per design. The alignment of the terminal is known as terminal registration. The Institute for Interconnecting and Packaging Electronic Circuits (IPC) document on component packaging and interconnecting, IPC-SM-780 [3], sets guidelines for minimal terminal-to-hole clearance. IPC states that too small a clearance, as seen in Figure 6, can result in lack of solder "wicking", while too much clearance may also result in lack of solder "wicking" due to solder drainback. Lack of wicking can result in void formation, insufficient fillets, or a skipped topside fillet (three-sided solder joint). Furthermore, lack of clearance may also interfere with the fluxing action, thus further impeding wetting and intermetallic formation. Misalignment can also cause preferential damage and premature damage initiation in the weakest

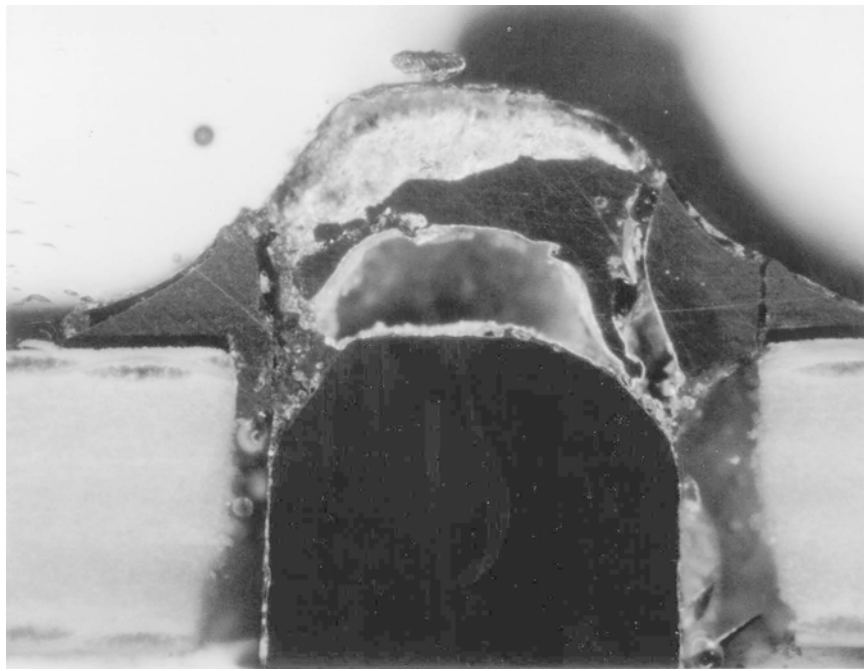
Figure 7 (25x): Cross-section of a single-sided through-hole solder joint displaying low terminal height. Note the large reduction in solder/pin contact area as compared to Figure 1b. The bridge of solder over the terminal suggests the terminal slipped during solder cool-down.

Low terminal height, displayed in Figure 7, can result in an inadequate solder joint, with the cross-sectional area of the solder/terminal interface greatly reduced. Due to the nature of the wave soldering process, the solder will sometimes "fill in" the missing volume due to the low terminal height, resulting in a joint which will pass visual inspection, but may be close to experiencing an electrical open. Low terminal height can also lead to a change in the path of highest shear deformation, which may reduce the solder joints' resistance to periodic hygro-thermo-mechanical stresses. Terminal height that is higher than design specifications is rarely a problem unless the top of the terminal impedes or interferes with other parts of the electronic package.

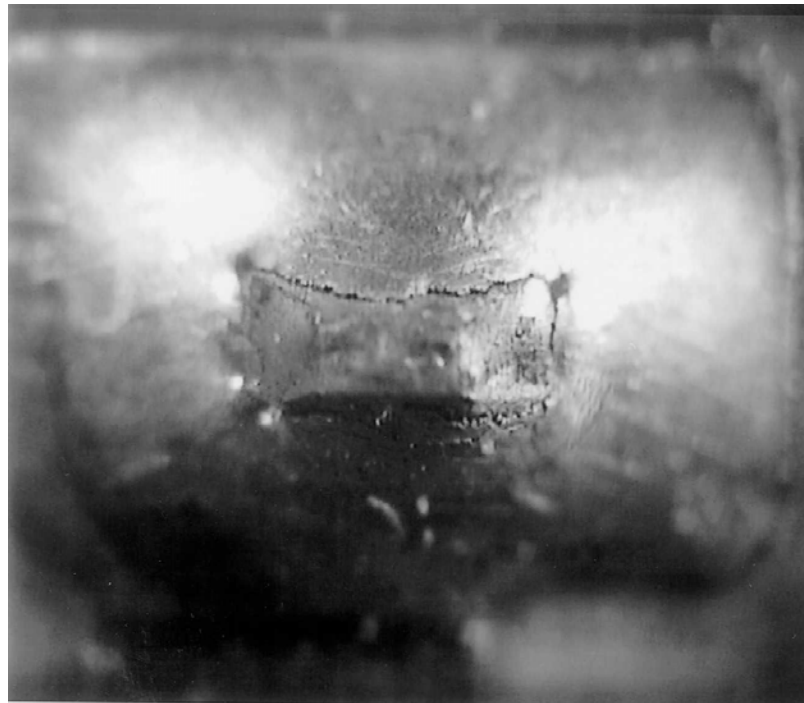
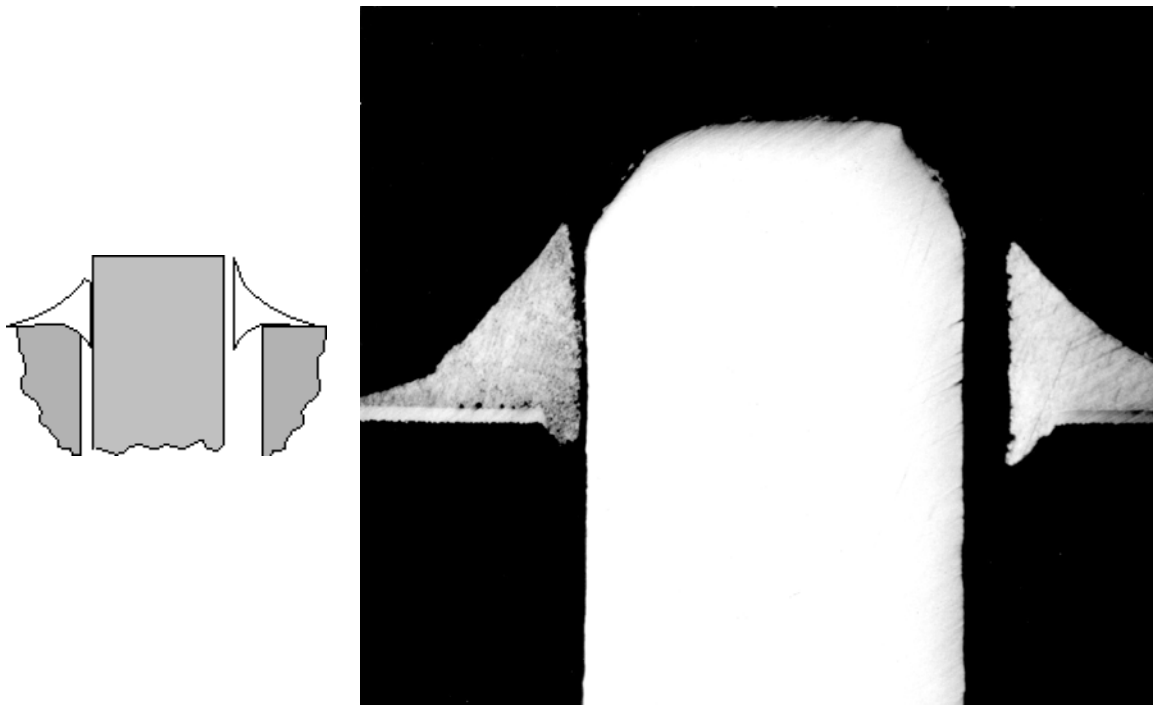
Figure 8: Top view at 16x (a) and cross-section at 25x (b) of a single-sided through-hole solder joint. Observation of crack propagation along the solder/pin interface, and not out in the bulk of the solder joint, suggests poor intermetallic formation. This particular solder joint electrically failed during accelerated testing.

Crack propagation at the solder/terminal interface is identifiable by visual inspection or cross-sectioning (Figure 8) and can sometimes be an indication of poor wettability, inadequate intermetallic formation, or excessive intermetallic formation. Proper failure analysis requires an examination of the interface at much higher magnifications before the underlying failure mechanism can be determined. An example of this can be seen in the solder joints displayed in Figures 9a through 9c. All three solder joints were subjected to thermal cycling until an electrical open was detected. Crack propagation near the solder/terminal interface was observed upon optical examination of the cross-section of each of the solder joints. Using electron microscopy, at a higher magnification of 2500x, Figure 9a shows complete separation of the solder from the terminal. The lack of any solder or intermetallic on the terminal surface suggests a wettability problem. In addition, the small grain size in the solder adjacent to the separation implies that this area experienced negligible amounts of cyclic loading before separation. In Figure 9b, crack propagation can be seen to occur between the intermetallic phase and the solder. This does not imply poor wettability, but instead could be either a result of excessive intermetallic formation, or could indicate that the highest stressed region has moved close the interface due to faulty fillet formation (Figure 9c). Wettability can also be a problem at the solder/copper bond pad interface, as seen in Figure 10. If wetting is poor on the PWB bond pad, a fatigue crack can initiate at the same site as in a nominal joint, but propagate along the solder/pad interface, instead of taking a 45 degree path through the bulk of the solder.

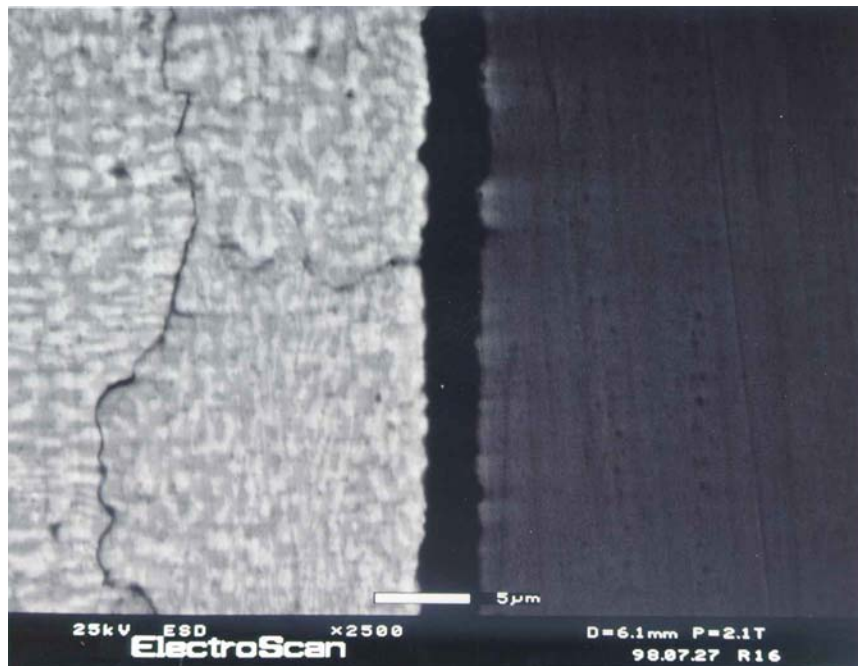
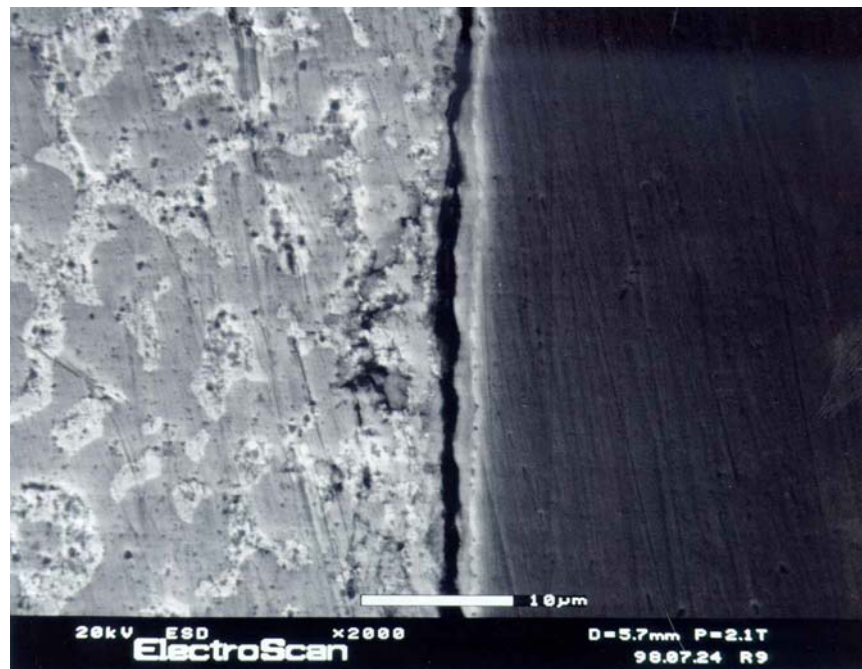
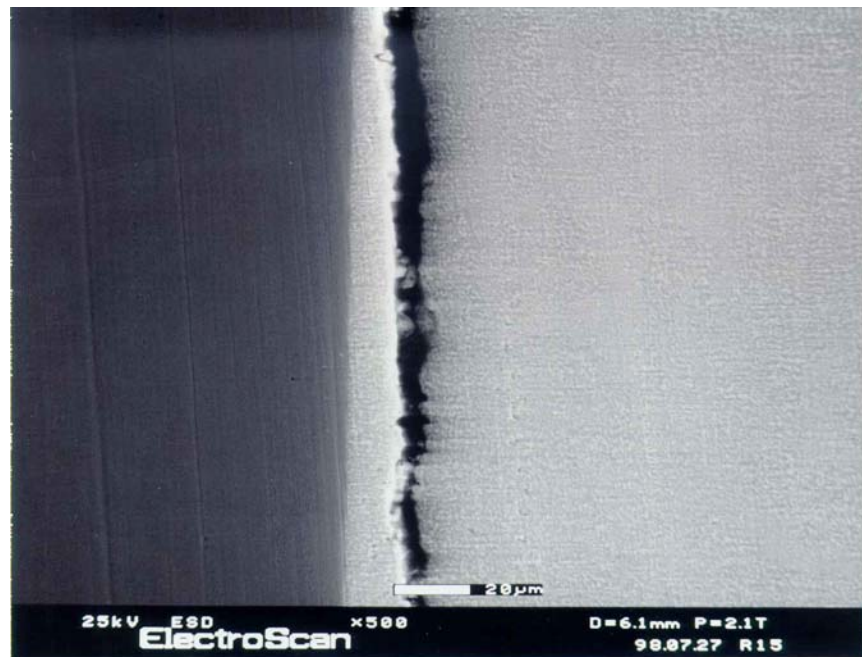
Figure 9: Electron micrographs of separations of solder (white/gray) from brass terminal pins (dark). All separations occurred on components subjected to accelerated testing. (a) The lack of any solder on the terminal surface and the uniform domain size in the solder suggest that separation occurred due to poor wetting or insufficient intermetallic formation. (b) The larger domain size in the solder suggests stress cycling. In addition, the crack appears to have propagated at the solder/ intermetallic interface. (c) The location of the crack surfaces, in the solder and approximately 15 μ m from the intermetallic layer, suggests that crack propagation at this site was not influenced by wettability or intermetallic formation.

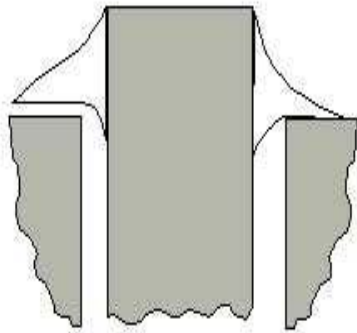
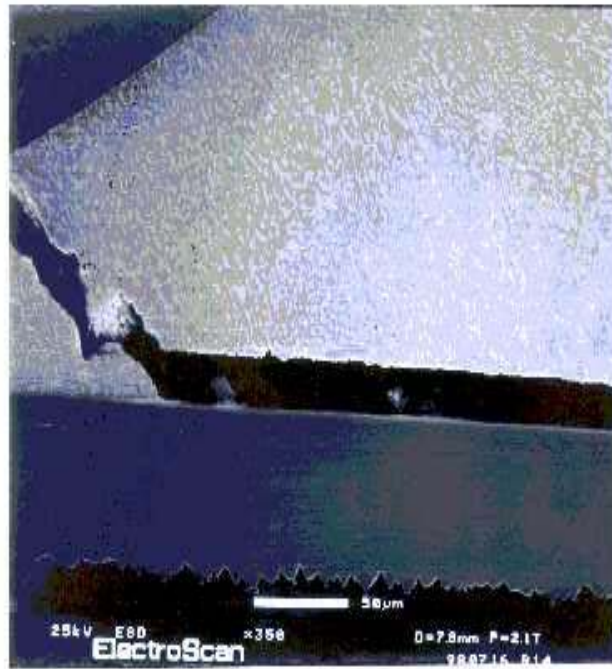
Figure 10 (350x): Electron micrograph of the separation of the solder from the copper bond pad in a single-sided through-hole solder joint that has failed during operation. The lack of solder over most of the bond pad surface suggests poor wetting or insufficient intermetallic formation. The solder microstructure is uniform, which implies no cyclic stresses were experienced

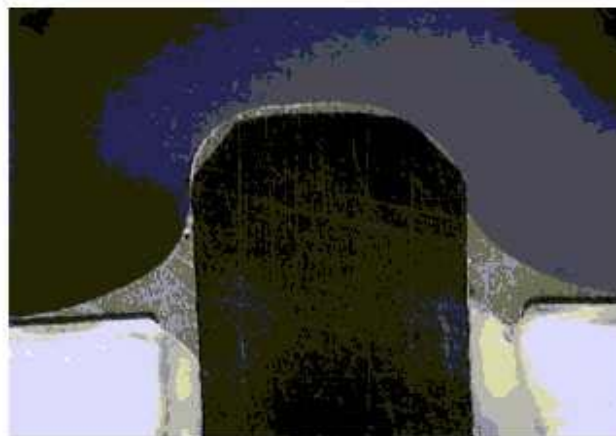
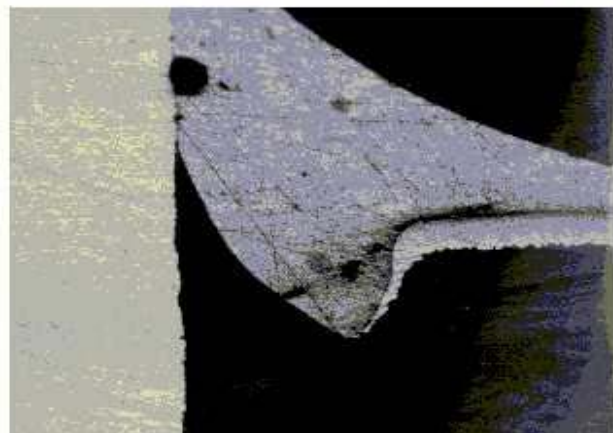
Figure 11: Optical images at (a) low (20x) and (b) high (100x) magnification of a single-sided through-hole solder joint with an insufficient solder fillet.

An optimum amount of solder in the top-side and bottom-side fillets is critical in creating a durable single-sided joint. Insufficient solder fillets, such as shown in Figure 11, weaken the solder joint due to a reduction in the solder area. In addition, the change in the solder fillet shape leads to a change in the path of maximum shear strain in a solder joint due to differential thermal expansion. This can lead to a change in the failure initiation site and will alter the crack propagation path. The initiation site will shift from the root of the bottom fillet, near edge of the copper bond pad, to an area near the terminal/solder interface. The fatigue crack will then propagate along the solder/terminal interface, an area greatly reduced in cross-sectional area and strength in comparison to the nominal 45 degree bulk solder fatigue path.

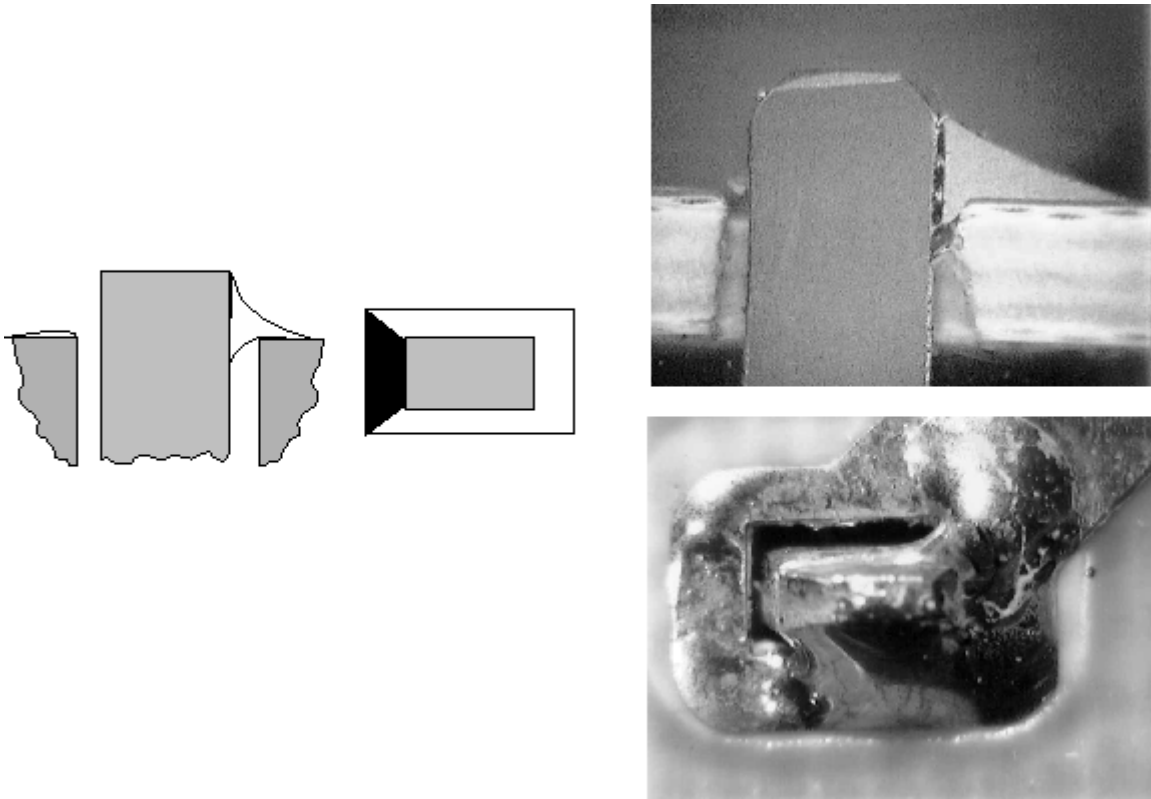
Figure 12 (17x): Optical micrograph of the cross-section and top view of a solder joint in a single-sided insertion-mount PWB. Note missing solder fillets on the top and left sides of the pin. An excess amount of solder can also be observed on the metallization line (top-right corner). This type of defect is designated as a two-sided solder joint.

Soldering process problems can lead to missing solder on one or more sides of the terminal, as seen in Figures 12. Two- and three-sided solder joints are of particular interest because they are easily observable indicators (using non-destructive visual inspection) of a manufacturing process that is not "optimal" for the design and is thus producing parts that can be intrinsically weak. A complete lack of solder can lead to degradation of the durability of the solder interconnect. Probable causes of incomplete solder formation include lack of plating on terminal or pad, oxides or other contamination of the terminal or pad surfaces, poor terminal seating or alignment, inadequate terminal fluxing, outgassing, a poorly controlled solder process, and inadequate slot dimensions and shape.

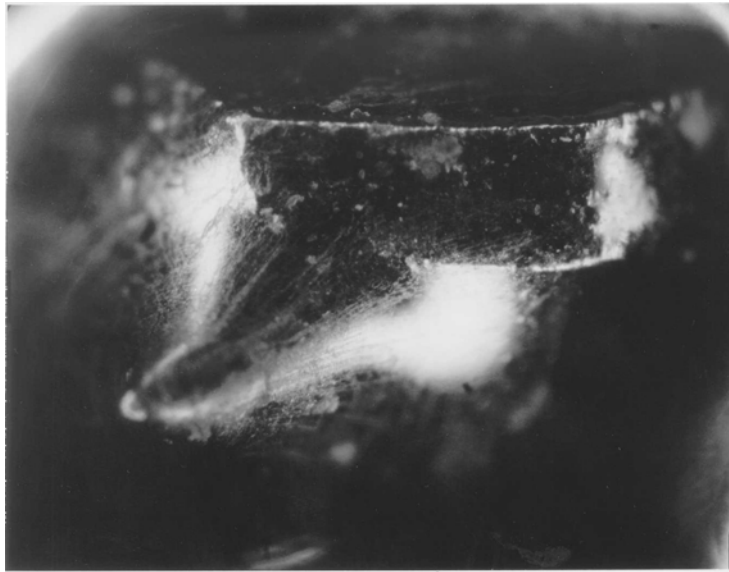
Figure 13 (57x): Icicle formation on the board-side of a terminal in a single-sided insertion-mount solder joint. The schematic shows a side view; the image shows the view looking down the long-axis of the terminal.

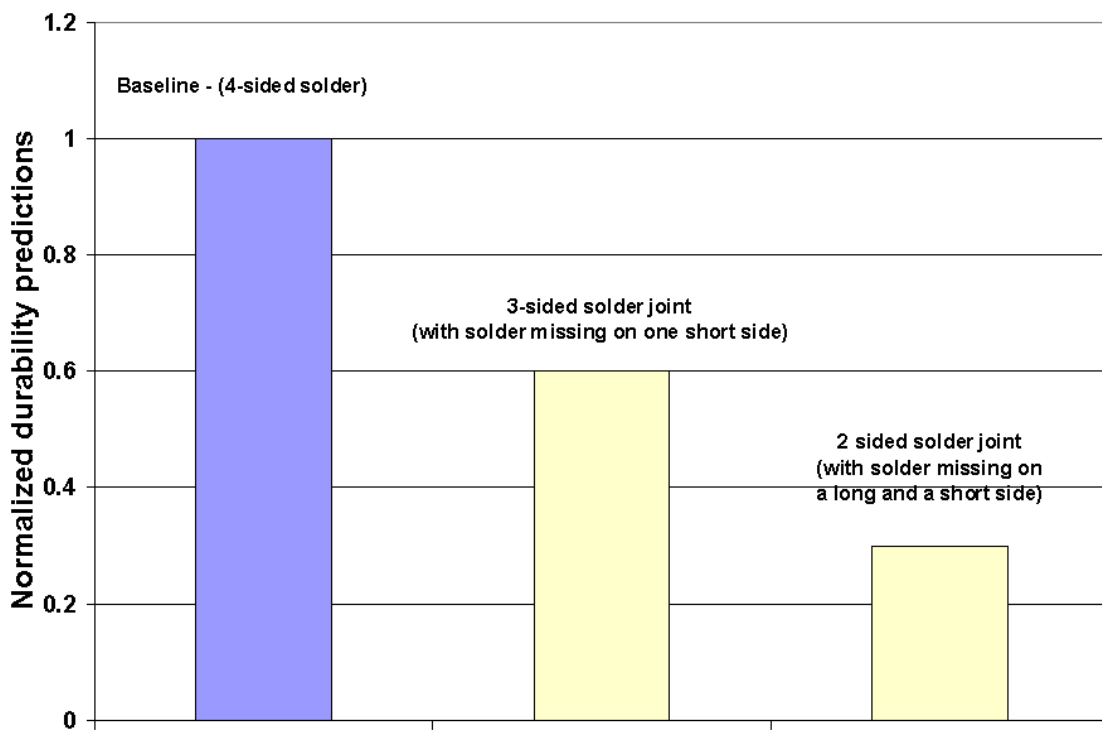
Figure 14: The effect of missing solder fillets on the durability of single-sided insertion-mount solder joints.

joint durability. The methodology adopted by the CALCE Consortium to predict damage in solder interconnects under temperature cycling has been described previously [7-9]. A thermal loading profile is applied to the three-dimensional finite element model. The energy metrics from the resulting stress-strain hysteresis loop is used in an energy-partitioning model to create lifetime predictions. This analysis separates structural responses from material behavior, which allows for a wide range of applicability across various parameters, such as terminal materials and geometries, substrate materials, solder joint design, etc. As an example, a rectangular, single-sided, insertion-mount solder joint with complete wetting on all four sides was treated as a baseline nominal 3-D model. The effect of incomplete or missing solder fillets can be seen in Figure 14. Detailed stress and damage analysis indicates that a three-sided solder joint, a commonly encountered manufacturing flaw, will have 60% of the expected lifetime of the four-sided nominal solder joint. A two-sided solder joint was found to be only one-third as durable as the four-sided case.

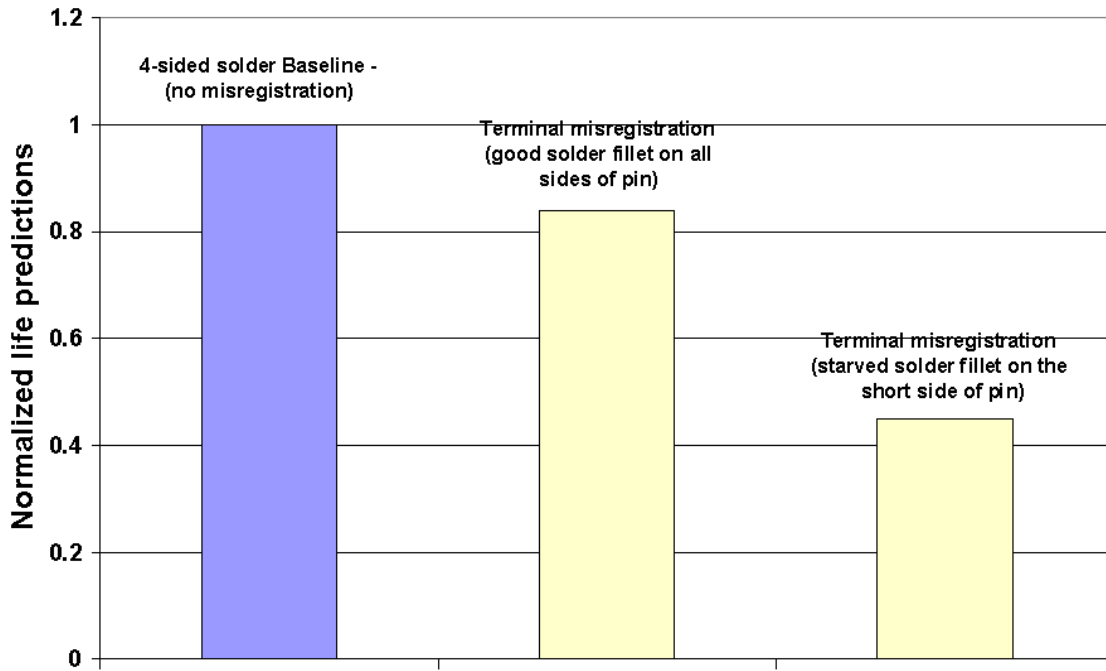
Figure 15: The effect of misregistration on the durability of single-sided insertion-mount solder joints.

The effect of misregistration and the accompanying starved solder fillet is displayed in Figure 15. Poor wetting, defined as a lack of interfacial strength between the solder and terminal surface, results in premature delamination and a corresponding increase in the stresses experienced by the remaining portions of the solder joint. Analysis of the situation for poor wetting on two sides of a terminal shows that the joint will last approximately half as long as the baseline case (Figure 16).

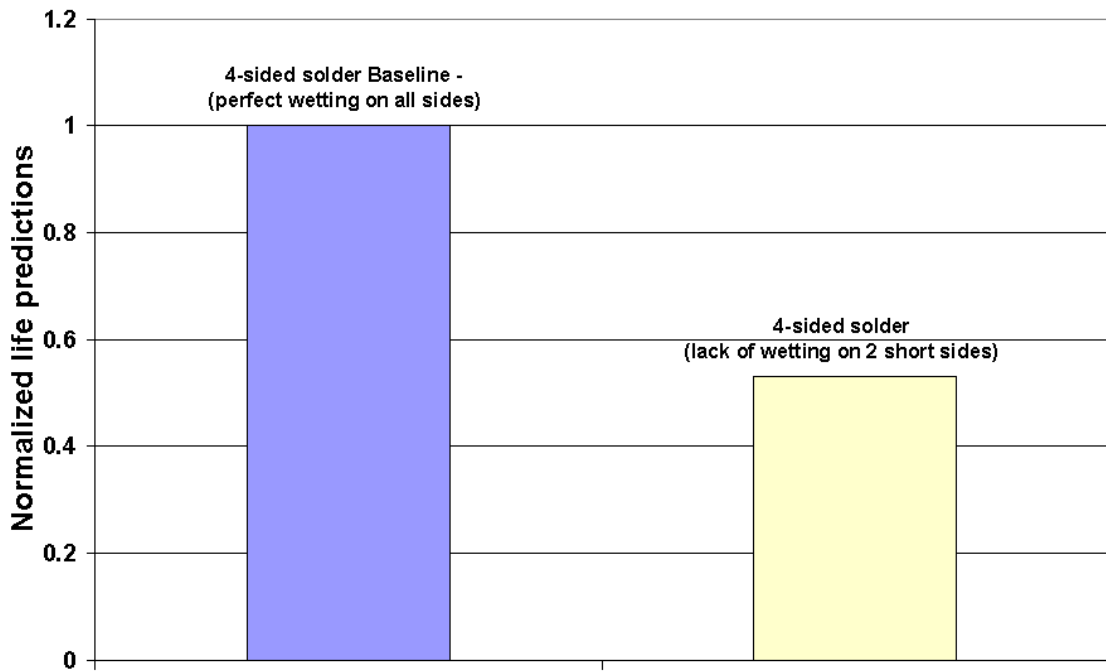
Figure 16: The effect of poor wetting on the durability of single-sided insertion-mount solder joints.
