White Paper

Discussion on Cracking/Separation in Filled Vias

By: Nathan Blattau, PhD

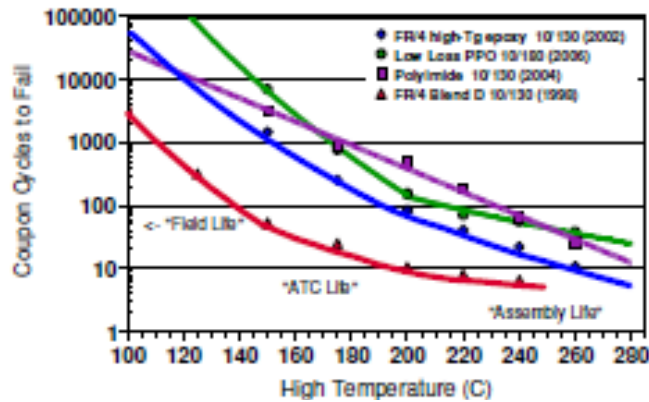
Figure 1 – CICT Plated Through Hole Life Curves-Impact of Unfilled Vias

The Knadle “PTH life curve” has been used for over 15 years to characterize new materials or PTH structures, and to calculate via life for any combination of temperatures. **Error! Reference source not found.** depicts these life curves to review the problem that drives all others—the CTE mismatch between the copper barrel and the laminate at reflow temperatures. This mismatch can produce deformations such that that even well plated vias can survive only a handful of assembly passes without cracking. Typically, 1-2 reflow cycles are required for SMT attach, and an additional 2 reflows for each rework (remove & replace). Therefore, 8 reflow cycles of greater than 220C could be possible during assembly. A methodology for increasing the reliability of these circuit boards was to epoxy fill the vias to add strength and extend the product life.

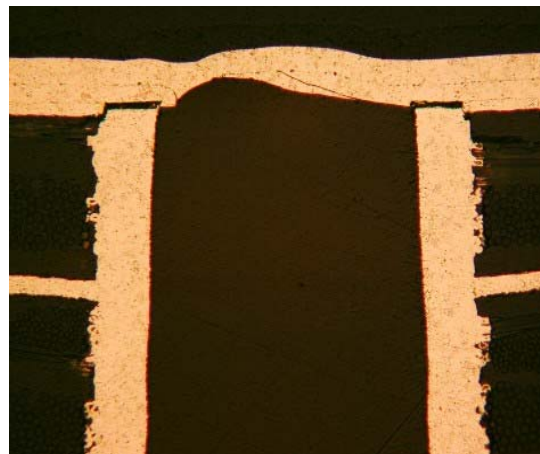
Figure 2 : Example of cap separation, no wrap plating

A DfR customer experienced cracking and separation of epoxy-filled vias and was interested in identifying the root-cause that initiated cracking/separation and determining the risk to existing product in the field. Figure 2 illustrates the issue.

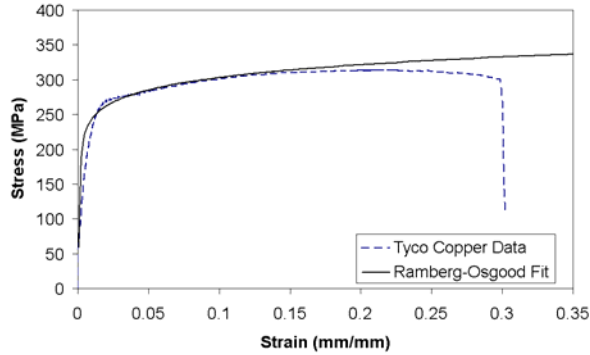
Figure 3 : Ramberg-Osgood fit of the Tyco copper test data

The structure is composed of three materials, resin, laminate and copper. The copper has elastic plastic behavior and is modeled using a Ramberg-Osgood equation fit to the Tyco copper test data, as shown in Figure 3. The materials and their associated elastic and expansion properties are shown in Table 1. Some assumptions were made for the behavior of the materials above their glass transition temperature. The assumptions are based upon the behavior of other PCB material systems which typically show an order of magnitude drop in elastic modulus above their Tg, as shown in Figure 4. The thermal and electrical properties used for the coupled transient thermal and electrical analyses are shown in Table 2.

The first thermal mechanical analysis is done to quantify the stresses that occur during reflow and to determine if cracking of the cap structure is possible. The temperature is ramped up from 25°C to 210°C and back down to 25°C to simulate a reflow event. The stress required to initiate cracking is determined by adjusting the fracture criterion of the tied contact surfaces such that a partial fracture occurs after one reflow event. As shown in Figure 3 (the stress strain plot for the copper), fracture typically occurs between 300 and 350 MPa.

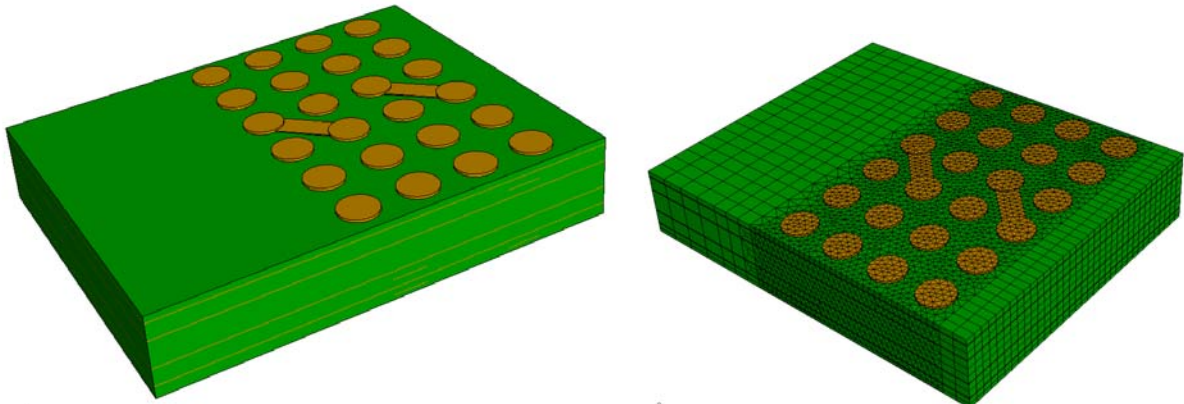
Figure 6: Three dimensional representation of IST coupon section (left) mesh details (right)

Three dimensional FEA modeling is done to determine the thermal gradients developed during IST. The layer structure and dimensions are taken directly from the gerber plots of the IST coupon (as shown in Figure 5). Only a 4 x 6 grid of the plated through holes are modeled due to the complexity and number of elements required, as shown in Figure 6 (left). A combination of brick and tetrahedron elements are utilized due to the complex structure, as shown in Figure 6 (right)

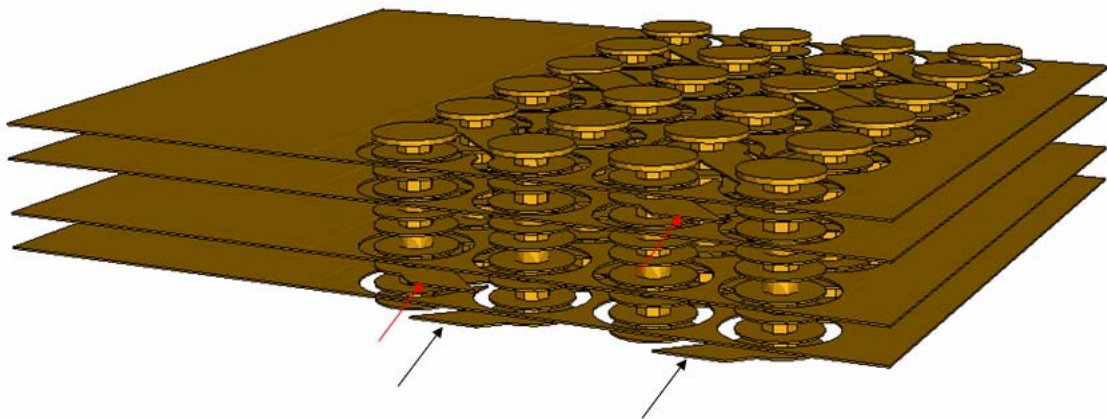
Figure 7: Copper layers with current load application regions

During IST current is applied to the traces and causes the board to heat due to the resistance of the copper. By knowing the temperature resistance relationship, the temperature of the copper can be determined and controlled. The FEA model has current applied to the heating traces, as shown in Figure 7. The amount of current applied during IST is not known but was adjusted so that the steady state temperature of the model was 220°C.

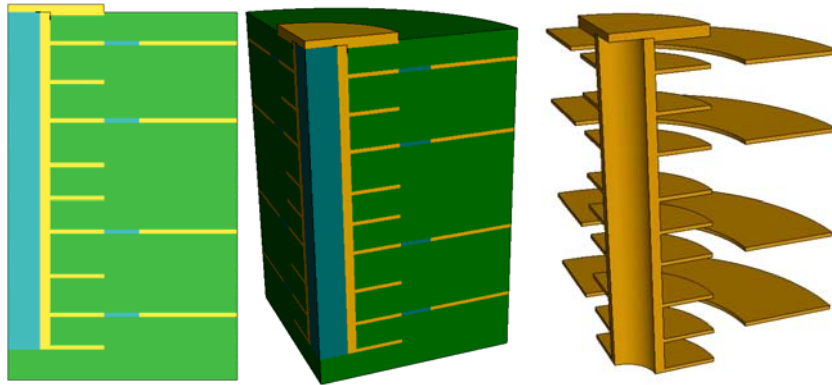
Figure 8: Axisymmetric model of capped via structure

Two dimensional axisymmetric modeling is done to determine the stresses necessary to cause the failures being experienced. The structure of the capped via lends itself to this type of modeling due to its circular configuration. A worst case assumption of no-wrap is assumed for the models. The geometric model is shown in Figure 8, and includes the via and the surrounding material. A coupling constraint is applied to the outer circumference to force the planarity of the outer edge nodes, as indicated in Figure 9. The mesh details in the region of interest are shown in Figure 10 and include tied contact surfaces that can debond at a set stress level, as shown in Figure 11.

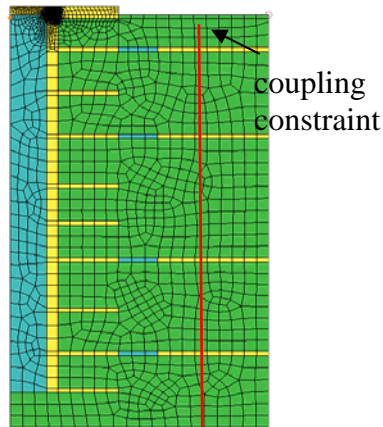
Figure 9: Coupling constraint

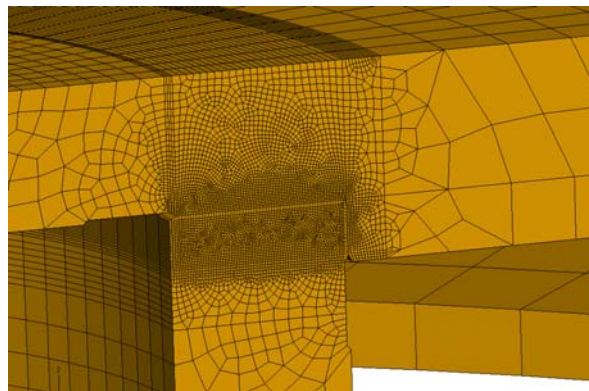
Figure 10: Mesh details, critical region

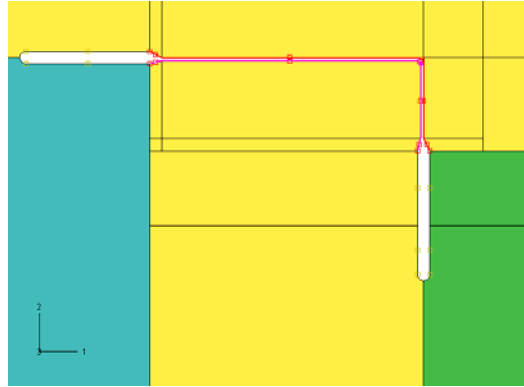
Figure 11: Contact Surface Area (red lines indicate surfaces that can debond)

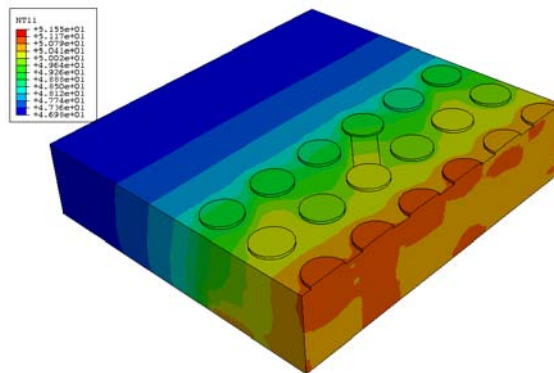
The result of the electrical thermal analysis is shown in Figure 12. The thermal gradients are at a maximum during the ramp up to temperature and diminish as the coupon reaches steady state. However, as shown by the figure the temperature difference within the via is very small and there is less than 0.5°C thermal gradient. Therefore the amount of additional stress due to the thermal gradients is negligible and uniform heating of the via can be assumed.

Figure 12: Thermal gradients during ramp up

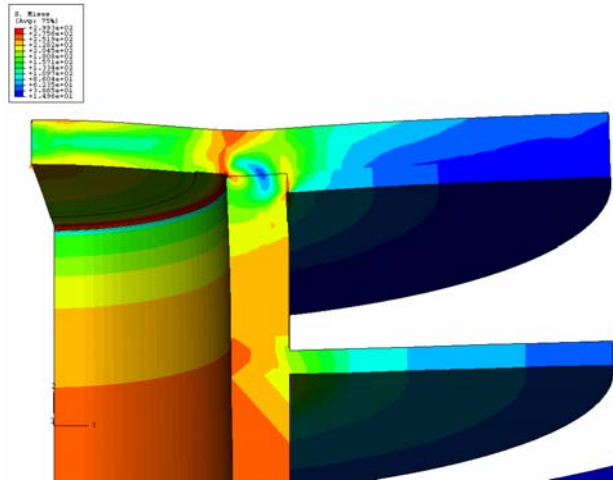
During a reflow event the stresses that develop near the via cap are very high and plastic deformation occurs. The stresses present just prior to fracture are shown in Figure 13 and are almost 300 MPa. During fracture the stresses are in excess of 300 MPa and cracking may occur during reflow if the interface is brittle (See Figure 14). The plastic

Figure 13: Stresses developed at cap prior to fracture at 205°C, 5X deformation magnification

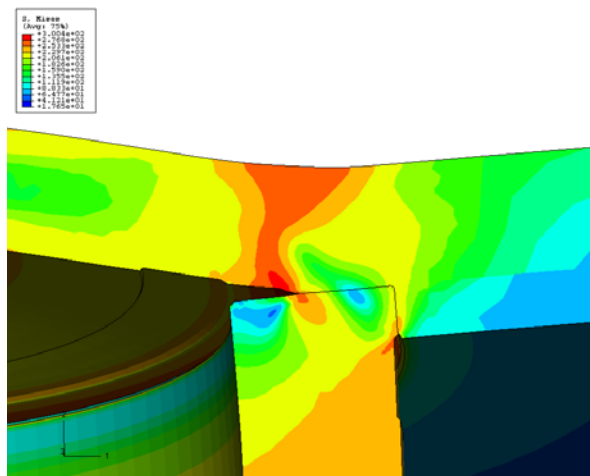
Figure 14: Stresses developed at cap during fracture at 210°C, 5X deformation magnification

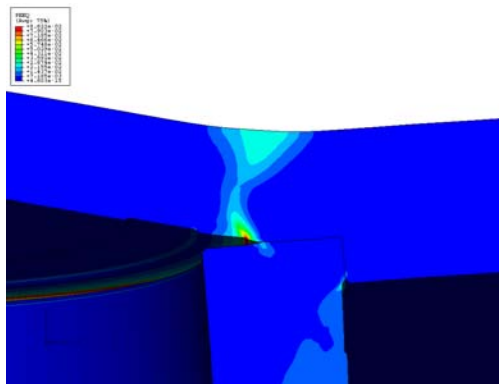
strains developed in the via are shown in Figure 15 and are around 8.6%. A comparison between the FEA deformations and the cross-section provided by Tyco is shown in Figure 16.

Figure 15: Plastic strains developed at cap during fracture at 210°C, 5X deformation magnification

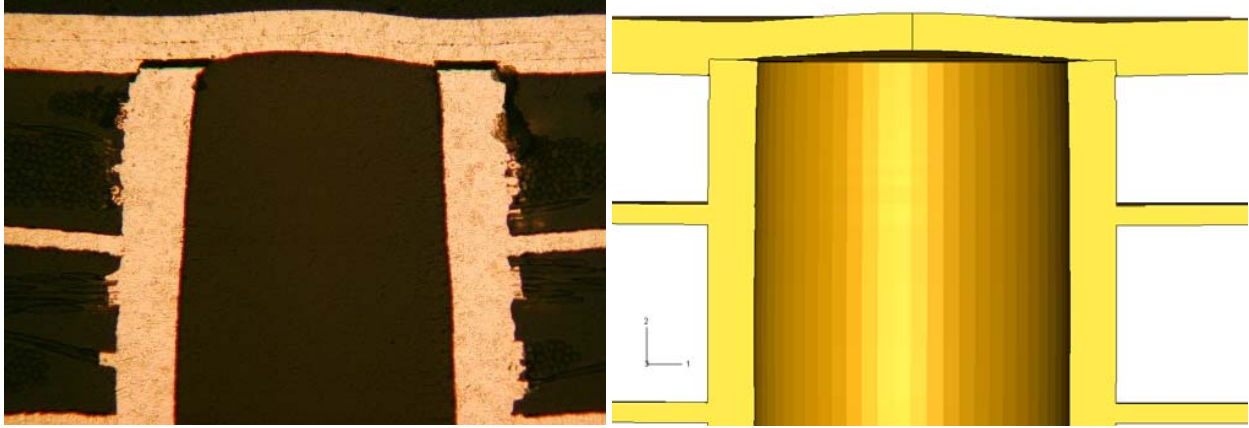
Figure 16: Comparison of x-section and FEA deformation

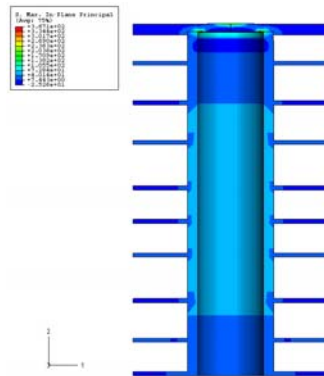
The model is modified to remove interfacial cracking and the fatigue predictions are made based upon the stresses and strains developed during a thermal cycle. The thermal cycle is assumed to be from -55°C to 70°C and occurs a total of 417 times. The maximum principal stresses developed in the via are shown in Figure 17, the plastic strains at -55°C and 70°C are shown in Figure 18 and Figure 19. The area with the highest stresses and strains is at the inside corner where the cap connects to the barrel.

Figure 17: Maximum principal stresses developed at 70°C, residual tensile stresses in cap

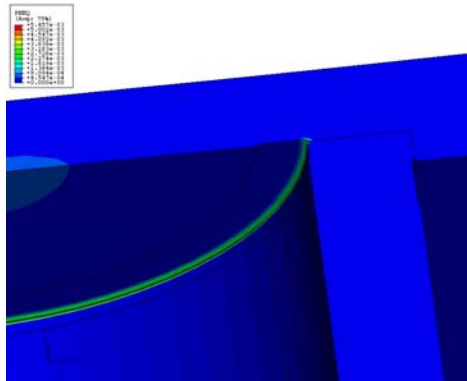
Figure 18: Equivalent plastic strains at 70°C

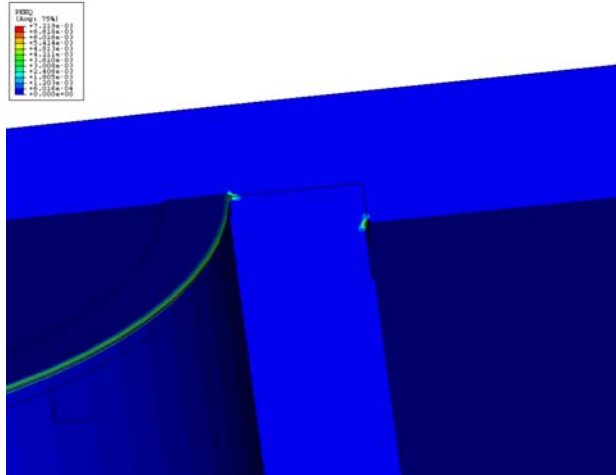
Figure 19: Equivalent plastic strains at -55°C

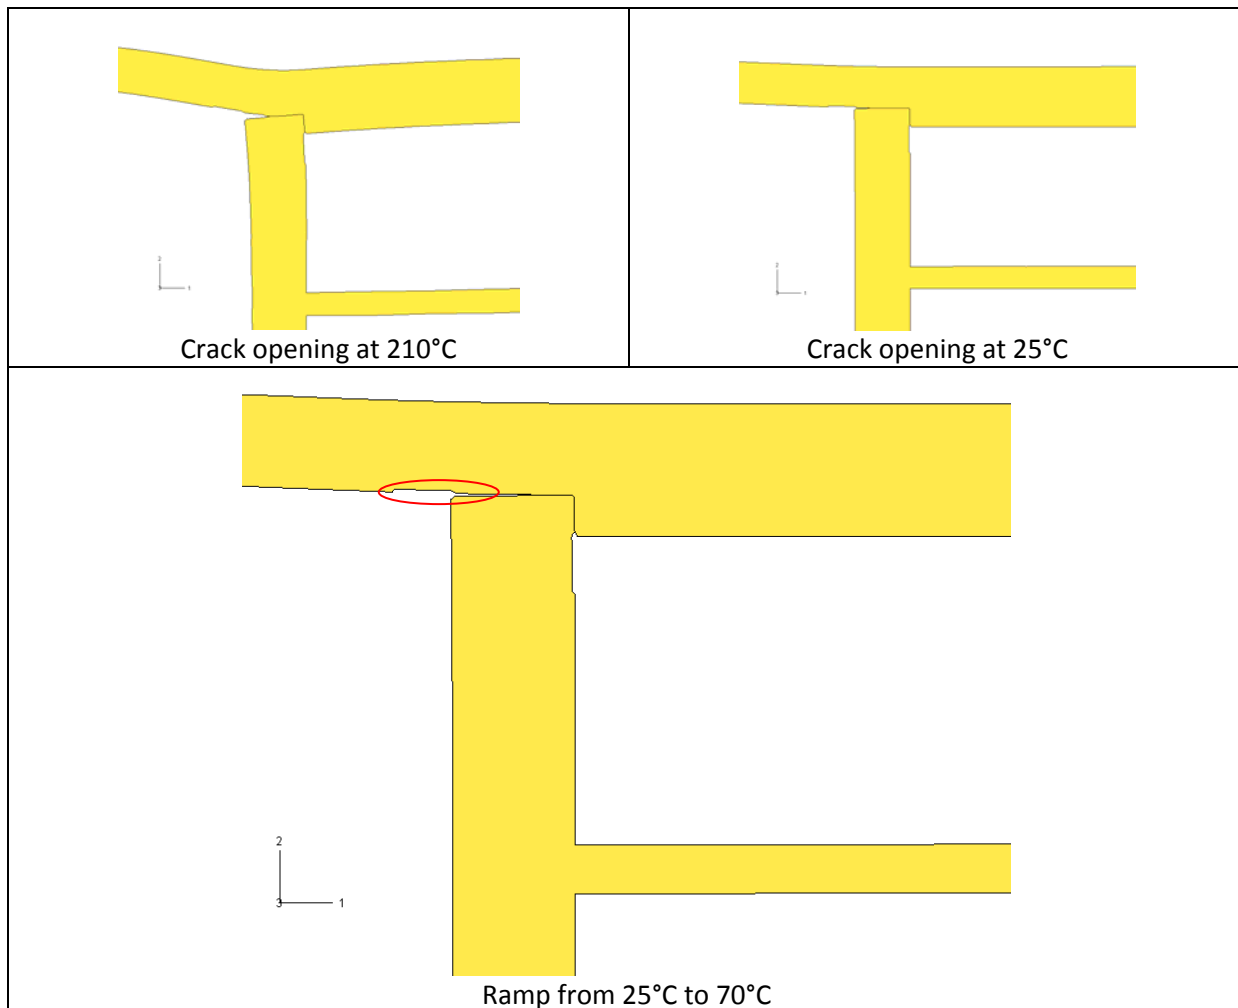
The results show that an uncracked capped via will survive over 8000 thermal cycles from -55°C to 70°C and will meet the assumed life requirements (10,000 hours, 417 cycles). However, when cracking occurs this result is no longer valid and the via may fail much earlier. As shown by the FEA results, the stresses developed in the via are sufficient to cause the initiation of a crack if the copper to copper interface is weak. Once this crack has occurred, it will propagate along the interface and cause separation of the cap from the barrel. This was simulated with the FEA model by adding an additional ramp up to 70°C after the 210°C temperature excursion. Figure 21 shows the crack opening at 210°C followed by the closed but still separated crack at 25°C. The large image in Figure 21 shows the crack propagation after an additional temperature ramp to 70°C. This caused the crack to propagate about 20% further, and indicates that this type of failure should occur quickly and should be captured during the ESS testing (assuming thermal cycling is performed) or early in the life of the product.

Figure 21: Crack growth during ramp to 70°C

DfR recommended that our customer should review their ESS procedure to ensure that a sufficient number of thermal cycles are performed to capture the defects.

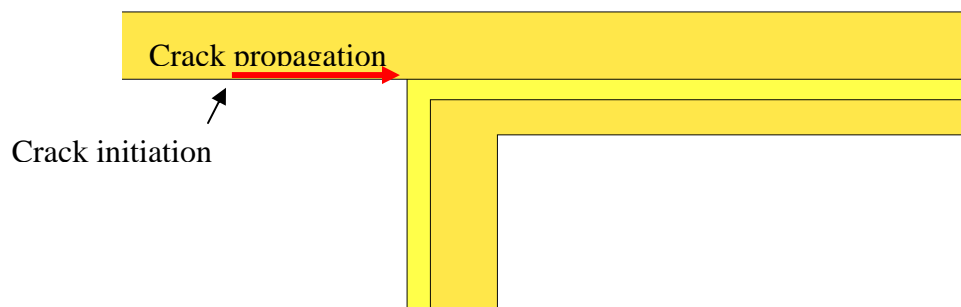
The presence of a wrap will not stop the crack initiation but will change the crack propagation path so that failure is unlikely, as shown in Figure 22. As the crack grows, the opening stress will decrease until it is insufficient to propagate the crack.

Figure 22: Effect of wrap on crack propagation path
