COPPER WIRE BOND FAILURE MECHANISMS

Randy Schueller, Ph.D.
DfR Solutions
Minneapolis, MN

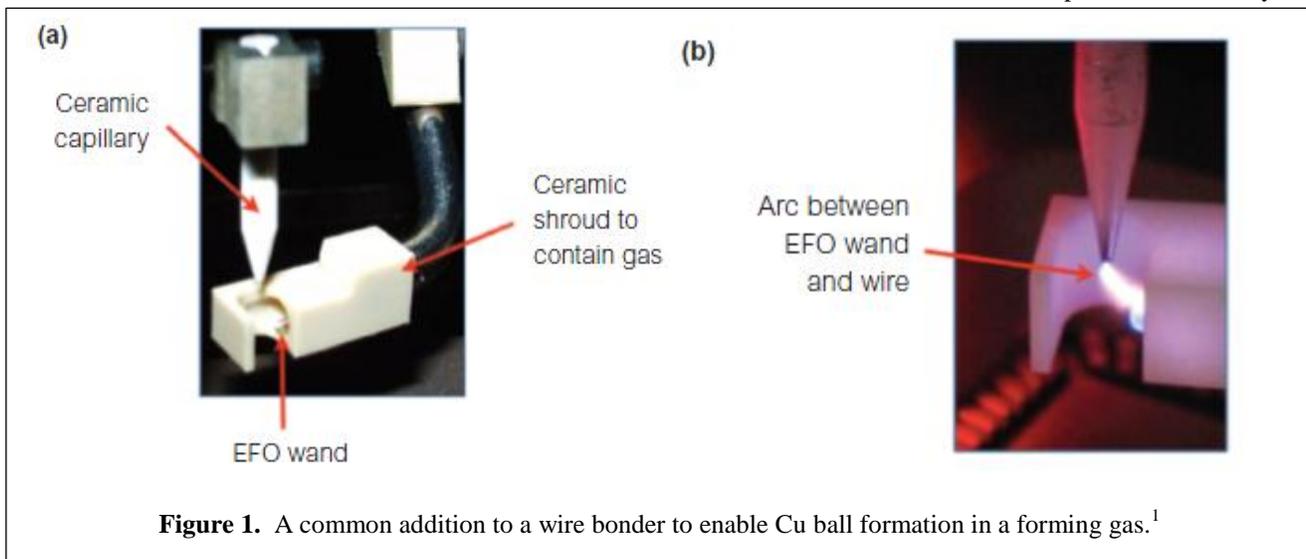
Figure 1. A common addition to a wire bonder to enable Cu ball formation in a forming gas.¹

With the cost of gold having risen from \$350 to over \$1600 an ounce in the past several years, it is easy to understand the attractiveness for finding an alternative to gold wire for interconnecting a die to the package substrate. Aluminum wire is often used in wedge bonding, however, it is not practical for use in fine pitch ball bonding since Al oxidizes too readily during the spark formation of the ball. The industry has selected copper as the best alternative to gold. Cu does oxidize during a ball formation, but this can be kept to an acceptable level using forming gas (95%N and 5%H₂). Figure 1 shows a machine modification that enables ball

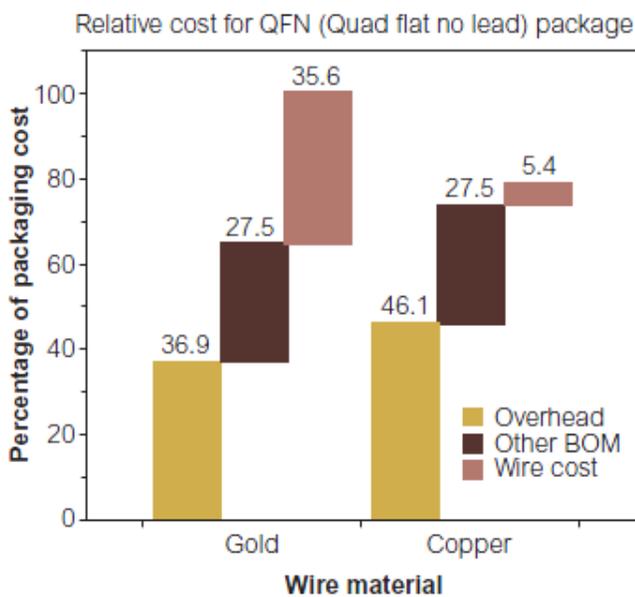
Figure 3. Comparative cost of assembling an 85 lead QFN package with gold and copper wires.¹

producing a quad flat pack no-lead package with 85 wires (a lower cost package) with Cu wires vs. gold. He assumed slower throughput that added 10% to the manufacturing cost and a wire cost savings of 85%. Figure 3 shows the results of this analysis.

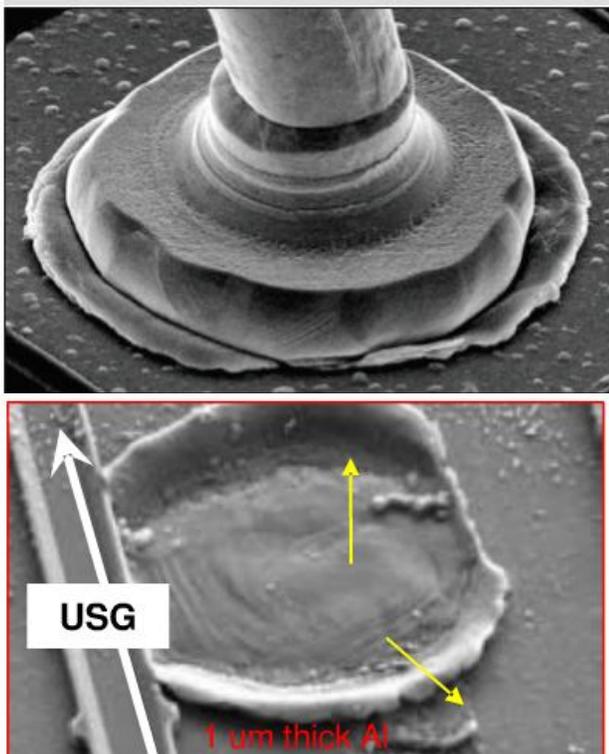
Figure 5. An example of Al splash.

Because of the higher hardness of copper, the process of pressing the ball onto the surface while vibrating will cause actual displacement of the Al on the bond pad. The softer Al will be forced out to the side, as shown in Figure 5. The harder the copper or the higher the bonding energy the more Al is moved to the edges of the ball. This leaves less Al on which the copper can bond. It also puts more stress on the underlying silicon or passivation layer, which can lead to

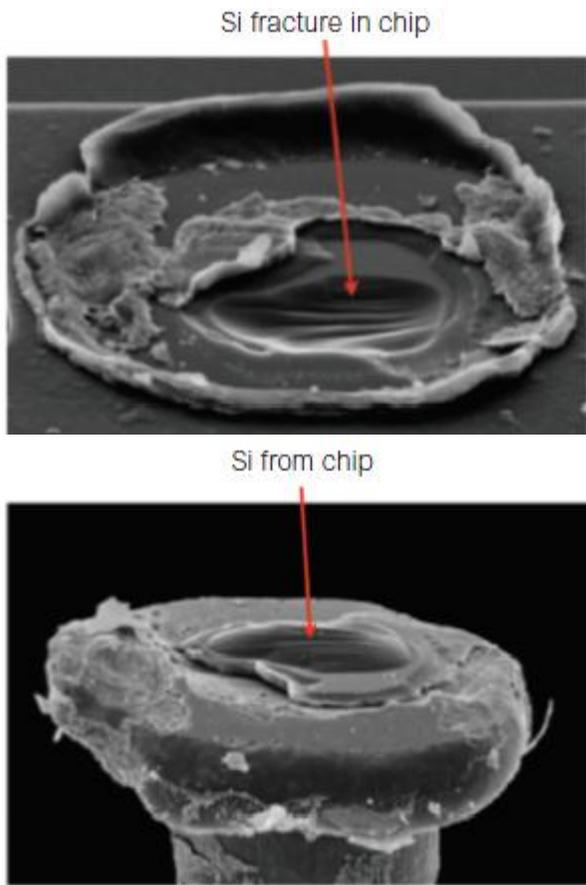
Figure 6. An example of cratering due to Cu wire bonding.

When the passivation layer or the silicon beneath the Al bond pad fractures it is called cratering. This type of defect is caused by too much ultrasonic energy being transferred to the Si and has become a more significant issue with Cu wire bonding. A small chip out type defect as shown in Figure 6, does not always cause an actual functional failure since active circuitry does not typically lie beneath the bond pads. However, it can cause weakness of the overall bond interface and can fail early in the field due to thermal cycle stress. It is important to perform bond pull and shear testing as part of the process optimization and to inspect the die surface and record the type of failure that is occurring. Interfacial fractures should not show signs of cratering. Thicker Al on the die pad can also be used to minimize cratering. The Al layer was purposefully rather thin for Au bonding to reduce the growth of thick Au-Al intermetallic, however, the Al-Cu intermetallic grows very slowly so the Al layer can presumably be made thicker without causing a reliability concern.

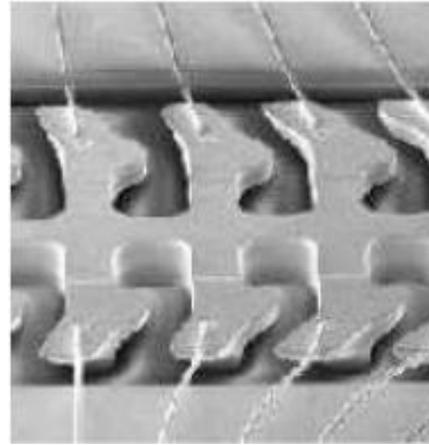
Figure 7. Bonding to a QFN lead can be difficult with copper, since the leads are not well supported.⁵

bond is placed, are supported by tape (see Figure 7). Cu wire bonding to these is difficult since the lead can move during the bonding operation. Additionally, it can be difficult to transfer heat to these bond pads.

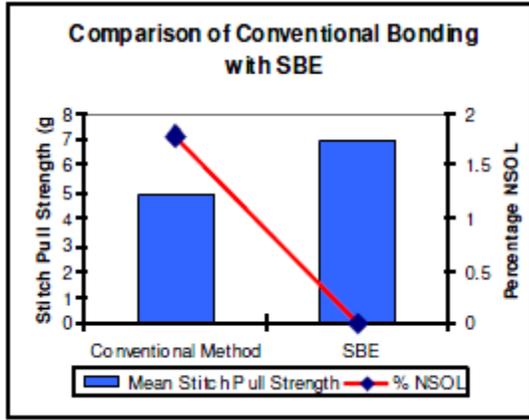
Figure 8. Results of using a stitch bond enhancement feature on a wire bond machine. Non-stick-on-lead failures were eliminated.

A ball bond machine used for fine pitch bonding creates two types of bonds. The first is the ball bond that was described previously. The second bond (or stitch bond) is created when the capillary crushes the wire against the bond surface. Oxidation of the copper wire becomes a greater concern with the second bond because the oxide has had longer to form on the wire surface (unlike the freshly molten ball). Additionally, this oxide layer must be broken through with less plastic deformation of the copper and the bonding area is smaller than the ball bond. There are a number of modifications that have been implemented to overcome a weak copper stitch bond. Some bond machines come with a Stitch Bond Enhancement (SBE) feature that includes programmable table displacement cycles, directions, amplitude and bond force/power.⁶ These have proven to be effective, as shown in Figure 8.

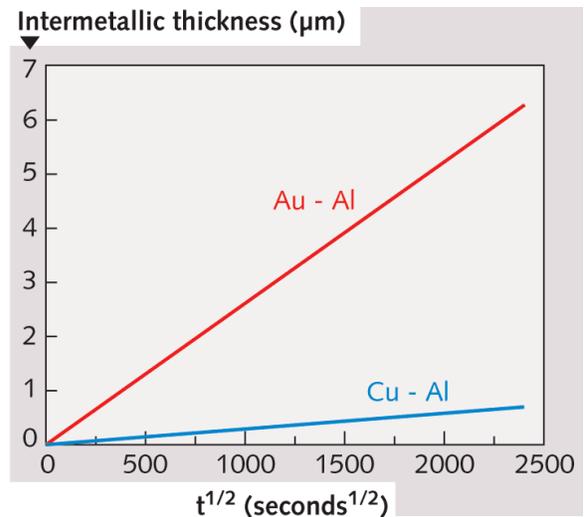
Figure 9. Growth of intermetallic thickness vs. time at 175°C.¹⁰

However, with Cu bonding to Al the intermetallic growth rate is much slower and the formation of Kirkendall voids is not a real concern. Figure 9 shows measurements of IMC growth for Au and Cu at 175°C.⁸ The growth rate is of Cu IMC is about 1/5 that of gold. Figure 10 shows cross section examples of IMC thickness under high temperature exposure conditions. As one might expect, the slower growth of intermetallic results in more stable bond strength over time at elevated temperature. Figure 11 shows shear strength of Au and Cu ball bonds made on Al bond pads after aging at various temperatures and times.⁹ Interestingly the strength loss differences are not nearly as pronounced as the IMC growth rates. At temperatures of 120°C or below Cu and Au are very similar in strength loss.

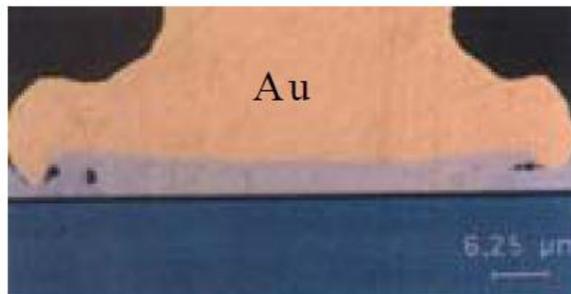
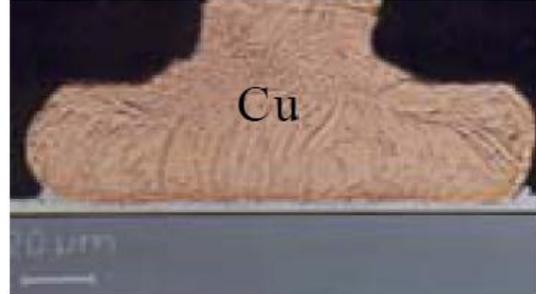
Intermetallic Penetration - AlSi-Au Bond (aged 200 hours at 200°C)

Intermetallic Penetration - AlSi-Cu Bond (aged 800 hours at 180°C)

Figure 10. A comparison of intermetallic growth rate with Au and Cu ball bonds on Al.¹

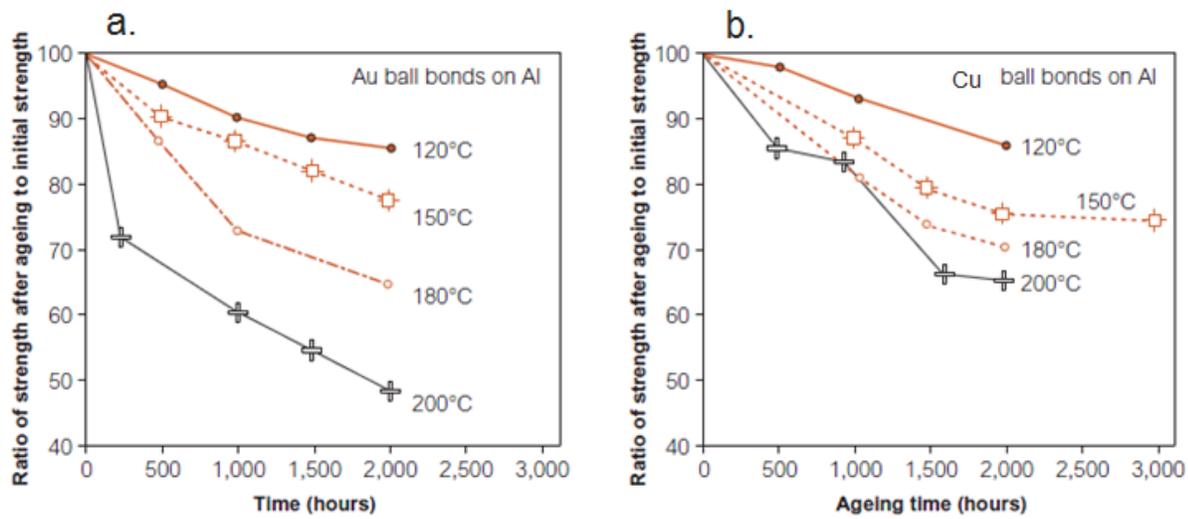
Figure 11. Shear strength of Au and Cu ball bonds on Al bond pads after aging. At temperatures of $<120^{\circ}\text{C}$ they are similar after 2000 hours.⁹

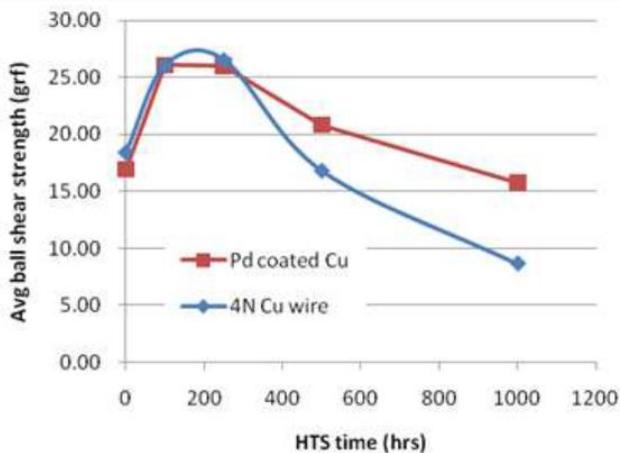
Figure 12. Shear strength of ball bonds after aging at 200°C .

More recent studies have shown some surprising results that occur when Cu wire or Pd coated Cu wire is aged at 200°C . It was found that Pd coated wire performed better over time (see Figure 12)¹¹. Most concerning was the discovery that after 500 hours of aging, the shear failure mode changed from fracture within the copper to a brittle crack along the IMC. Figure 13 shows such results. This newly discovered and concern actually highlights a common problem among component manufacturers and New Technology: the assumption that standard testing and standard acceleration factors (such as Peck's Law) are relevant for New Technology (hint: it usually isn't).

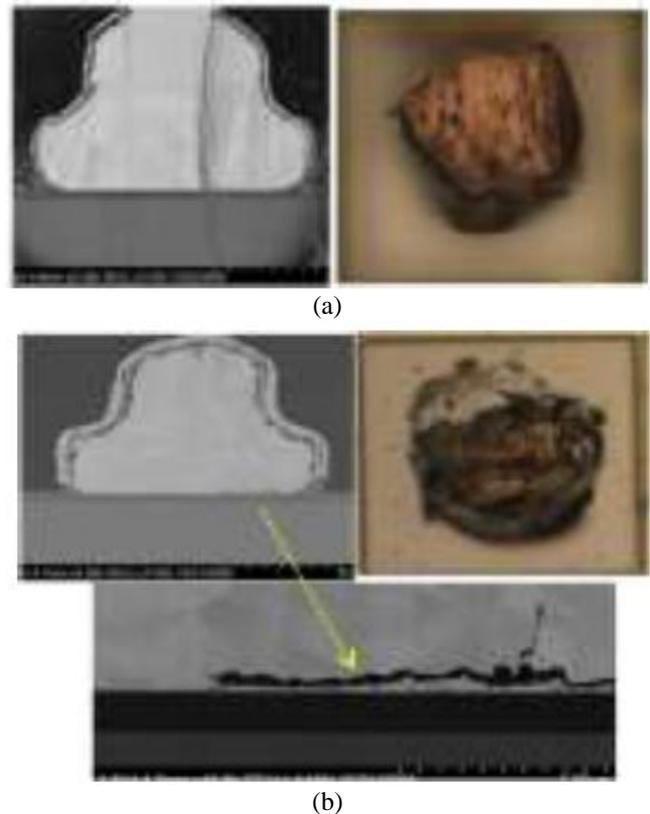
Figure 13. A change in fracture mode is observed from (a) 250 hours of aging at 200°C to (b) 500 hours of aging.¹¹

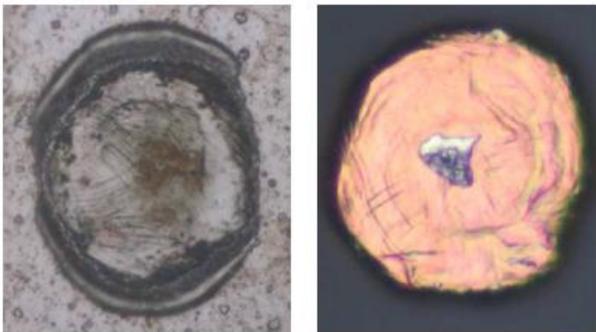
Figure 14. A weak interface revealed by ball shear after autoclave testing.

Even after large scale introduction of Cu wire bonding, the industry is learning about new and unexpected failure mechanisms. Perhaps the most worrisome is the susceptibility to oxidation/corrosion when exposed to autoclave conditions (130°C/85%RH plus bias).^{12, 13} This weakness was validated at the Fraunhofer Institute where they found early failures in T/H testing and determined it was due to galvanic corrosion of the copper oxides between the intermetallic and Cu bond wire.¹⁴ Figure 14 shows an example of the weakened and fractured interface between the Cu and the Al. Analysis showed the presence of Cl as a corrosion activator and high oxidation of the Al near the edges of the Cu ball. The primary IMCs that form in a Cu-Al bond is CuAl₂ and CuAl, however, this study also revealed a Cu₉Al₄ phase that formed presumably during preconditioning at 260°C. This Cu rich phase was highly susceptible to galvanic corrosion, acting as the sacrificial anode; leading to delamination.

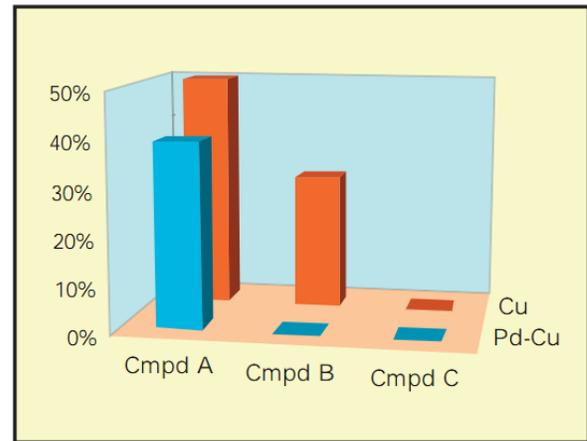
Figure 15. Failure rates after 336 hours biased HAST test for three mold compound formulations with 0.8 mil Cu wire on Al pads (5V bias, 130°C, 85% RH).¹⁵

Additionally, under voltage bias testing (T/H/B) the copper can migrate and cause shorting between pads on the device. The prevalence depends on the type of mold compound used, as noted by H. Clauberg (see Figure 15). In this failure mechanism, the Pd coating can actually help prevent the copper from migrating. The bottom line is that encapsulants and molding compounds should be carefully selected with Cu wire bonding. They should resist moisture absorption and be free of Chlorine, that is, contain fire retardants specifically designed to eliminate copper corrosion.
