White Paper

Capturing the Robustness of Glass Panels in Touch-Screen Displays

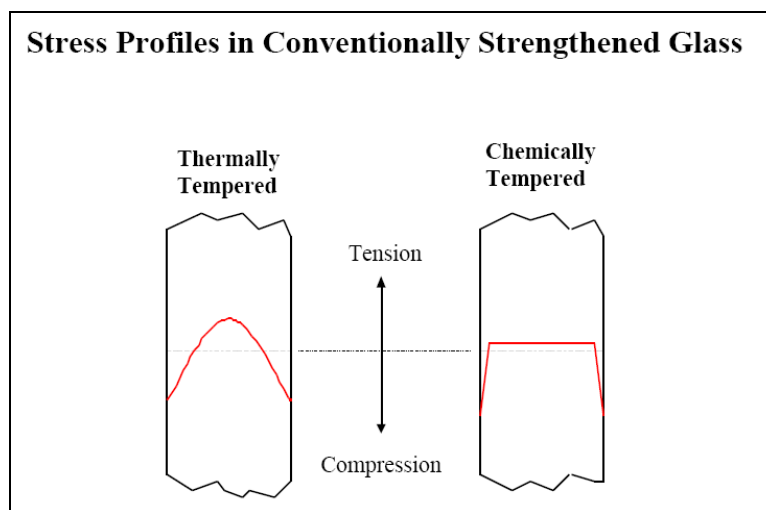
Figure 1: Cross Sections Showing Residual Stress Profiles Due to Thermal and Chemical Strengthening

The strength of glass panels is critical for the performance of touch-screen displays, especially in regards to how it responds to impact or drop. Insufficient drop testing performance can be related to two parameters: fracture strength and flaw size. The fracture strength of touch screen panels, everything else being equal, is primarily driven by the degree of strengthening performed on the surface of the glass. Glass of less than 1/8th inch thickness for touch screen panel applications tends to require a chemical strengthening process as thermal quenching can induce warpage in these thinner glass sheets. Chemical strengthening is performed through an ion-exchange mechanism, typically in a potassium-based solution. The larger potassium ion ($r+ = 0.133$ nm) substitutes for the smaller sodium ion ($r+ = 0.098$ nm), inducing a volumetric increase and creating residual compressive stresses at the outer layer of the glass (see Figure 1).

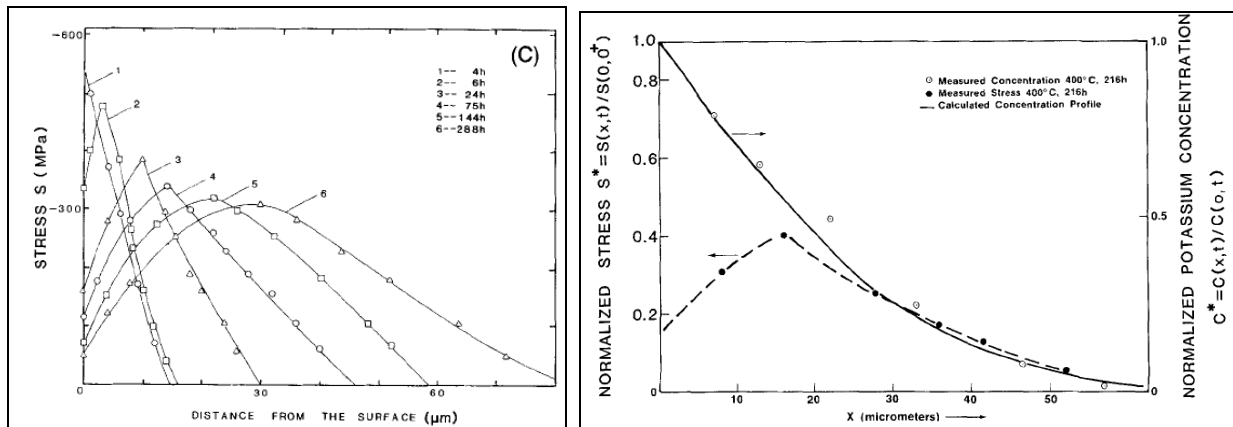
Figure 2: Change in residual stress as a function of time of exposure (left) and in comparison to potassium depth profile (right)[Sane, et. al., Stress Buildup and Relaxation During Ion Exchange Strengthening of Glass, JACerS, 70 [2] 86-89 (1987)]

The degree of chemical strengthening can thus be characterized through depth profiling of the exchanged ions and stress measurement. While the degree of ion exchange will provide important information on the manufacturing processes, stress measurement is also an important measurement as post-exchange anneals can result in substantial changes in compressive stress values (see Figure 2).

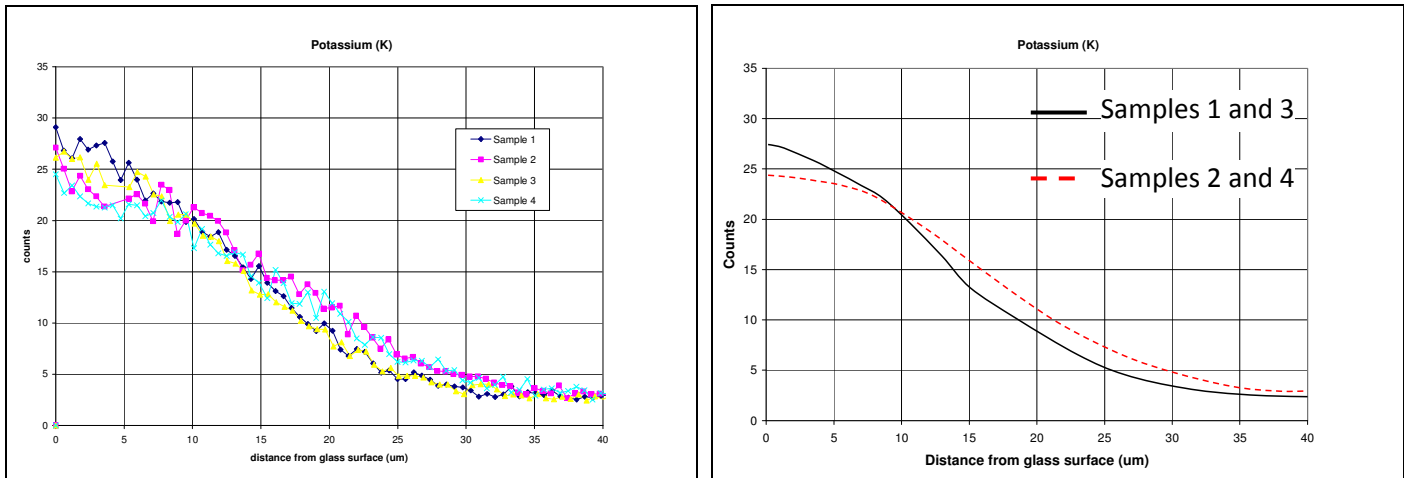
Figure 3 shows the potassium distribution for the four measured samples. Sample 1 and sample 3 have higher potassium values at the surface with a steeper decline, compared to samples 2 and 4. This could be due to a higher concentration of potassium in the exchange solution and a shorter exposure time.

Figure 3: Measured (left) and average (right) potassium concentration distribution in Samples 1/3 and 2/4

Definitive differences in potassium concentration profiles and degree of beveling were observed between Samples 1 and 3 and Samples 2 and 4. Based on these results, it is speculated that Samples 2 and 4 will demonstrate insufficient performance when subjected to ball drop testing and product drop testing. To ensure better performance, the following recommendations are suggested

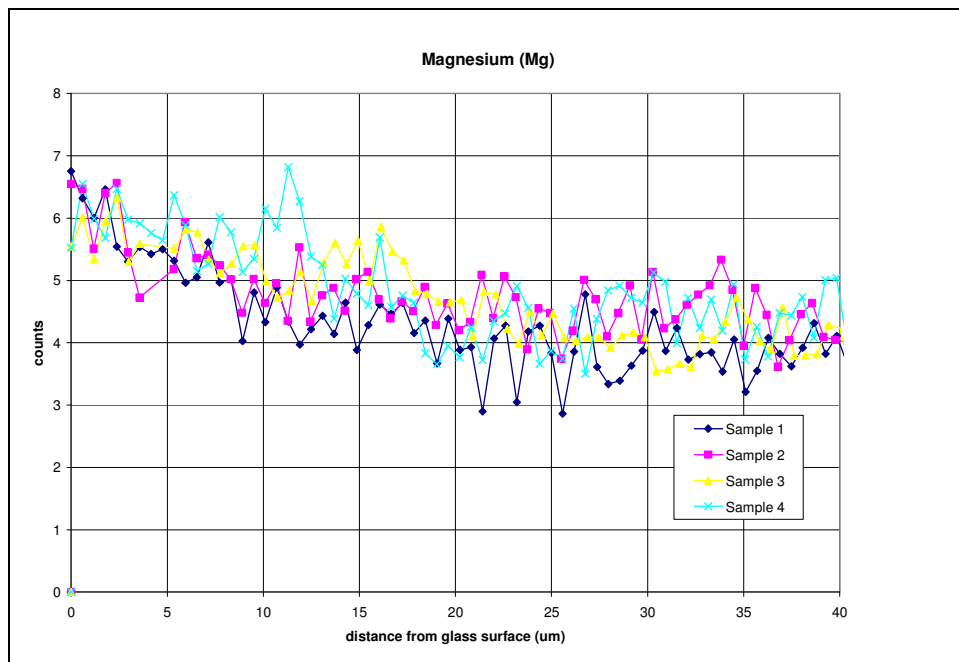
Figure 4 shows the distribution of magnesium. Magnesium must be present in the ion exchange solution and diffuses into the glass during the exchange process. As with potassium, the magnesium distribution also shows a declining concentration starting from the surface of the glass. Within measurement accuracy, a difference between the samples cannot be detected.

Figure 4: Magnesium distribution for ion-exchange strengthened glass

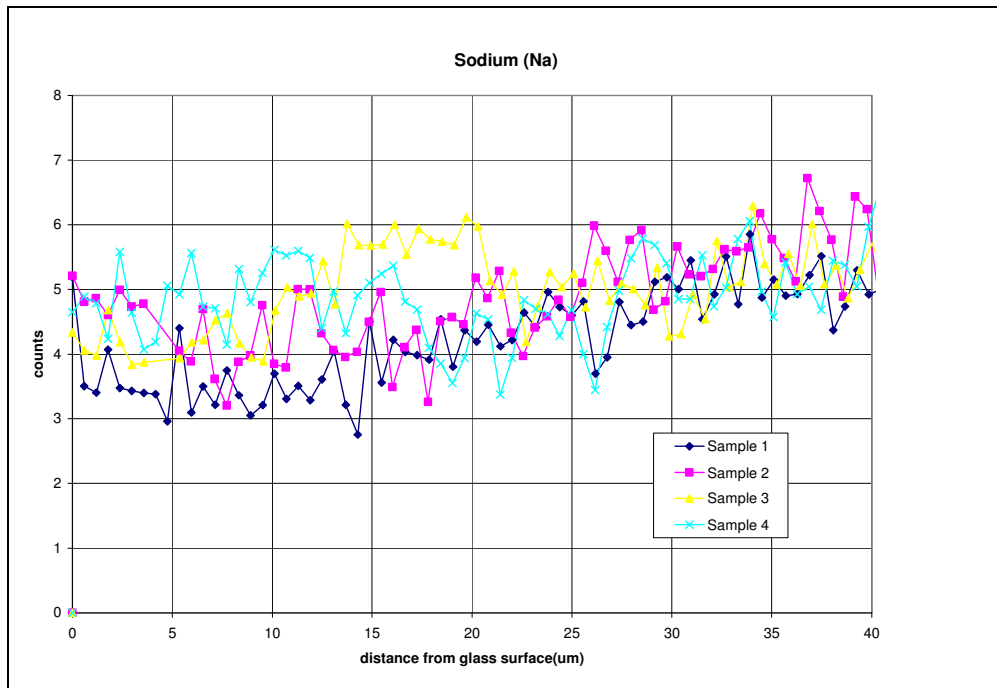
Figure 5 shows the sodium distribution in the four samples. Potassium is expected to replace the sodium, strengthening the glass. The measurement of the sodium shows a high variability, making it difficult to reliably detect a difference between the samples. Sample 1 shows the lowest variability, and also exhibits the smallest sodium concentration close to the glass surface.

Figure 5: Sodium distribution for the ion-exchange strengthened glass samples.

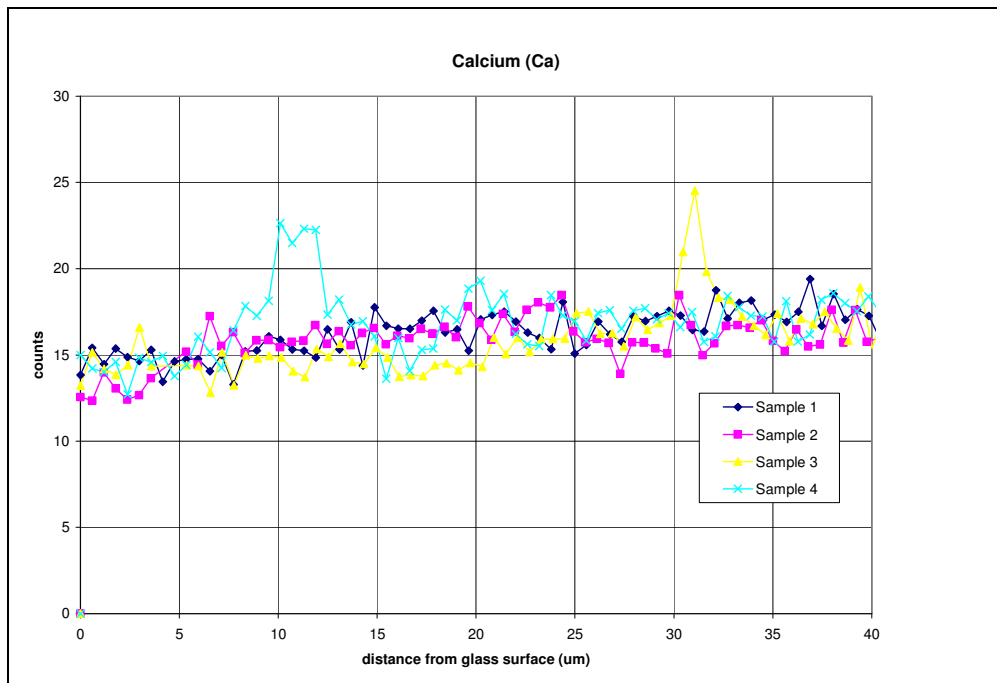
As seen in Figure 6 the calcium distribution close to the glass surface is reduced. Calcium as present in the glass originally is being replaced by magnesium or potassium. A difference between all four samples cannot be detected.

Figure 6: Calcium distribution for the ion-exchange strengthened glass samples.

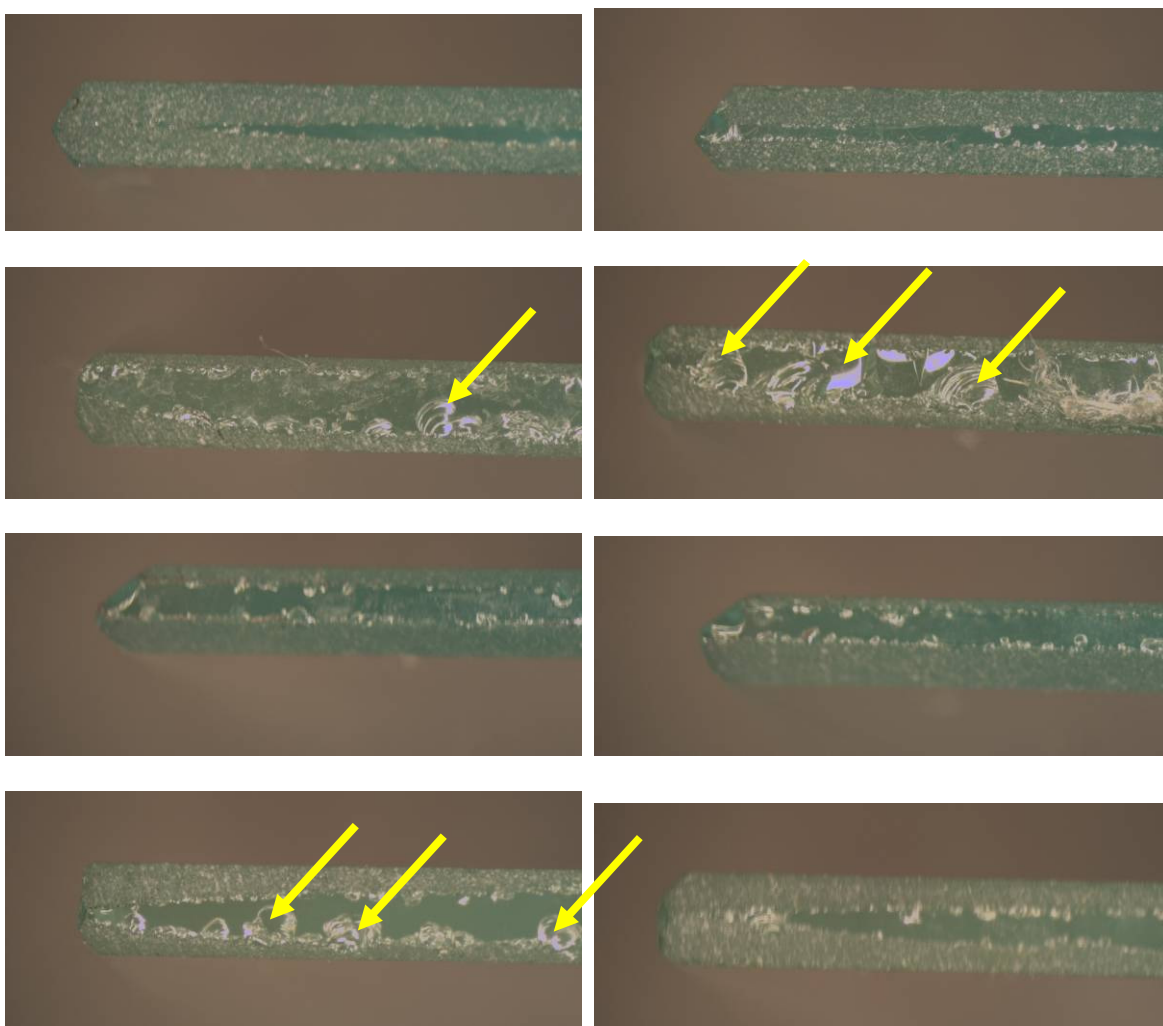
The degree of bevel on the four samples is displayed in Figure 7 and Figure 8. Two definitive differences were noted. In samples 1 and 3, the bevel is relatively severe, extending to the mid-plane of the glass panel. In samples 2 and 4, the bevel is much less severe, with only a minimal degree of rounding at the corners.

In addition, samples 2 and 4 displayed relatively large chip outs in comparison to samples 1 and 3. These chip outs are well known to induce failures during drop testing, but should have no influence on crack initiation during ball drop testing.

Figure 7: Edge-on view of glass panel showing the degree of beveling in Samples 1 through 4 (top to bottom). Yellow arrows mark relatively large chip outs at the edge of the glass panel.

- Modify bath parameters. This could include increasing potassium salt concentration or decreasing bath temperature or exposure time
- Improve beveling process and perform periodic visual inspection of bevel to ensure limited chip out (size and frequency)

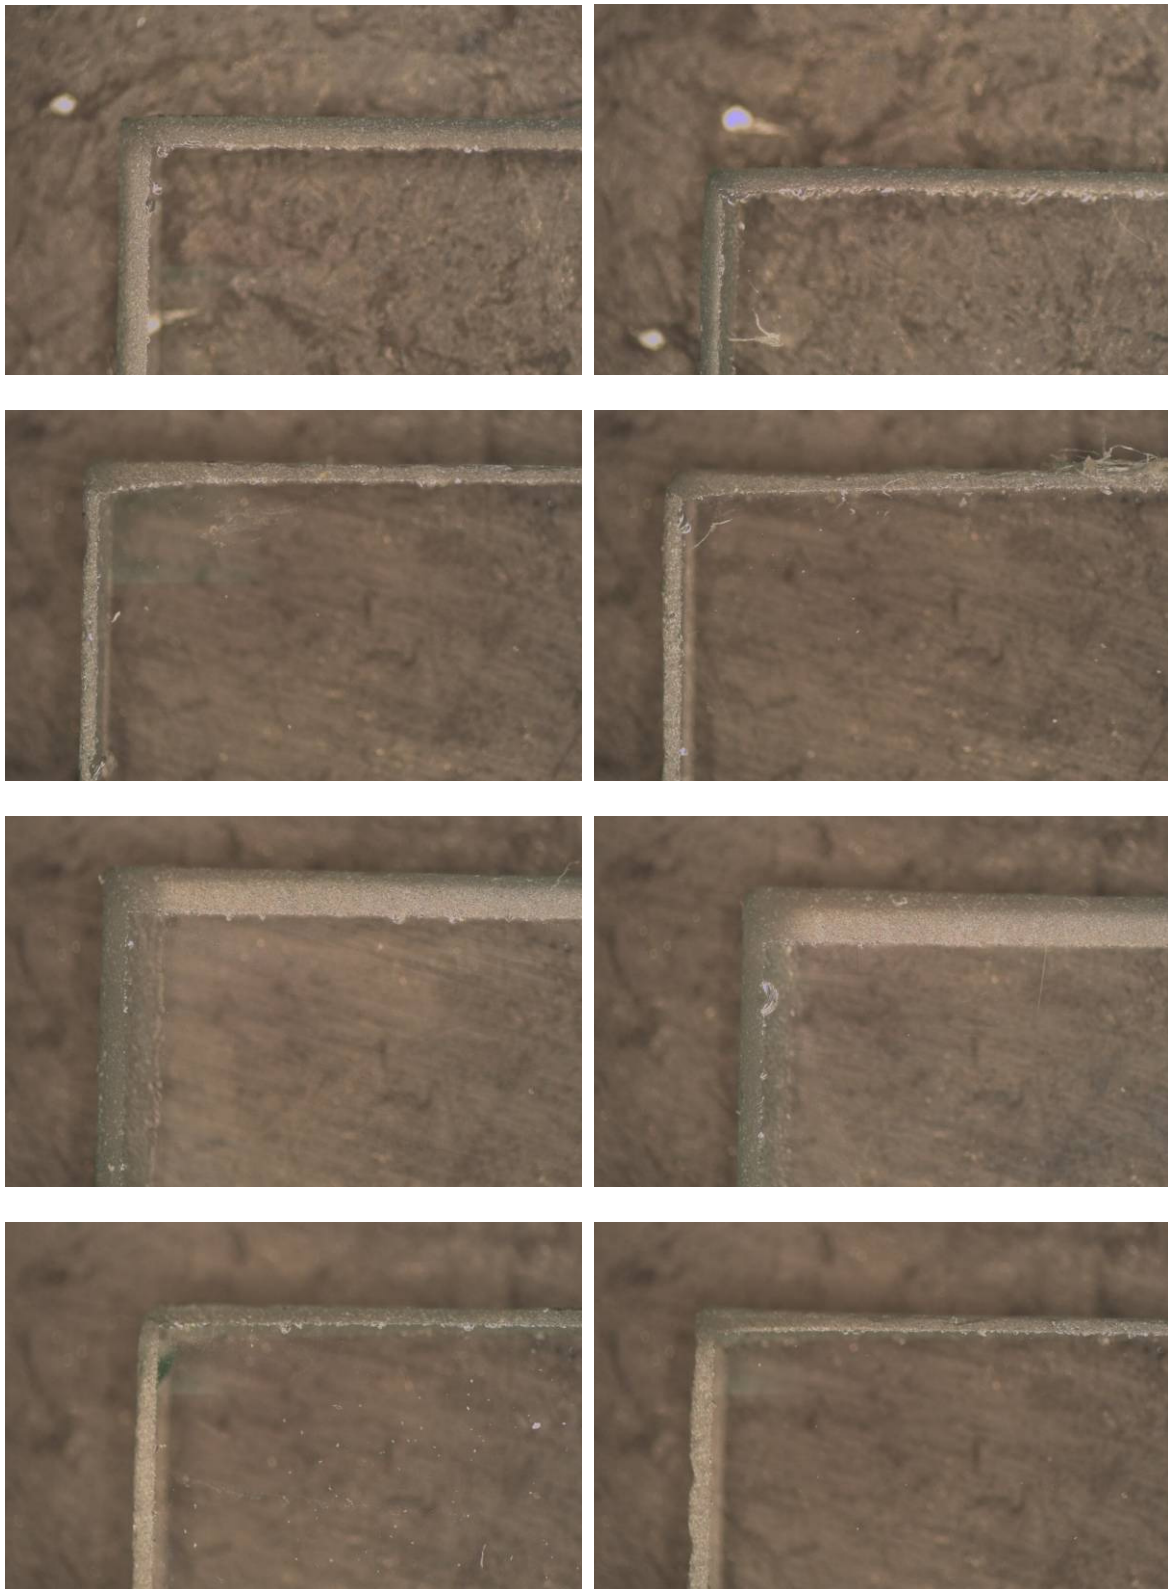
Figure 8: Top-down view of glass panel showing degree of beveling in Samples 1 through 4 (top to bottom)
