COPPER WIRE BOND FAILURE MECHANISMS

Randy Schueller, Ph.D.
DfR Solutions
Minneapolis, MN

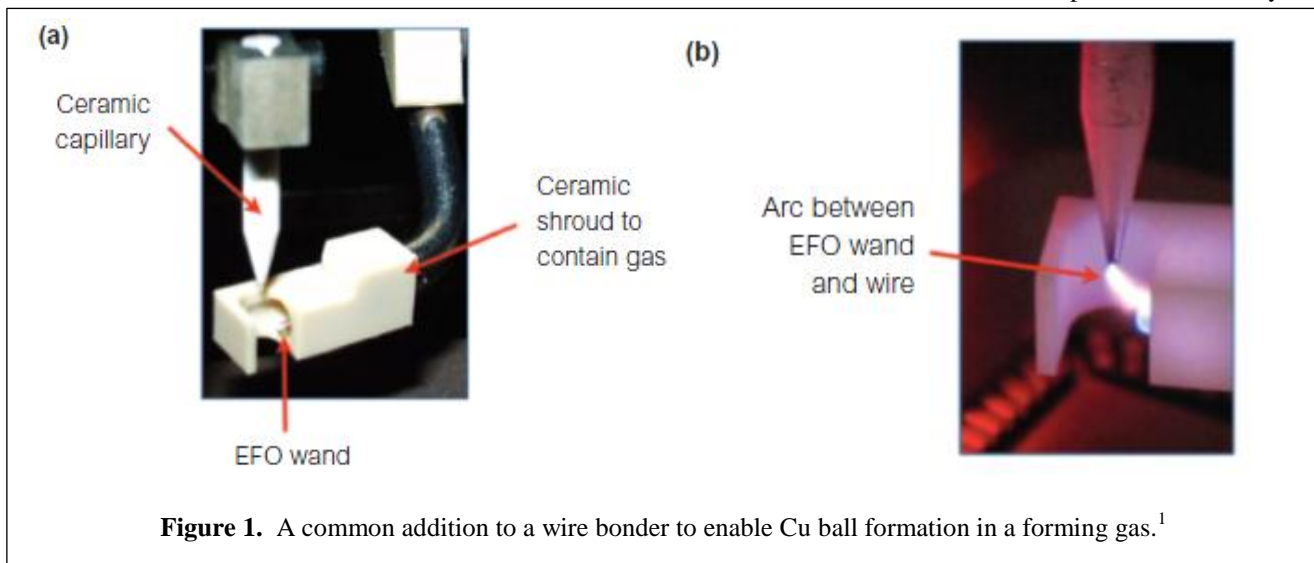
Figure 1. A common addition to a wire bonder to enable Cu ball formation in a forming gas.¹

With the cost of gold having risen from \$350 to over \$1600 an ounce in the past several years, it is easy to understand the attractiveness for finding an alternative to gold wire for interconnecting a die to the package substrate. Aluminum wire is often used in wedge bonding, however, it is not practical for use in fine pitch ball bonding since Al oxidizes too readily during the spark formation of the ball. The industry has selected copper as the best alternative to gold. Cu does oxidize during a ball formation, but this can be kept to an acceptable level using forming gas (95%N and 5%H₂). Figure 1 shows a machine modification that enables ball

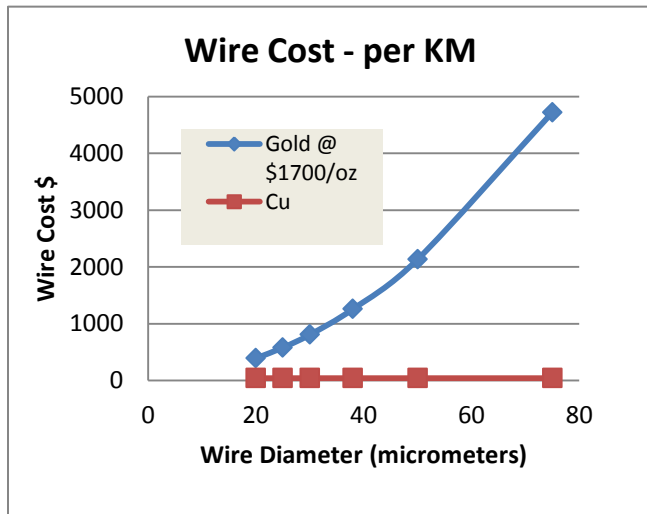
Figure 2. Cost savings for Cu wire compared to gold

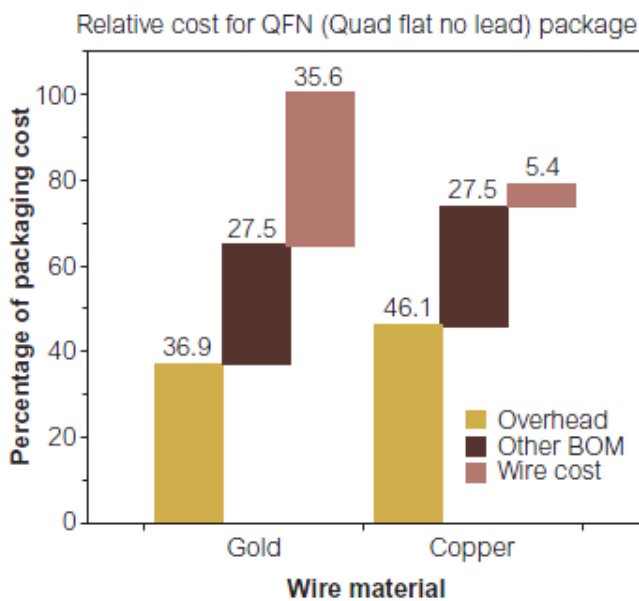
Figure 3. Comparative cost of assembling an 85 lead QFN package with gold and copper wires.¹

producing a quad flat pack no-lead package with 85 wires (a lower cost package) with Cu wires vs. gold. He assumed slower throughput that added 10% to the manufacturing cost and a wire cost savings of 85%. Figure 3 shows the results of this analysis.

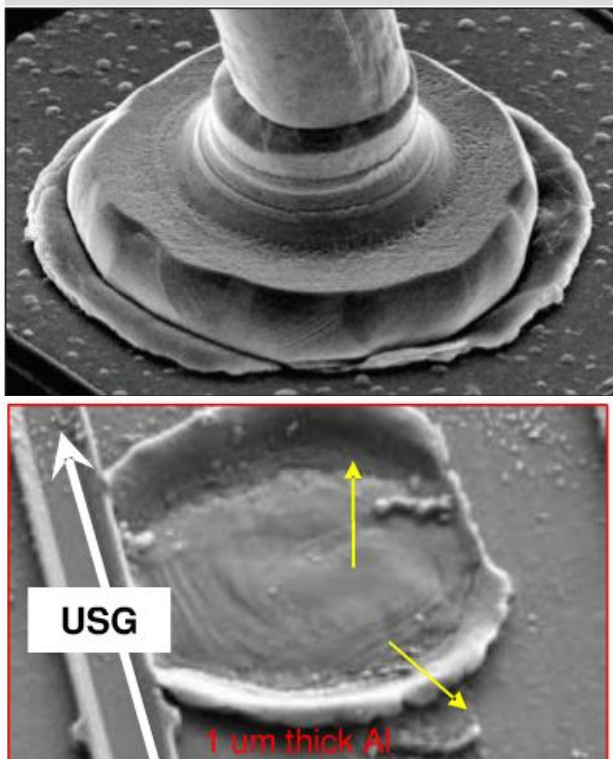
Figure 5. An example of Al splash.

Because of the higher hardness of copper, the process of pressing the ball onto the surface while vibrating will cause actual displacement of the Al on the bond pad. The softer Al will be forced out to the side, as shown in Figure 5. The harder the copper or the higher the bonding energy the more Al is moved to the edges of the ball. This leaves less Al on which the copper can bond. It also puts more stress on the underlying silicon or passivation layer, which can lead to

cratering (to be discussed next). Higher purity copper (softer wire) will help reduce the Al splash and minimizing the oxidation of the ball and improving the cleanliness of the bond pad will reduce the ultrasonic energy required for a strong bond (thus less splash). For example it has been found that use of forming gas will result in a much cleaner ball surface than if simple N₂ is used.⁴ Some amount of Al splash is acceptable, however it is important that enough Al remains to form a bond and that the remaining Al is not consumed to form intermetallic after long term aging.

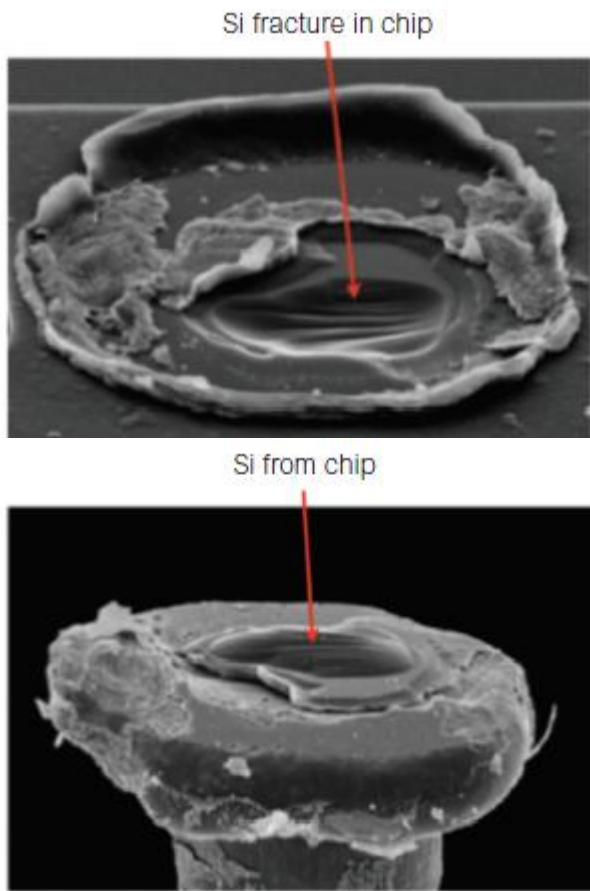
Figure 6. An example of cratering due to Cu wire bonding.

When the passivation layer or the silicon beneath the Al bond pad fractures it is called cratering. This type of defect is caused by too much ultrasonic energy being transferred to the Si and has become a more significant issue with Cu wire bonding. A small chip out type defect as shown in Figure 6, does not always cause an actual functional failure since active circuitry does not typically lie beneath the bond pads. However, it can cause weakness of the overall bond interface and can fail early in the field due to thermal cycle stress. It is important to perform bond pull and shear testing as part of the process optimization and to inspect the die surface and record the type of failure that is occurring. Interfacial fractures should not show signs of cratering. Thicker Al on the die pad can also be used to minimize cratering. The Al layer was purposefully rather thin for Au bonding to reduce the growth of thick Au-Al intermetallic, however, the Al-Cu intermetallic grows very slowly so the Al layer can presumably be made thicker without causing a reliability concern.

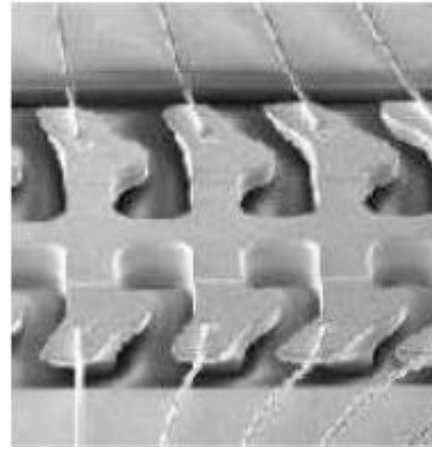
Figure 7. Bonding to a QFN lead can be difficult with copper, since the leads are not well supported.⁵

Consistent and solid support under the bond pad is also required for transfer of the thermosonic energy to the bond surface. This scrubbing energy is what allows the displacement of surface oxides and films that then allows metal-to-metal welding. Gold wire that has no oxide and is softer will allow bonding to a less rigid pad, however, copper is much less forgiving. For example with a QFN package, the gold plated bond pads on which the second

bond is placed, are supported by tape (see Figure 7). Cu wire bonding to these is difficult since the lead can move during the bonding operation. Additionally, it can be difficult to transfer heat to these bond pads.

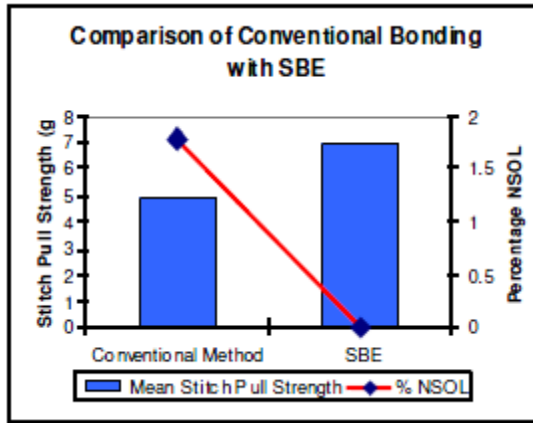
Figure 8. Results of using a stitch bond enhancement feature on a wire bond machine. Non-stick-on-lead failures were eliminated.

A ball bond machine used for fine pitch bonding creates two types of bonds. The first is the ball bond that was described previously. The second bond (or stitch bond) is created when the capillary crushes the wire against the bond surface. Oxidation of the copper wire becomes a greater concern with the second bond because the oxide has had longer to form on the wire surface (unlike the freshly molten ball). Additionally, this oxide layer must be broken through with less plastic deformation of the copper and the bonding area is smaller than the ball bond. There are a number of modifications that have been implemented to overcome a weak copper stitch bond. Some bond machines come with a Stitch Bond Enhancement (SBE) feature that includes programmable table displacement cycles, directions, amplitude and bond force/power.⁶ These have proven to be effective, as shown in Figure 8.

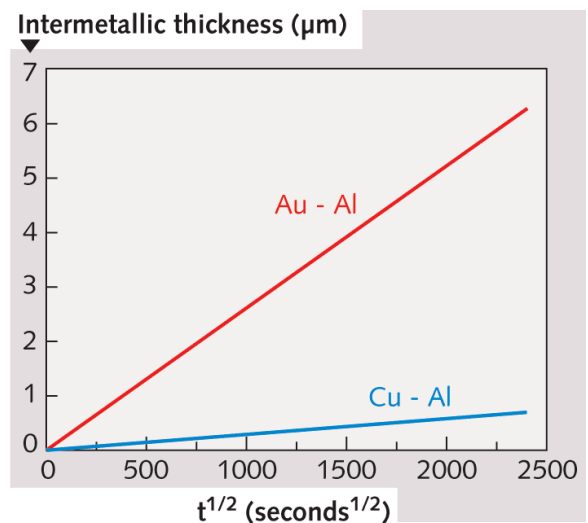
Figure 9. Growth of intermetallic thickness vs. time at 175°C.¹⁰

However, with Cu bonding to Al the intermetallic growth rate is much slower and the formation of Kirkendall voids is not a real concern. Figure 9 shows measurements of IMC growth for Au and Cu at 175°C.⁸ The growth rate is of Cu IMC is about 1/5 that of gold. Figure 10 shows cross section examples of IMC thickness under high temperature exposure conditions. As one might expect, the slower growth of intermetallic results in more stable bond strength over time at elevated temperature. Figure 11 shows shear strength of Au and Cu ball bonds made on Al bond pads after aging at various temperatures and times.⁹ Interestingly the strength loss differences are not nearly as pronounced as the IMC growth rates. At temperatures of 120°C or below Cu and Au are very similar in strength loss.

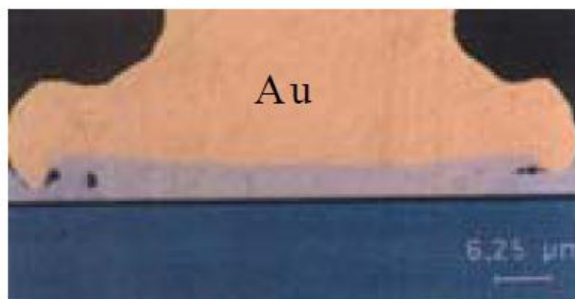
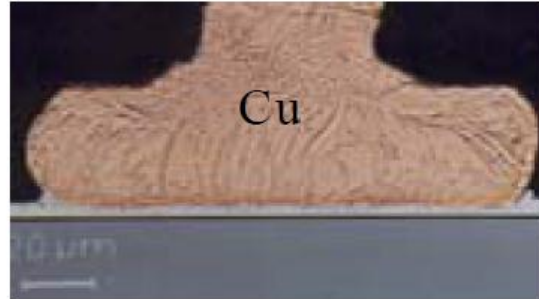
Intermetallic Penetration - AlSi-Au Bond (aged 200 hours at 200°C)

Intermetallic Penetration - AlSi-Cu Bond (aged 800 hours at 180°C)

Figure 10. A comparison of intermetallic growth rate with Au and Cu ball bonds on Al.¹

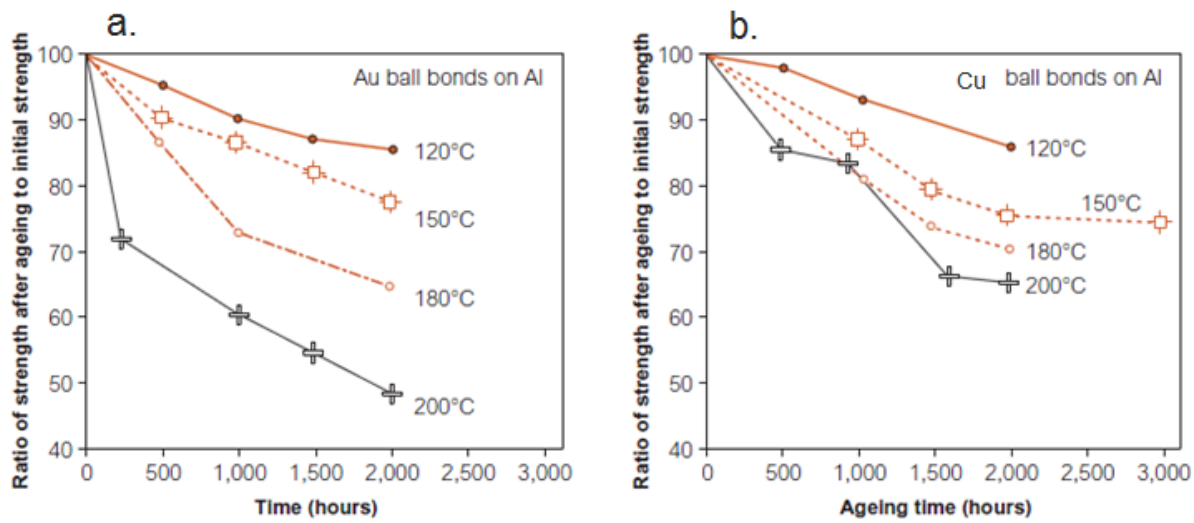
Figure 11. Shear strength of Au and Cu ball bonds on Al bond pads after aging. At temperatures of <120°C they are similar after 2000 hours.⁹

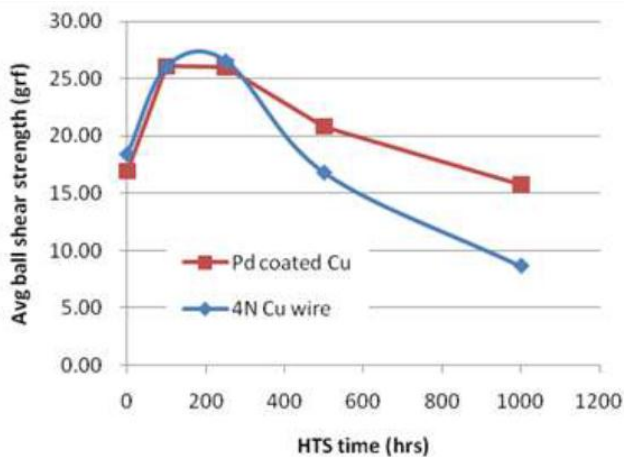
Figure 12. Shear strength of ball bonds after aging at 200°C.

More recent studies have shown some surprising results that occur when Cu wire or Pd coated Cu wire is aged at 200°C. It was found that Pd coated wire performed better over time (see Figure 12)¹¹. Most concerning was the discovery that after 500 hours of aging, the shear failure mode changed from fracture within the copper to a brittle crack along the IMC. Figure 13 shows such results. This newly discovered and concern actually highlights a common problem among component manufacturers and New Technology: the assumption that standard testing and standard acceleration factors (such as Peck's Law) are relevant for New Technology (hint: it usually isn't).

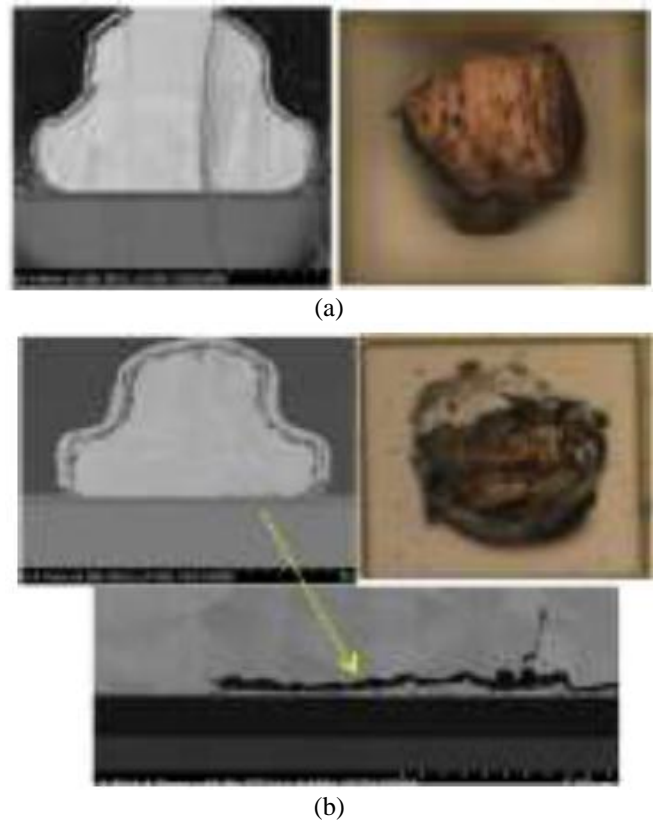
Figure 13. A change in fracture mode is observed from (a) 250 hours of aging at 200°C to (b) 500 hours of aging.¹¹

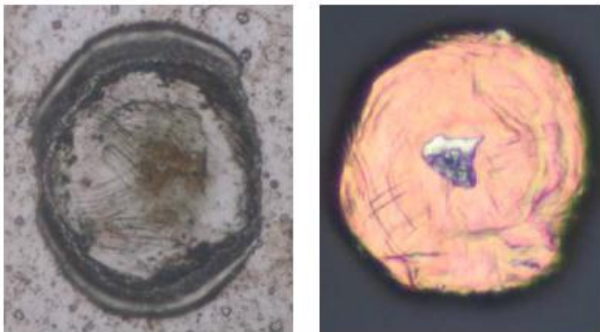
Figure 14. A weak interface revealed by ball shear after autoclave testing.

Even after large scale introduction of Cu wire bonding, the industry is learning about new and unexpected failure mechanisms. Perhaps the most worrisome is the susceptibility to oxidation/corrosion when exposed to autoclave conditions (130°C/85%RH plus bias).^{12, 13} This weakness was validated at the Fraunhofer Institute where they found early failures in T/H testing and determined it was due to galvanic corrosion of the copper oxides between the intermetallic and Cu bond wire.¹⁴ Figure 14 shows an example of the weakened and fractured interface between the Cu and the Al. Analysis showed the presence of Cl as a corrosion activator and high oxidation of the Al near the edges of the Cu ball. The primary IMCs that form in a Cu-Al bond is CuAl₂ and CuAl, however, this study also revealed a Cu₉Al₄ phase that formed presumably during preconditioning at 260°C. This Cu rich phase was highly susceptible to galvanic corrosion, acting as the sacrificial anode; leading to delamination.

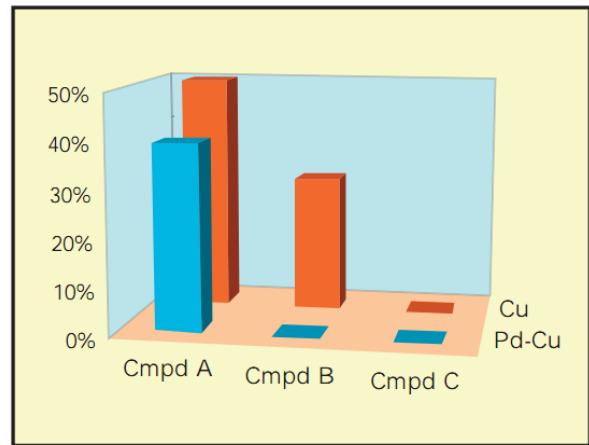
Figure 15. Failure rates after 336 hours biased HAST test for three mold compound formulations with 0.8 mil Cu wire on Al pads (5V bias, 130°C, 85% RH).¹⁵

Additionally, under voltage bias testing (T/H/B) the copper can migrate and cause shorting between pads on the device. The prevalence depends on the type of mold compound used, as noted by H. Clauberg (see Figure 15). In this failure mechanism, the Pd coating can actually help prevent the copper from migrating. The bottom line is that encapsulants and molding compounds should be carefully selected with Cu wire bonding. They should resist moisture absorption and be free of Chlorine, that is, contain fire retardants specifically designed to eliminate copper corrosion.
