Slow Body Diode Failures of Field Effect Transistors (FETs)

Slow Body Diode Failures: Root-Cause and Corrective Actions

A telecommunications customer recently experienced field failures in a power supply. DfR initiated a root-cause investigation to determine the drivers for the failure and provide recommended corrective and preventative actions.

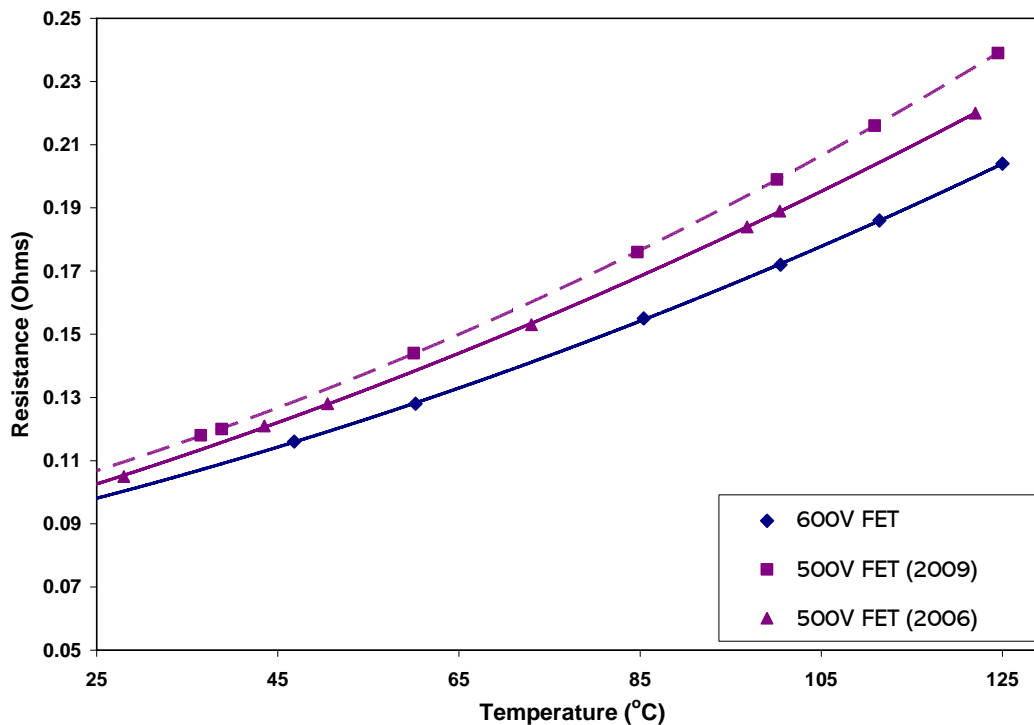
Figure 1

A comparison of the drain to source resistance between the 500V device and the 600V device is shown in Figure 1. This shows that RDS of the 600V device is lower and therefore better than the 500V FET.

Testing was done to compare the on resistance of the FETs as a function of temperature. The experimental design included a cold plate, a high current power supply, and a digital multimeter to capture voltage and current measurements. The FETs were thermocoupled and the plate temperature was adjusted till a steady state condition was reached at the temperature of interest.

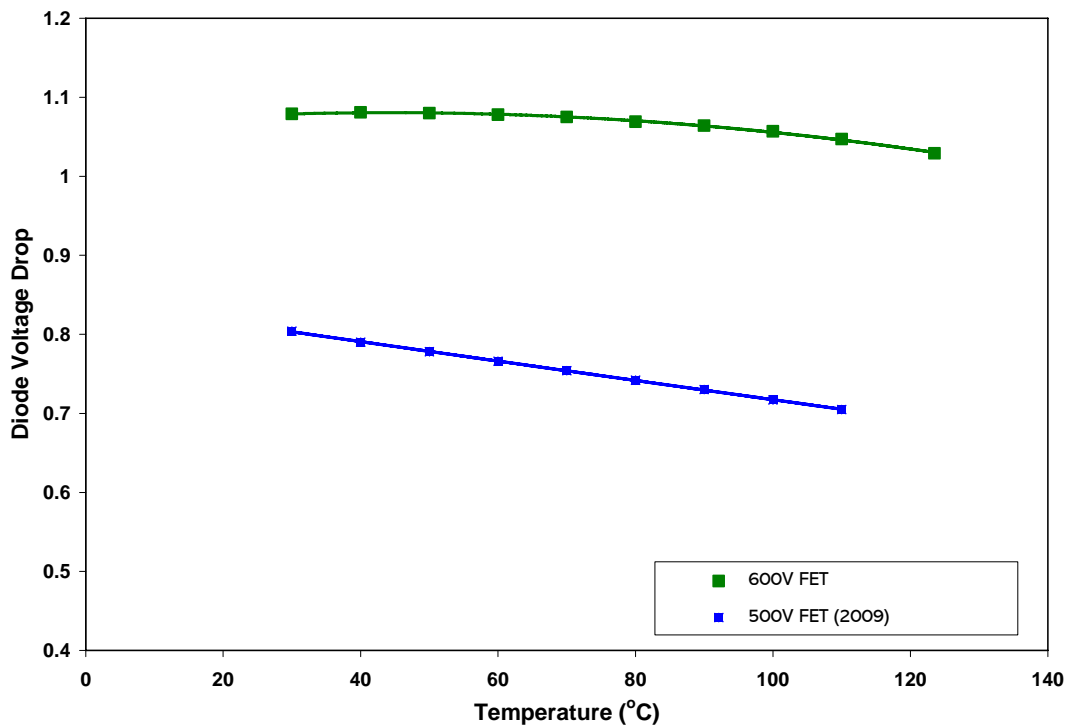
Figure 2

The same experimental setup used to capture drain to source resistance was also used to characterize the diode voltage drop as a function of temperature. One new 500V FET and one new 600V FET were tested. The results are shown in Figure 2. The 500V FET was found to have a significantly lower diode voltage drop than the 600V FET.

This finding is significant as a typical slow reverse recovery diode will have a 0.6V to 0.8V forward drop. In FETs, these body diodes are normally slow and can be modified by doping the junction with gold or irradiating the device to damage the lattice which reduces the minority carrier life times and charge. This in turn reduces the reverse recovery time of the diode so that it can be used in faster circuit applications. However, the forward voltage is increased above 1V and as high as 2V for hyper-fast diodes used in PFC Boost applications. Therefore, this shows that 600V device had a much faster, lower charge body diode than the 500V device and is more suitable for the use in this power supply design.

Based on the knowledge gained in the failure investigation, the most likely theory for the cause of failure is related to the slow body diode characteristics of the 500V FET. As mentioned earlier, the 500V FET had a body diode with properties consistent with body diodes found in slower devices. A paper by International Rectifier titled "MOSFET Failure Modes in the Zero-Voltage-Switched Full-bridge Switching Mode Power Supply Applications," explains a failure mode using slow reverse recovery body diode devices. The failures result when a parasitic transistor turns on and allows high current to be drawn from drain to source when the FET is off. This results in overheating of the device similar to what was observed in the failed devices. The die and source bond connection showed high current yet there was no damage to the gate.

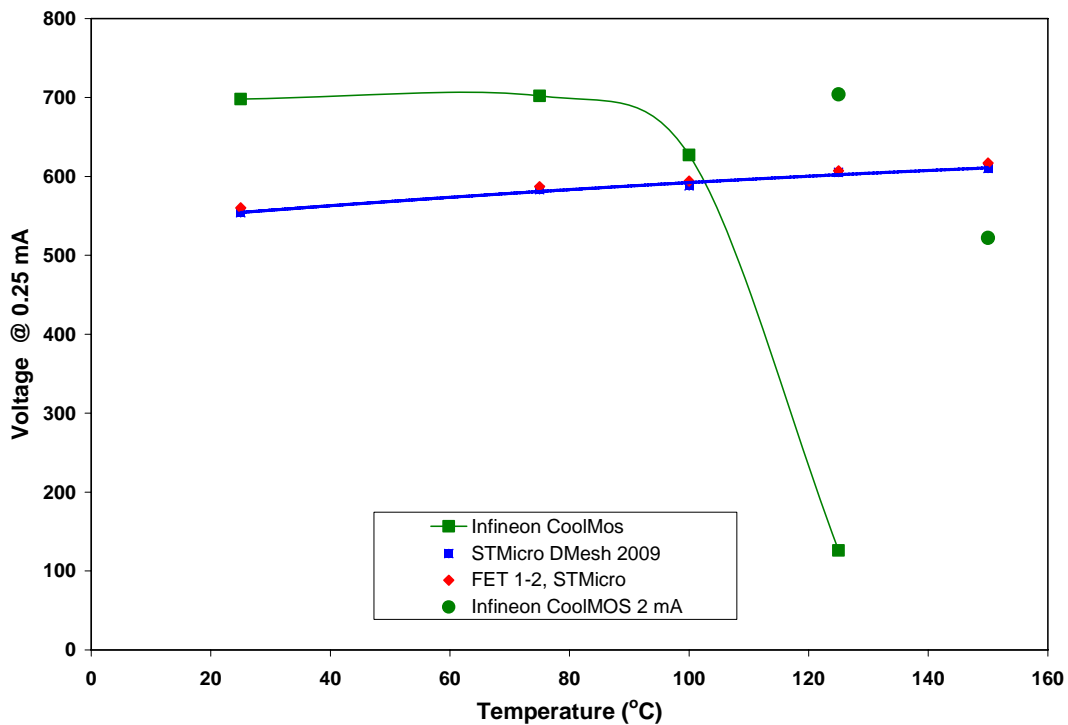
Figure 3

Additional testing of the breakdown voltage at elevated temperatures was conducted to determine the effect of temperature on the breakdown voltage. Testing was done at 250µA per the 500V FET manufacturer’s specification (note: the 600V FET manufacturer specified a much higher leakage current). The results for the breakdown voltages are shown in Figure 3.

The 500V devices had higher breakdown voltages at 250µA above 100°C junction than the 600V devices. This can be a problem with the 600V FETs because the power dissipation will be higher if the leakage current is increased. However, within the current application, the devices were running below 100°C junction. Given this operational condition, in combination with an applied voltage of 400V, this differentiation is not expected to be relevant to the failure mode.
