How Mitigation Techniques Affect Reliability Results for BGAs

Greg Caswell and Melissa Keener

DfR Solutions

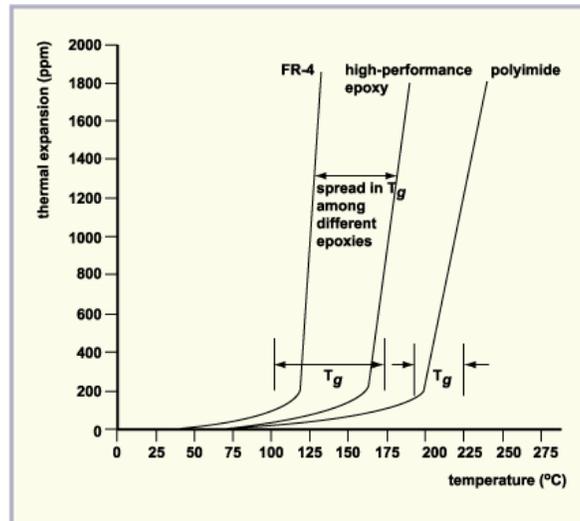
Figure 1: Graph of Glass Transition Behavior of board materials from www.mtarr.co.uk/courses/topics/0140_pl/index.html

With the enforcement of RoHS requirements, there has been some concern about the reliability of lead-free solders. The reliability of tin lead solder is well known as a robust solder and the failure rate is well characterized, whereas SAC solders are known to be less robust which is a problem for some high reliability applications. One solution is to mitigate the solder joints with a staking material to strengthen the joint, but the problem is choosing the correct material for the application. Several material properties, such as glass transition temperature (T_g) and coefficient of thermal expansion (CTE), need to be properly chosen. Improperly chosen mitigation materials will cause premature failures instead of extending the time to failure. If the expected operating temperature of the device is too close to the T_g , the CTE will drastically change which can cause solder joint failures as shown in Figure 1.

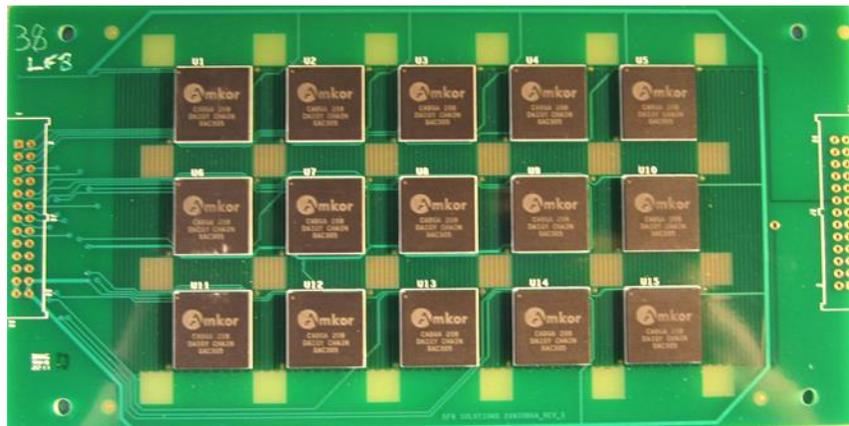
Figure 2: Test PCB

This study chose to focus on one component type: the Ball Grid Array (BGA). The BGAs that were chosen were 15mm by 15mm packages with 208 balls. The balls were 0.5mm in diameter and had a pitch of 0.8mm. The balls were attached to the BGA along the perimeter 4 rows deep. The BGAs were purchased with tin lead (SnPb) balls and reballed to attach the SAC305 and SN100C solder balls. The reballing process does not have an effect on the reliability of the component, it could increase the strength of the solder ball interconnect by at most 10%. [1] These BGAs were attached to 4 layer FR4 printed circuit boards (PCBs) as seen in Figure 2.

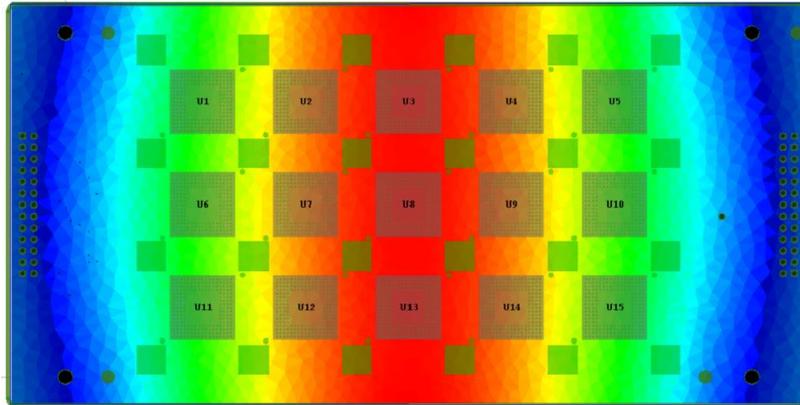
Figure 3: Finite Element Analysis of Test PCB showing natural frequency of the board

The PCBs arranged the components into 4 rows and 5 columns. The placement of the component was determined by first vibration mode as calculated through finite element analysis and shown in Figure 3. The figure shows that the center column and the column on either side are in the highest strain area. The two outside columns are in a lower strain area. This was done so that multiple strain levels could be investigated on one test PCB.
