White Paper

SnBi and SnPb

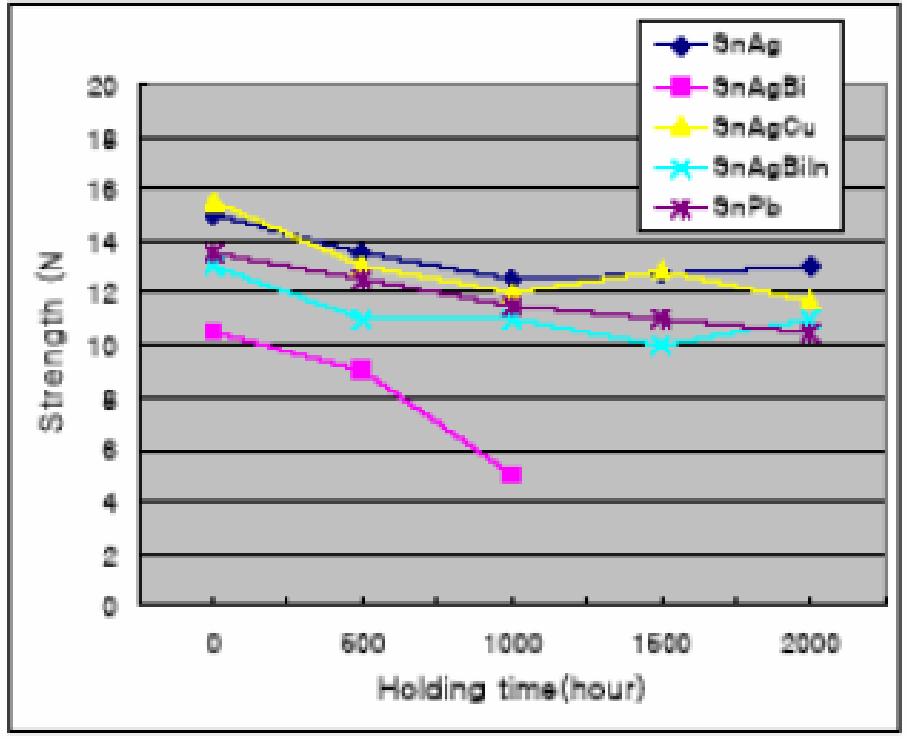
Figure 1: Change in fracture strength after aging as a function of solder and SnPb plating

- Strength degradation immediately after soldering SnPb-plated components with Sn3.0Ag5.0Bi (see Figure 1)¹
- Significant degradation in plasticity and fatigue life for a 93.3Sn/3.1Ag/3.1Bi/0.5Cu solder joint contaminated with 0.5% Pb²
- Reduction in tensile strength after soldering Sn10Pb-plated components with Sn2.5Ag1Bi0.5Cu (see Figure 2)³

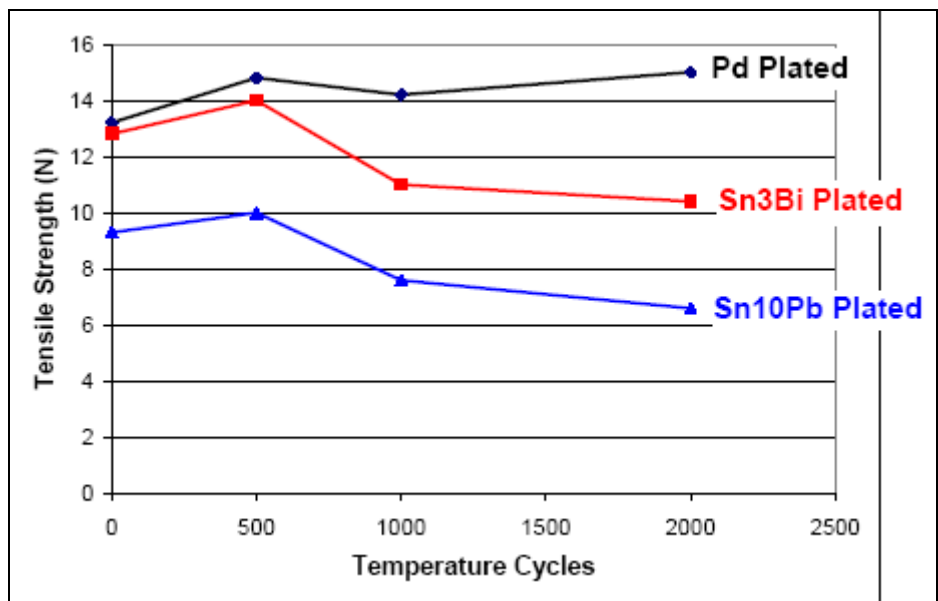
Figure 2: Tensile strength of quad flat pack (QFP) leads attached with Sn2.5Ag1Bi0.5Cu solder
